SERVICE BULLETIN

Reference number:	SB-06-1117V3	Issued: 22 August, 2019
Subject:	Brake Squeal	
Model(s):	DB11 & Vantage 19MY (with steel brake discs)	
VIN Range:	All	
Applicable to:	All Dealers	
Distribute to:	After Sales Manager Executive Manager Service Manager Sales Manager	Warranty Staff Technician(s) Parts Staff

Reason for this Service Bulletin

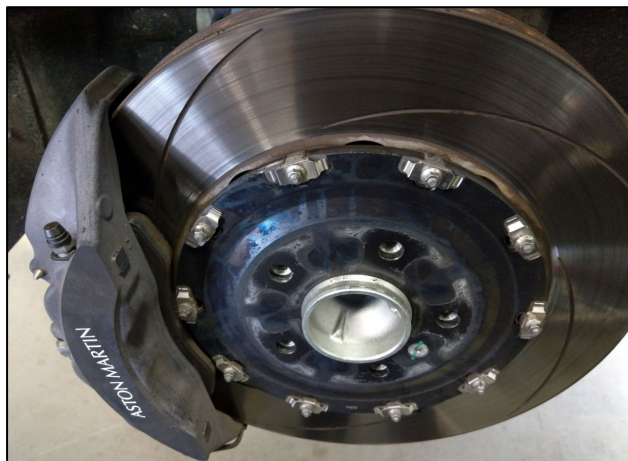
Do a visual inspection of the brake discs, pads and wheel mounting face for signs of external contamination. If there are signs of external contamination because the incorrect wheel cleaner was used, this damage will not be covered by the vehicle warranty. The brake pads must be replaced. Figure 1 gives an example of contamination on the wheel mounting face and caliper.

4. Use an abrasive paper to fully clean the braking surface of all four brake discs.
5. Clean all brake dust and contaminants with an aerosol brake cleaner.
6. Apply Tunap paste to the rear of the brake pads (refer to Service Bulletin SB-06-0344V2).
7. Do Service Bulletin: SB-06-1005 - Low-Speed Brake Modulation, if applicable.
8. Do the brake pad bedding-in procedure (refer to Workshop Manual procedure 06.03.BC)
9. If there is still a noise, start a SpotLight case for authority to send an order for parts with the -BB suffix.

Aston Martin recommends that After-sales personnel speak with the customer about what products they use when their vehicle is cleaned. Acidic cleaners can cause contamination of the brake pads which can cause brake noise symptoms.

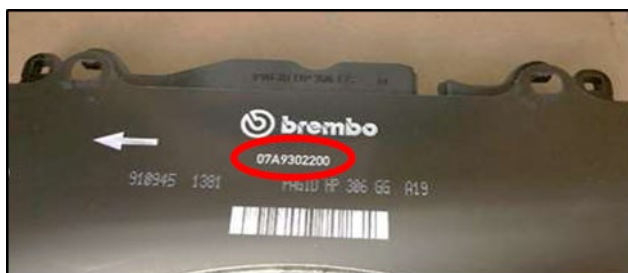
Figure 2

1. Remove the brake pads (refer to Workshop Manual procedure 06.03.AD or 06.04.AD).
2. Do a check of the manufacturer's part number (refer to Figure 2).

3. Use the manufacturer's part number to find the Aston Martin part version, in the table below (refer to Figure 3). Follow the recommendation for the part version.

- Pictures of the brake discs, pads, pad level information (refer to Figure 2), hubs and calipers
- A video file, with audio, before steps 1-6 are done.
- A video file, with audio, after step 6 is completed.
