**TECHNICAL INSTRUCTIONS
FOR
LIMITED SERVICE CAMPAIGN GLI
CARPET FLOOR MAT REPLACEMENT
CERTAIN 2016 MY RC 300 AWD & RC 350 AWD**

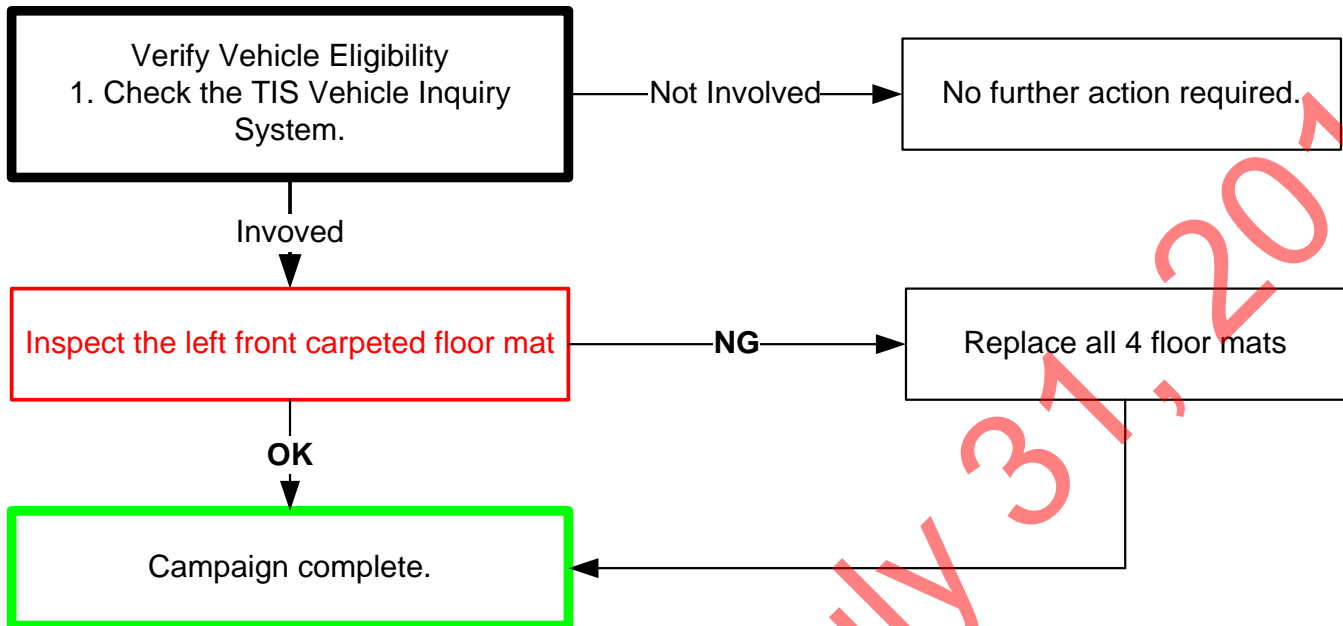
I. OPERATION FLOW CHART

The flow chart is for reference only. **DO NOT** use it in place of the full technical instructions. Follow **ALL** steps as outlined in the full technical instructions to confirm the campaign is completed correctly.

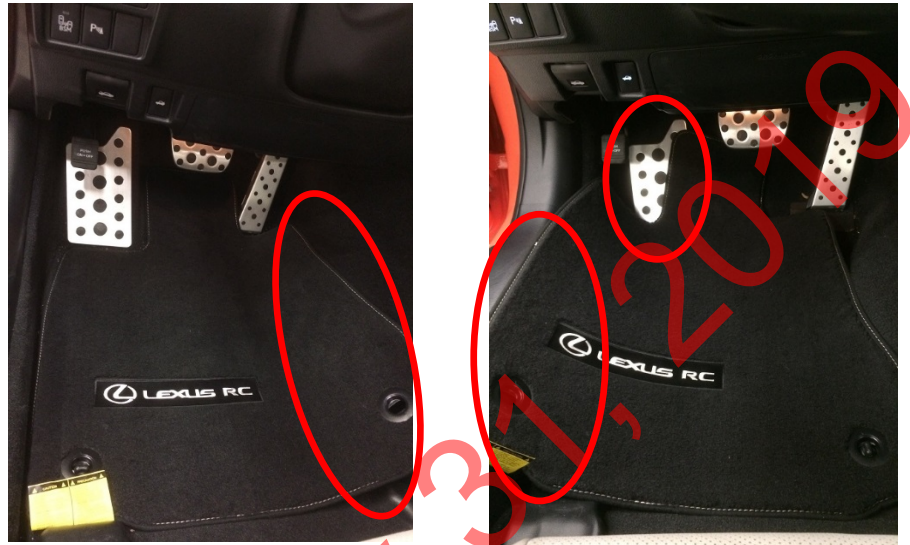
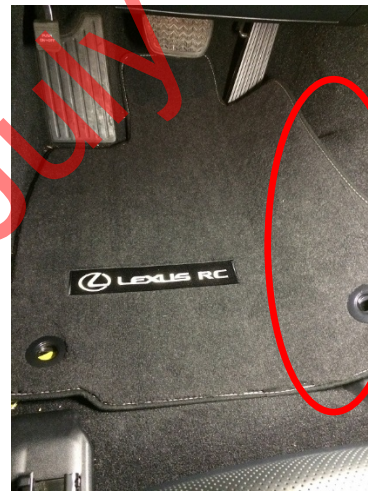
The subject AWD (All-Wheel Drive) vehicles received a set of carpet floor mats designed for a RWD (Rear-Wheel Drive) model. If installed, the driver's floor mat is too wide and cannot be secured in the correct position using the retaining clips.

The edge of the mat does not fit in the vehicle correctly.

The dead pedal may be partially covered.

One or both rear hold down clips do not line up and are unsecured.

**THIS IS THE INCORRECT MAT
REPLACE ALL 4 FLOOR MATS**

NOTE: All-weather floor mats are not involved in this LSC. If all-weather floor mats are installed in the vehicle and the carpeted floor mat is NG, place the new mats in the trunk. DO NOT install the carpeted mats on top of or under the all-weather mats.
