**Parasitic Draw - Dead Battery**

**2018 C-HR**

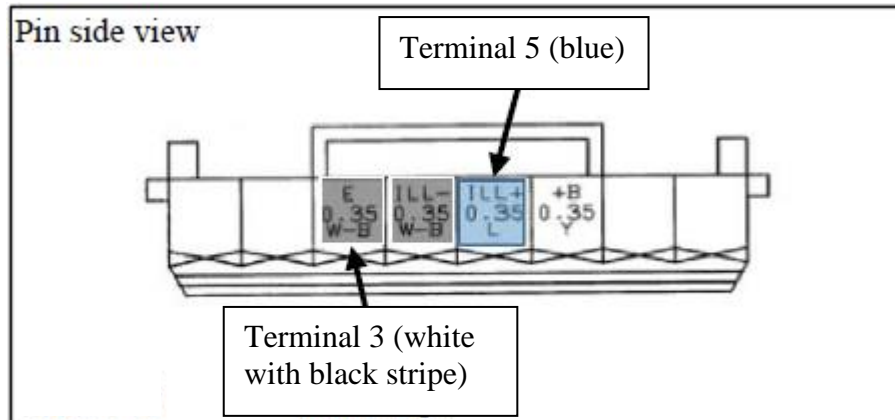
On connector F6 (Auto High Beam Switch) confirm the Scotchloks, used to install the fog lamp switch, are installed on terminals 3 and 5.

Inspect fog lamp switch for proper installation.
