# Keystone RV Company

## SERVICE ADVISORY # 19-353

### Fuzion Skylights

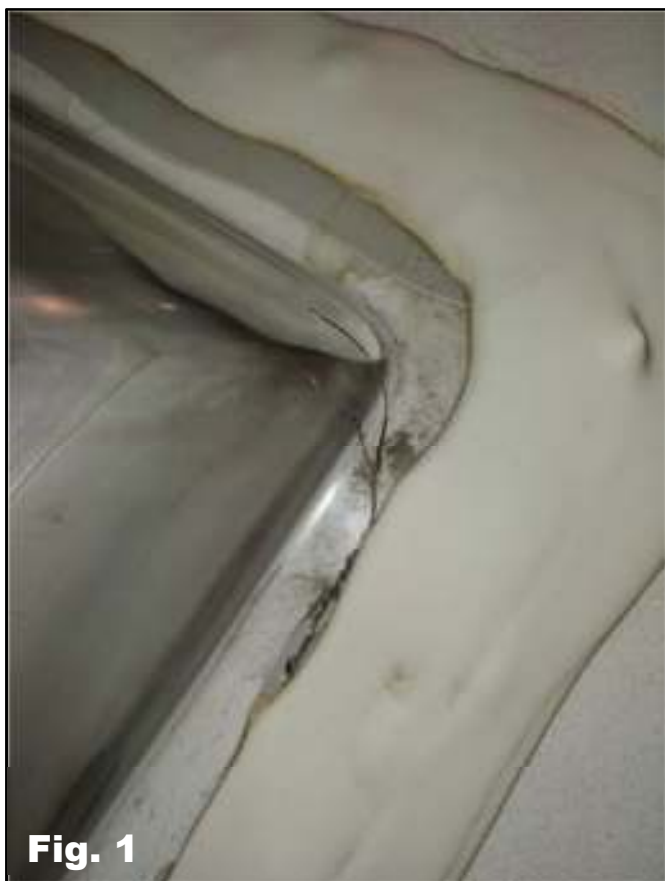
**Fig. 1**

It has been determined that Polycarbonate skylights used on Alpha Flex roof systems may crack. The following procedure describes how to identify and replace the polycarbonate skylights.

The remedy is to inspect the clear polycarbonate skylight on the new Alpha Flex Roof system. Inspect the clear skylight for cracks and replace if cracks are found. See Figure 1 as an example. A clear picture is required for authorization and the claim.

Locate the skylight on the exterior roof and inspect for cracks. If the skylight is cracked, take clear pictures for the authorization showing the defect. If no cracks are present, proceed to warranty reimbursement below and submit a claim for inspection. If the skylight is cracked, proceed to Step 3.

If the skylight is cracked, remove the skylight using normal industry standards and replace with the new skylight (KRV # 237000) using butyl tape (KRV # 100292) under the skylight as a primary seal and Alphathane (KRV # 639155) as a self-leveling secondary seal, then proceed to warranty reimbursement.
