Customer Satisfaction Campaign

Code: 91W4

Subject Performance Monitor

Problem Description The Performance Monitor was not activated for certain 2019 model year Volkswagen Golf R vehicles.

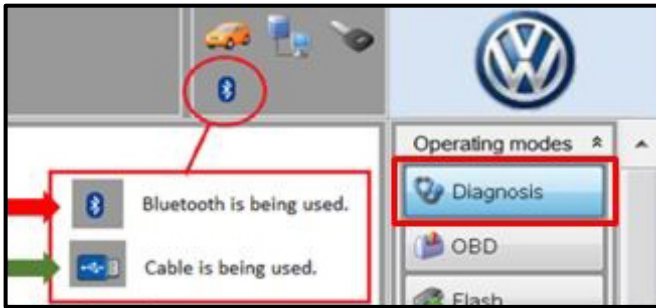
- Confirm that scan tool is communicating with the diagnostic head by USB <Green Arrow>.
 - If the Bluetooth symbol is shown <Red Arrow> then disconnect the diagnostic head from the vehicle and reconnect the USB cable to the diagnostic head and then reattach to the vehicle.
- Upon ODIS startup, verify the “Diagnosis” operating mode is selected <as shown>.

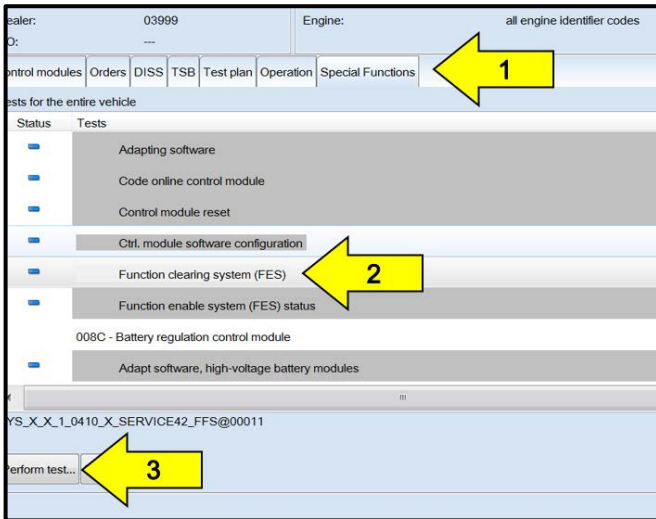
- Once the GFF scan is complete, select “Special functions” <arrow 1>, then “Function clearing system (FES)” <arrow 2>, then select “Perform test” <arrow 3>.

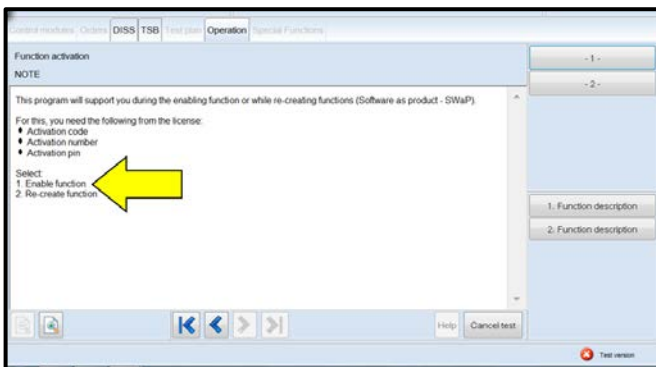
- Select the option to “Enable function”.
- Follow the on-screen prompts and enter the activation code, activation number and activation PIN when prompted.
- Follow the on-screen prompts.
- Enter your GEKO ID when prompted and follow the on-screen prompts.

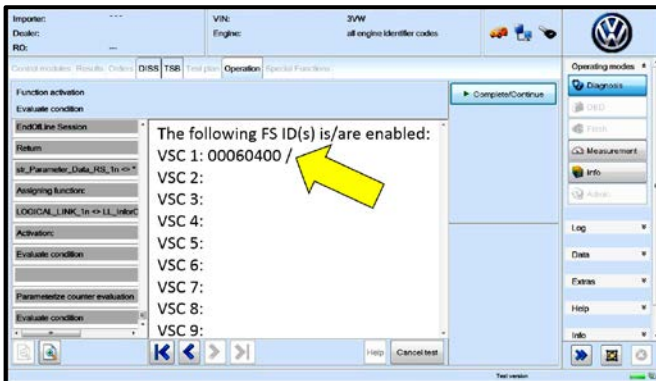
- Verify the license ID number <arrow> is displayed.

- The license ID number <arrow> assures that the Performance Monitor feature has been activated.
- The list of enabled FS ID(s) may vary based on what other features are already enabled.

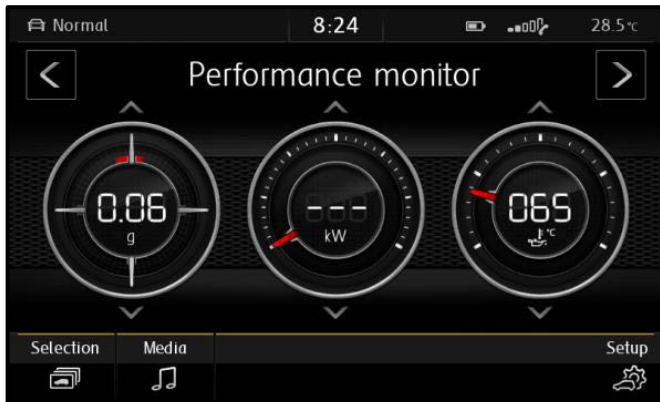
- The feature may not activate until the following is performed:
 - Disconnect scan tool from vehicle.
 - Shut ignition off.
 - Remove key from vehicle and lock vehicle with remote.
 - Wait approximately one minute for cluster to go blank.
- When the ignition is turned back on, the feature should now be available.
- The Performance Monitor feature can be accessed as follows:
 - Select **CAR** <arrow 1>.
 - Open the **Selection** menu <arrow 2>.
 - Select **Sport** <arrow 3>.
