# Service Bulletin

Bulletin No.: 19-NA-099

**Subject:** Add-On Equipment Inoperative, Melted Terminals on Auxiliary Relay, New Auxiliary Battery Relay for Police Tahoe Vehicles

**Attention:** This bulletin only applies to the Police Patrol Vehicles (PPV).

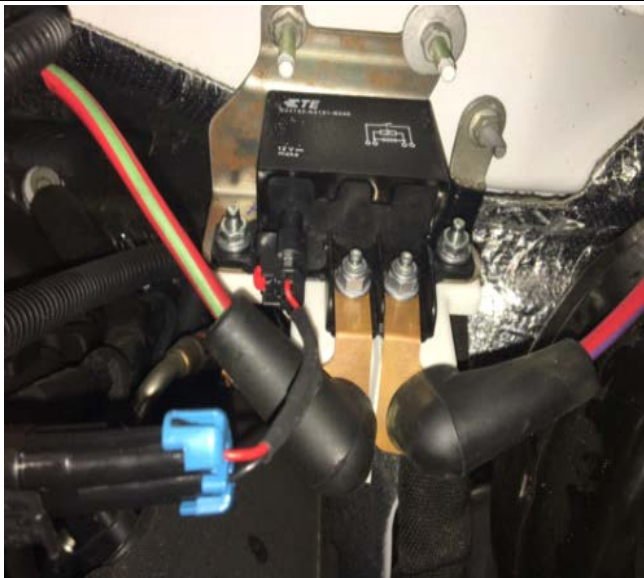
<b>Involved Region or Country</b>	North America, N.A. Export Regions
<b>Additional Options (RPOs)</b>	
<b>Condition</b>	Customer may comment on add-on equipment inoperative or possibly seeing melted terminals on the auxiliary battery relay.
<b>Cause</b>	The cause of the condition may be overheating of the relay during charging the auxiliary battery.
<b>Correction</b>	<div data-bbox="682 993 1321 1566" data-label="Image">

</div> <p>5333969</p> <p>Replace the original relay with new relay service part, shown in the graphic above. The new relay is more heat tolerant and should resist melting and losing electrical contact. Refer to the Service procedure below.</p>
