SIB 24 03 19

ZF 8HP – NO COMMUNICATION WITH EGS

2019-08-27

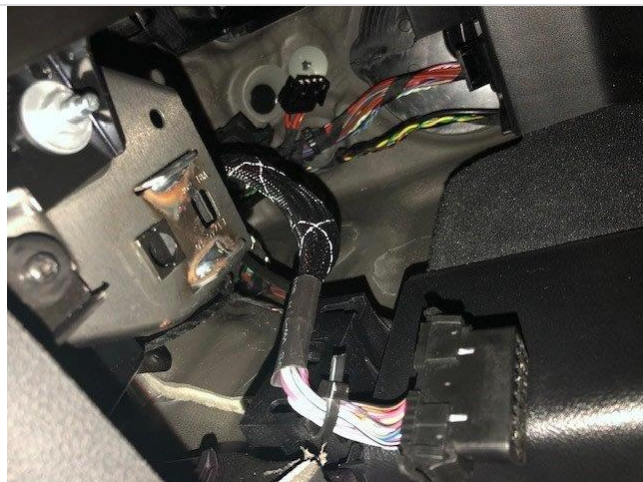
The V-adapter harness is shown installed to the OBD connector.

The OBD connector's part of an adapter is shown attached to dashboard support (usual location).

Prior to starting any diagnosis, first check for the presence of a tracking device V-adapter, and disconnect it.

Locate and remove vehicle's tracking device during diagnosis/programming session.

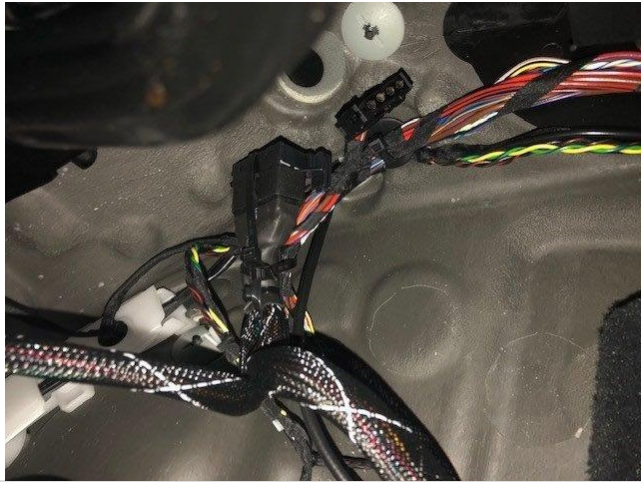
The other end of the OBD V-cable adapter, with the vehicle's tracking device connected.

The V-cable with the attached tracking device is hidden under the dashboard.

- If programming is successful, reconnect the tracking device
