# Technical Service Bulletin

<b>Topic</b>	Rotating Display - Fault Diagnosis
<b>Market area</b>	Bentley: worldwide (2WBE),Hongkong-Macau (5HK)
<b>Brand</b>	Bentley
<b>Transaction No.</b>	2055580/1
<b>Level</b>	EH
<b>Status</b>	Released for publishing
<b>Release date</b>	Aug 21, 2019

Various rotating display operational complaints or noises.

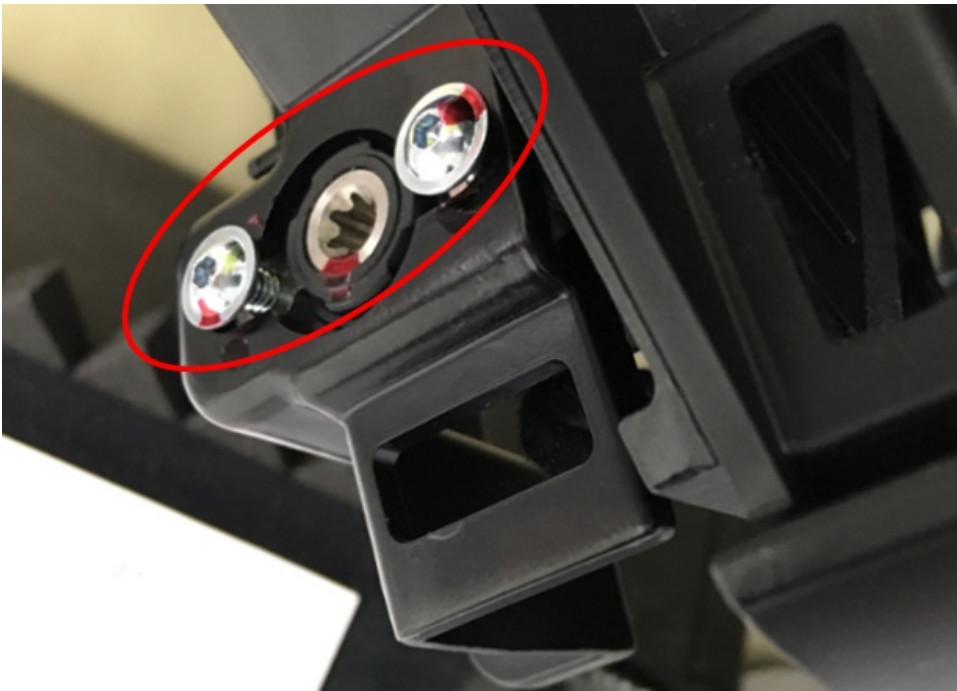
Figure 5

Check the tightness of the fixing screws highlighted (Figure 5), there are 8 fixing screws in total.

Check and retighten where necessary (3 Nm).

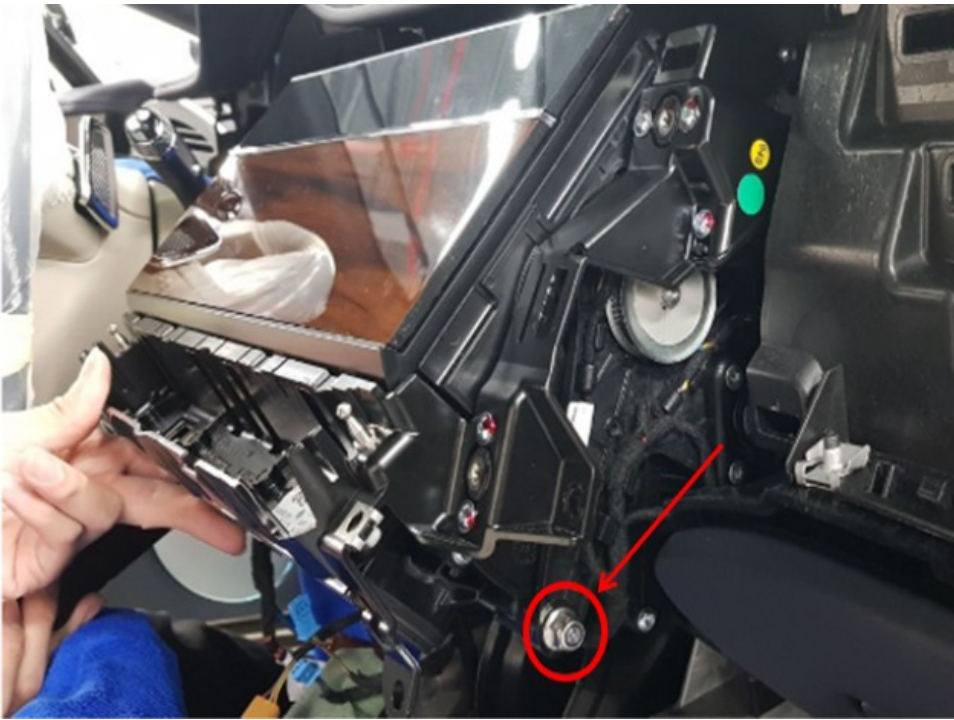
Figure 6

Check the tightness of the fixing nut highlighted (Figure 6), there is one nut on each side of the assembly.

Check and retighten where necessary (5 Nm).

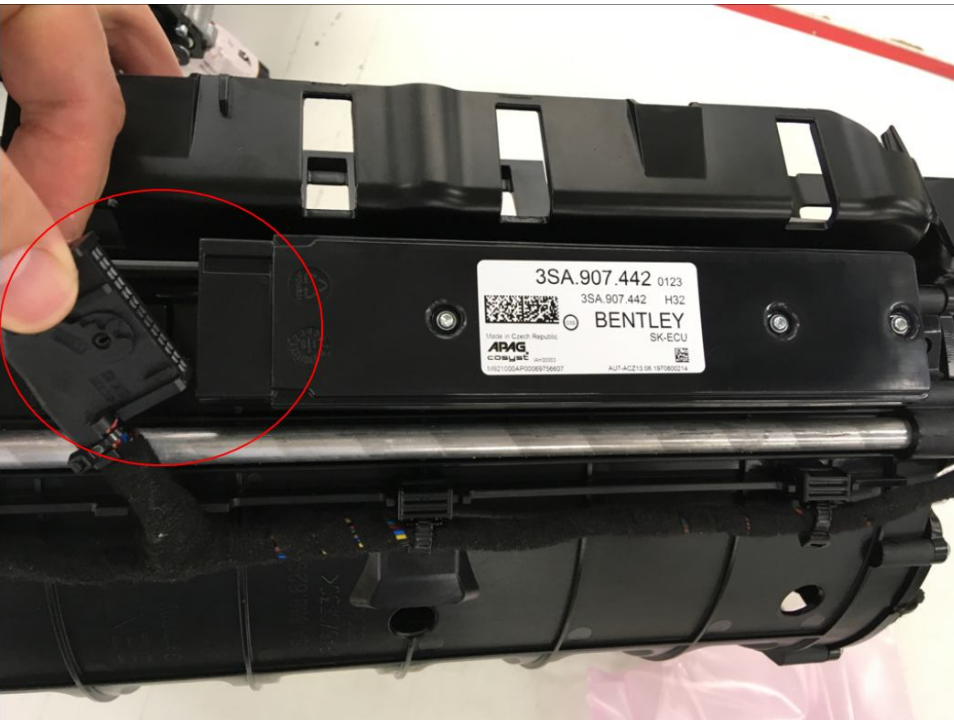
Figure 7

Disconnect and reconnect the connector from the control module (Figure 7).

**IMPORTANT:** After carrying out all check/repairs, refit the rotating display to a state that it can be tested then carry out re-initialisation and retest.

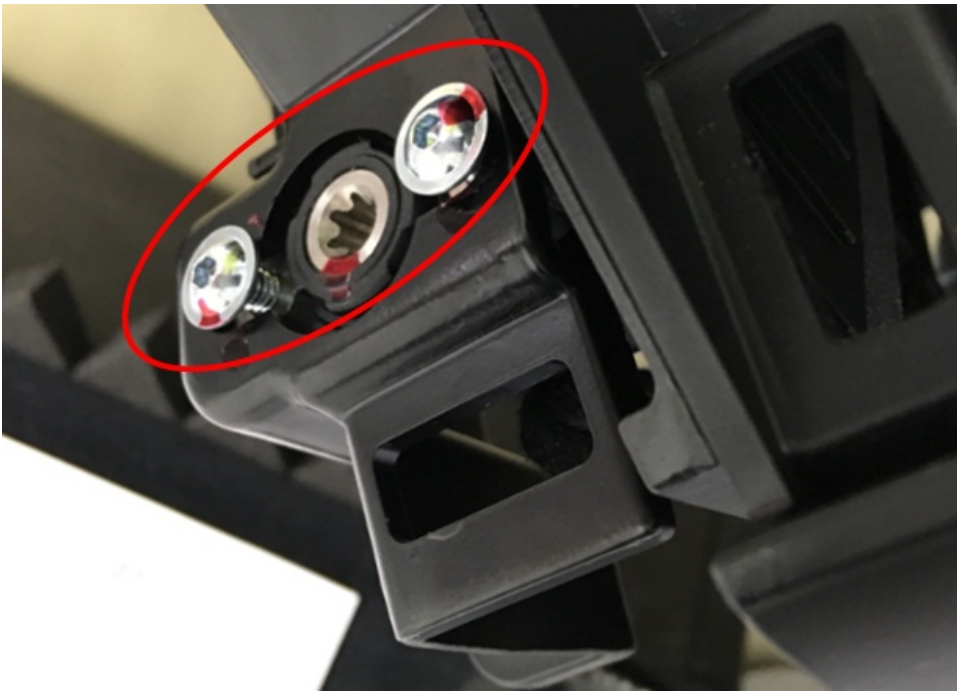
Figure 9

1. Remove rotating display then check and if necessary tighten fixing screws highlighted (Figure 9), there are 8 fixing screws in total. Check and retighten where necessary (3 Nm).

2. Refit the rotating display to a state that it can be tested then carry out re-initialisation and retest.

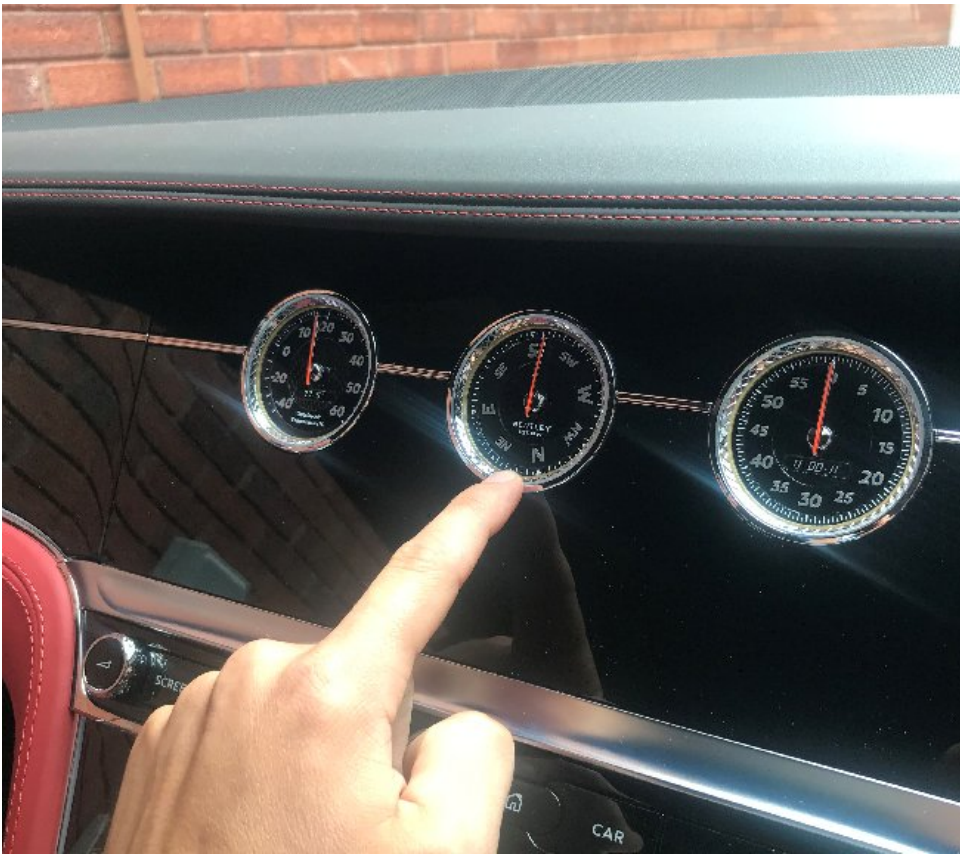
Figure 10

When noise is evident, press on outer bezels (Figure 10). If the noise disappears when the bezels of the dials are pressed then replace the dials.
