CVT Fill Plug Pops Out or Leaks?

Year	Model	Trim
2016-18	Civic	ALL with CVT
2015-18	Fit	ALL with CVT
2016-18	HR-V	ALL with CVT

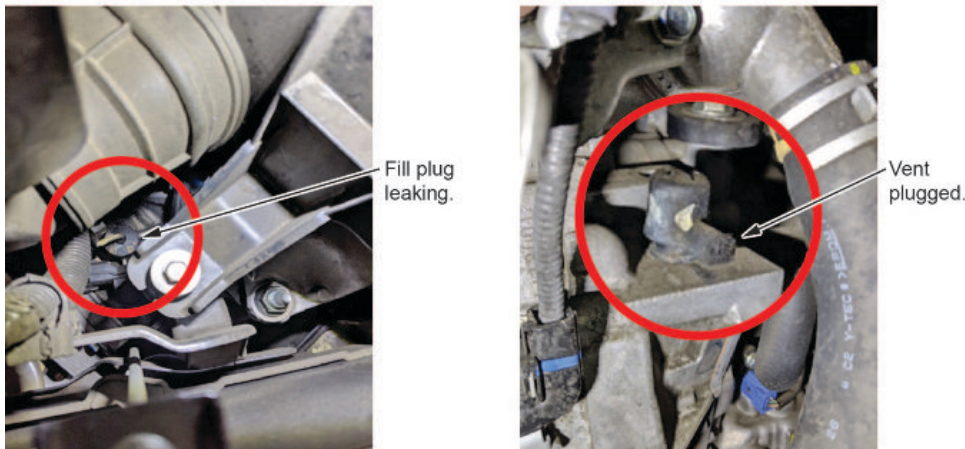
Have you noticed the fill plug on a CVT has popped out or seems to be leaking? This is caused by pressure building up at the fill plug due to the vent cap getting plugged with debris.

To fix the issue, simply remove the vent cap, clean it out with compressed air, and install with the arrow in the same direction. Then, replace the fill plug if it fits loose or has popped off and, if needed, top off the CVT with Honda Genuine HCF-2 Transmission Fluid (P/N 08200-HCF2)
