September 2019  
SF591A-D

## Subject: Wabco HP Air Dryer Turbo Cut-off Valve

**Models Affected:** Specific Model years 2019-2020 Freightliner 122SD, Cascadia, Western Star 4900, 5700, and 6900 manufactured March 6, 2018, through June 7, 2019, and equipped with a WABCO HP air dryer.

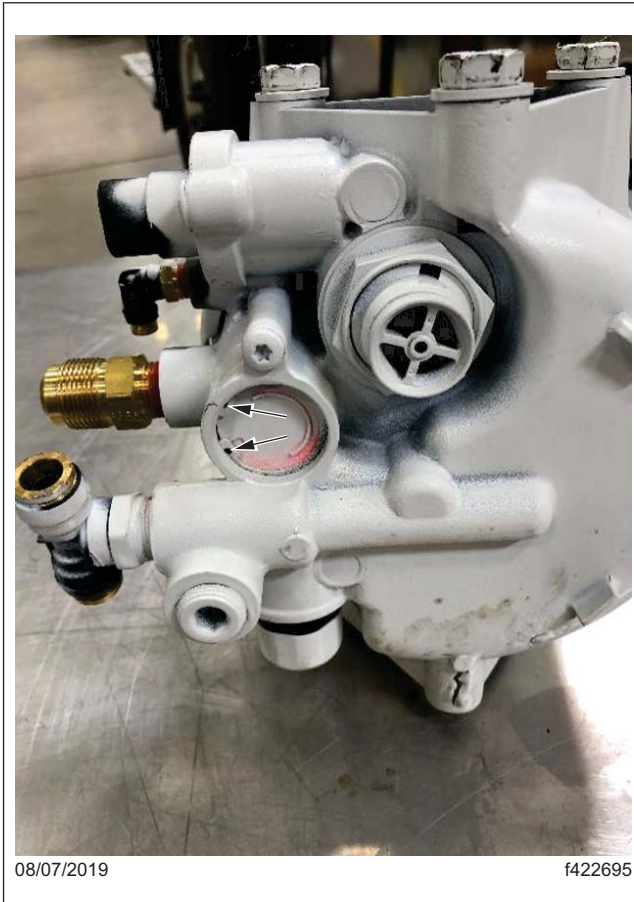
**Fig. 1, Snap Ring Holes**

11. Remove the snap ring that holds the turbo cut-off valve to the air dryer. See [Fig. 1](#).

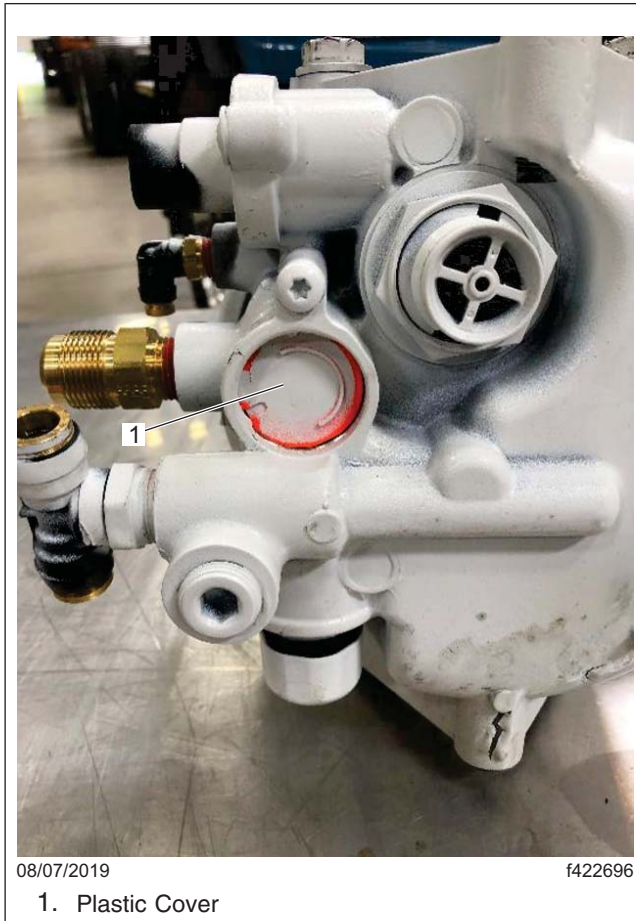
**Fig. 2, Removing the Plastic Cover**

12. Remove the plastic cover (orange and white in color) from the turbo cut-off valve. See [Fig. 2](#) and [Fig. 3](#).

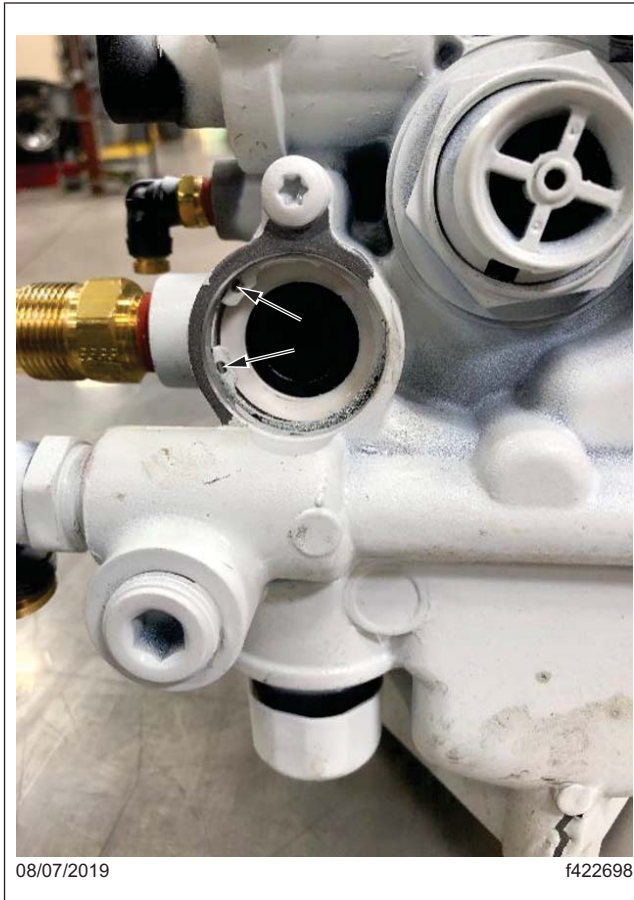
**Fig. 4, Snap Ring Installed**

13. Install the snap ring. See [Fig. 4](#).
14. Using 15 psi (103 kPa) shop air through the signal port of the air dryer, dislodge the turbo cut-off valve. See [Fig. 5](#).

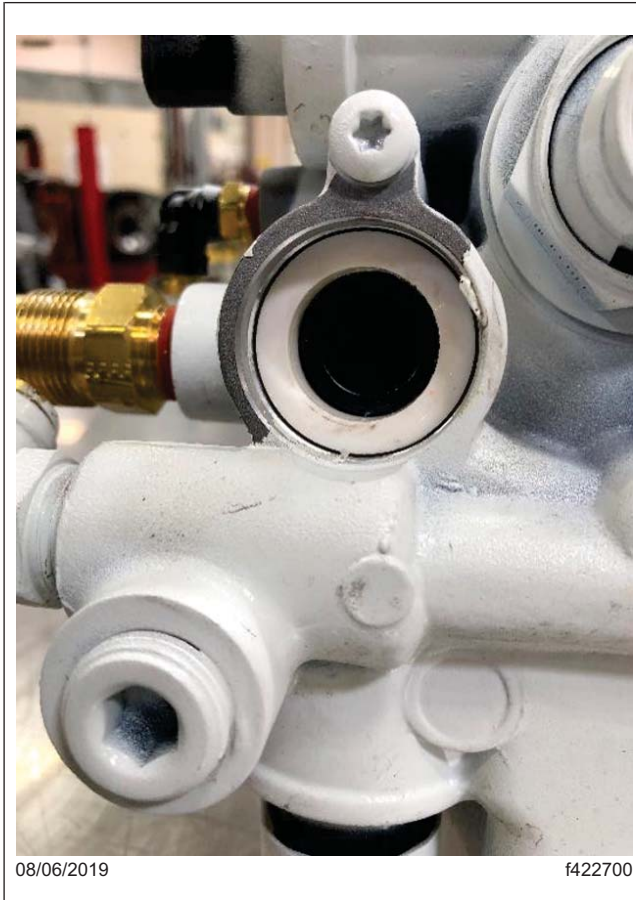
**Fig. 6, Snap Ring is Removed a Second Time**

15. Remove the snap ring again. See [Fig. 6](#)
16. Remove and discard the turbo cut off valve. See [Fig. 7](#) for an example of the valve.

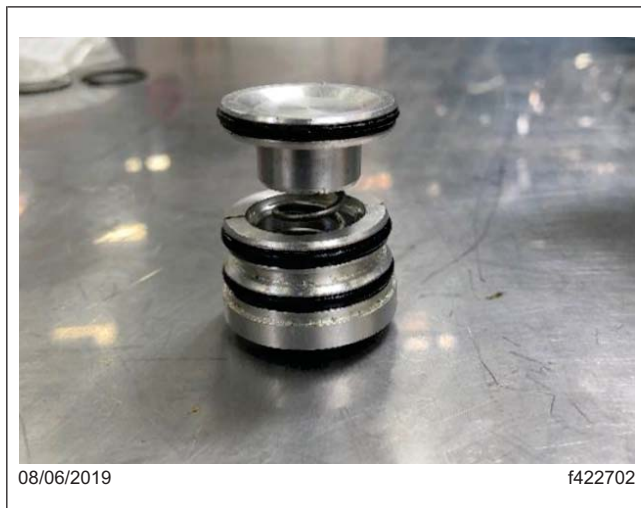
**Fig. 8, New Valve to be Installed**

19. Install the new turbo cut-off valve on the air dryer. See [Fig. 8](#) for an example of the valve.
20. Install the snap ring. See [Fig. 9](#).
