Subject: N192222300 - Customer Satisfaction Program
Transfer Case Oil Leak

Models: 2019 Chevrolet Silverado 1500 (New Model)
2019 GMC Sierra 1500 (New Model)
Equipped with Single Speed Transfer Case (RPO NP0) or 2-Speed
Transfer Case (RPO NQH)

Customer Satisfaction Program

N192222300 Transfer Case Oil Leak

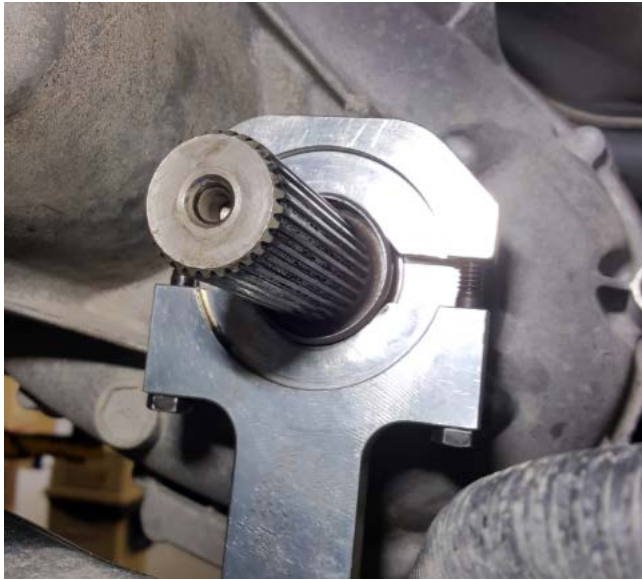
5360261

2. Install DT-51329-A on the transfer case front output shaft seal slinger as shown above.

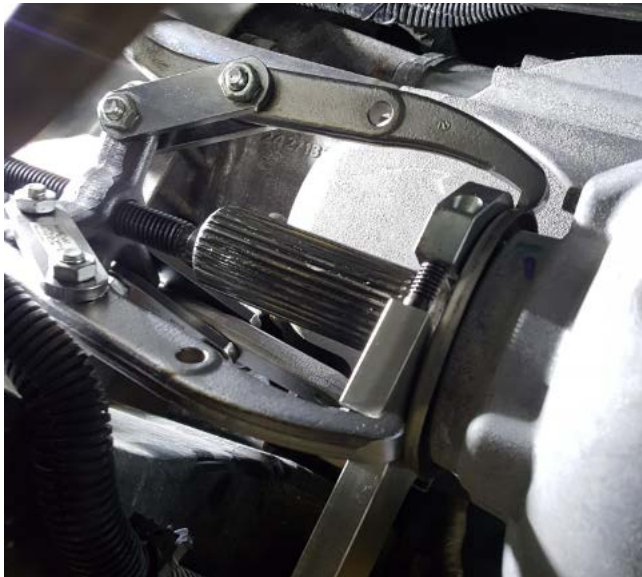
5360262

3. Using a standard 3-jaw puller, remove the slinger from the output shaft seal.

Caution: Take care not to damage the transfer case when prying the front output shaft seal out. If the transfer case is damaged excessively during seal removal, the new seal may not seal properly after installation.

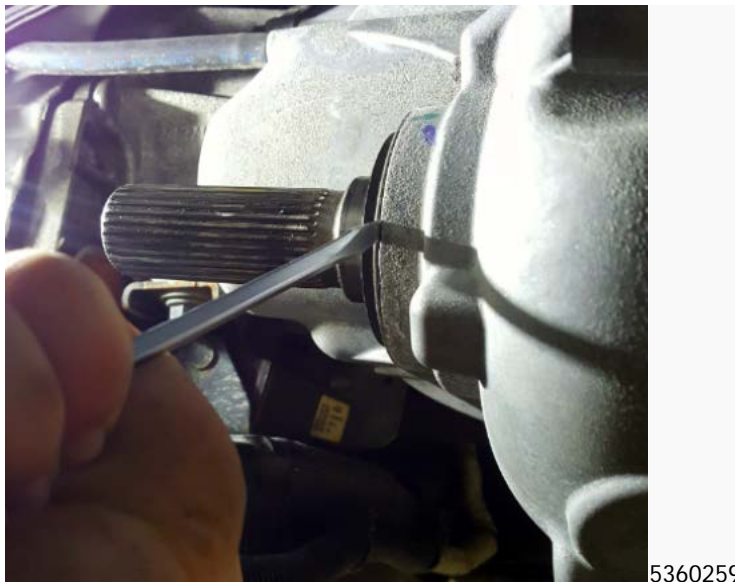
4. Using a flat head screwdriver, pry the front output shaft seal out of the transfer case.
5. Install the new seal in the transfer case. Using a mallet and a 3/8ths extension, carefully tap the seal in around the outer perimeter of the seal until it is fully seated.
6. Using J36614, drive the new slinger onto the front output shaft seal using a rubber or plastic mallet until it is seated flush against the transfer case.
7. Wipe the front output shaft and front output shaft seal off with a rag to clean off any metal slivers produced by driving the slinger onto the output shaft seal.
8. Reinstall the Front Axle Propeller Shaft. Refer to *Front Axle Propeller Shaft Replacement* in SI.
9. Check the transfer case fluid level and add fluid if necessary. Refer to *Transfer Case Fluid Replacement* in SI.
