Technical Service Bulletin

19-BD-004HG

G80 (DH)

SEAT BACKBOARD CLIP REPLACEMENT

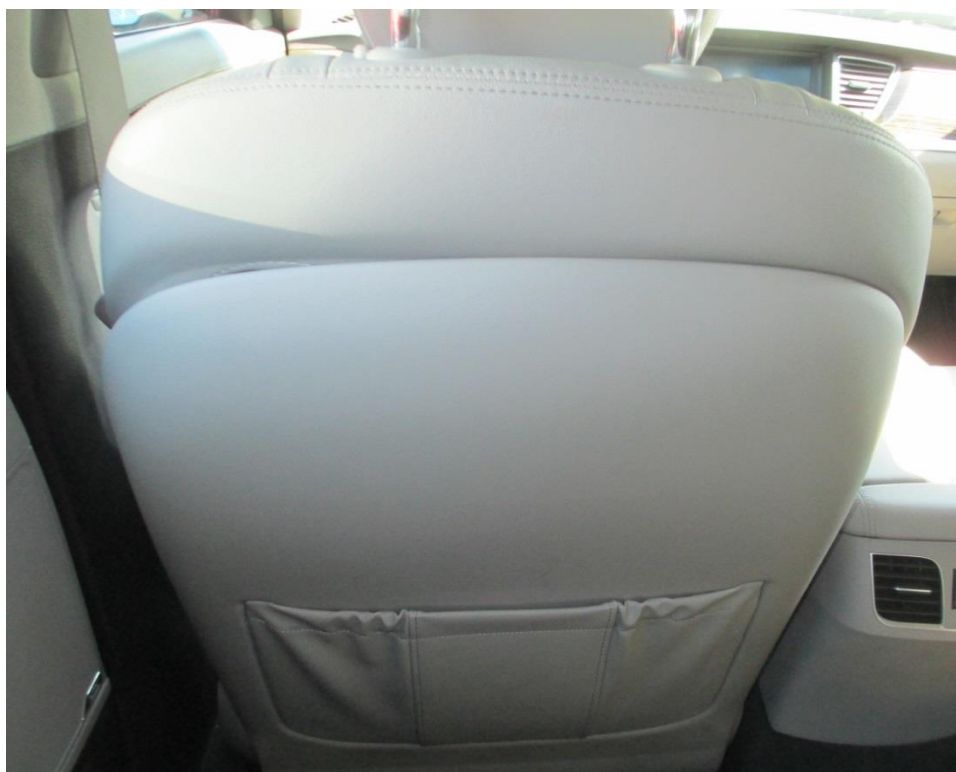
Description: This bulletin describes the procedure to replace the seat backboard clip. Some vehicles may experience the seat backboard coming loose.

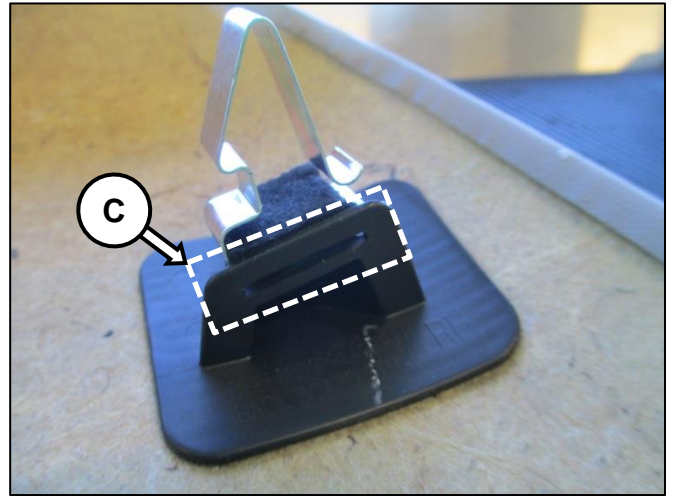
Base clip (C) appears normal.

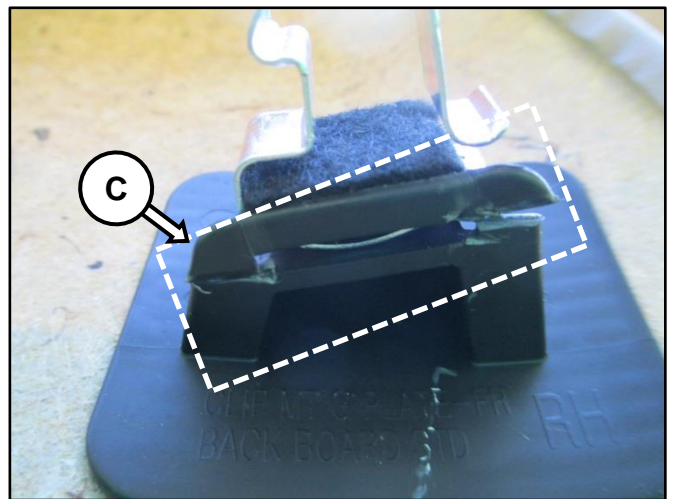
Base clip (C) is broken.
