| Title | Mack Chassis - Equipped With An Automated Manual Transmission Model D or F ( mDrive, AMT-D, AMT-F ) - Transmission Oil Leakage From Transmission Input Shaft Seal Or Output Shaft Seal - US10 And Newer Emissions, Common Model Years 2010 And Newer |

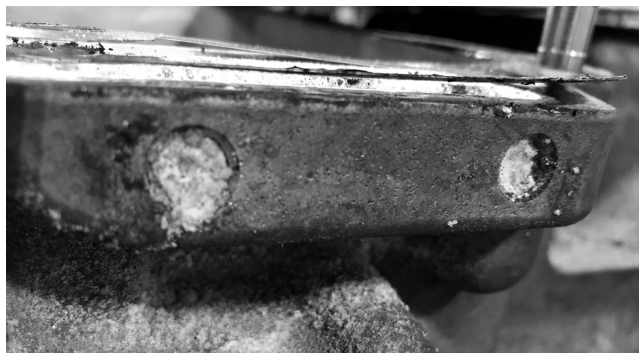
| Cause | <p>Accumulation of debris in the left side vent ports of the transmission main case (corrosion, road salt, dirt, etc) may result in oil leaks present at the transmission input and output shaft seals.</p> <p>The vent ports allow air exhausted from the shift solenoids and pistons to exit the main case. It also allows for equalization of internal and external pressures, as heat generated from operation will cause pressure in the case to increase. <b>For the AMT-F this is the only vent for the TECU and gearcase.</b></p> <p>Blockage of these ports allows pressure to build to a point that it forces oil past the input and output shaft seals. In extreme cases, the pressure buildup can be high enough that operation can be affected. Excessive internal pressure caused by blocked vents may result in slow or sluggish gear shifts.</p> |

1. Check the vent ports on the upper left side of the the main gearbox housing for any sort of blockage or obstruction.

Clogged vent ports

2. Clean out any debris that is observed during the inspection. (see inspection and cleaning below)
3. Check the transmission oil level in the gearbox.
  - **If the lube level is excessively low:** Proceed to the next section.
  - **If the lube level is at an acceptable level:** Fill the transmission oil to the correct level and check operation.

Due to the location of the vent ports it is very difficult, in most applications, to see the vents. An inspection mirror and flashlight can be used to see if there is a buildup of roadsalt or other debris in the ports.

If the ports are clogging then use a small screwdriver or similar tool to break up the deposits in the ports.

Wrap a clean rag around an air nozzle and blow air into the case. Use proper eye protection. A complete seal is not needed. All you want to do is create enough pressure to force the debris from the vents on the left side of the case.
