SERVICE BULLETIN

APPLICABILITY: 2013-16MY Forester
 2012-16MY Impreza
 2013-19MY Crosstrek

NUMBER: 05-70-19

SUBJECT: Rear Wheel Backing Plate- Design Change

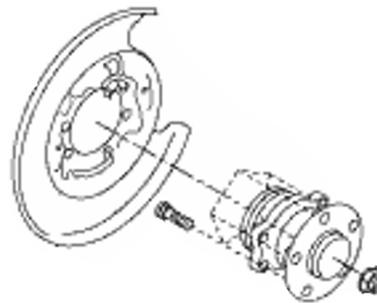
This bulletin announces a design change made to the rear wheel / brake backing plates. Under certain circumstances, some customers may have a concern regarding a howling-type sound from the rear of the vehicle later diagnosed as a faulty hub / bearing assembly. Unevenness of the backing plate surfaces may affect the concentricity (roundness) of the hub / bearing after torqued during assembly and over time, cause the howling -type sound to develop. Production changes for the backing plates have been implemented to optimize their mounting surface quality.

Description	Part Number
HUB / BEARING ASSY	28473FL040
BACKING PLATE RH	26704FJ002
BACKING PLATE LH	26704FJ012

NOTE: Although the service procedure for replacing these components remains unchanged, the backing plate and hub / bearing assembly must be replaced AS A SET (left OR right) when this condition occurs.
