Technical Service Bulletin

68 Noises from dash panel around MMI display

68 19 23 2056298/1 September 27, 2019.

Model(s)	Year	VIN Range	Vehicle-Specific Equipment
A6, A7	2019	All	Not Applicable

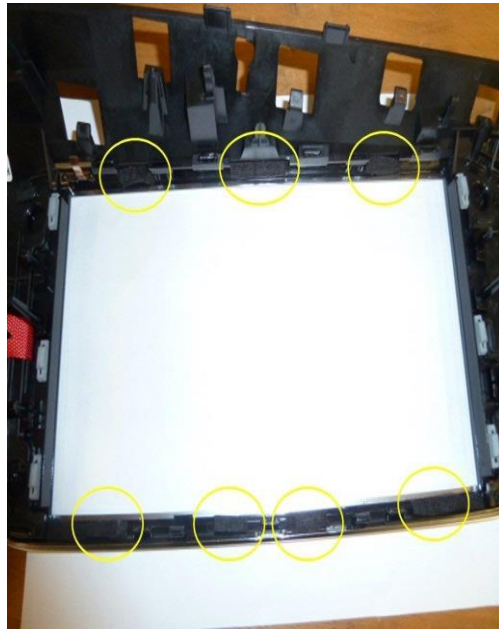
Figure 1. Apply felt strips to the circled areas.

- Felt strips 533 867 910A.
1. Remove the trim strip of the dash panel and stick the felt adhesive tape on the areas marked with yellow circles.

2. The felt strips shown in Figure 1 and 2 must be stuck on and folded back behind the clip.

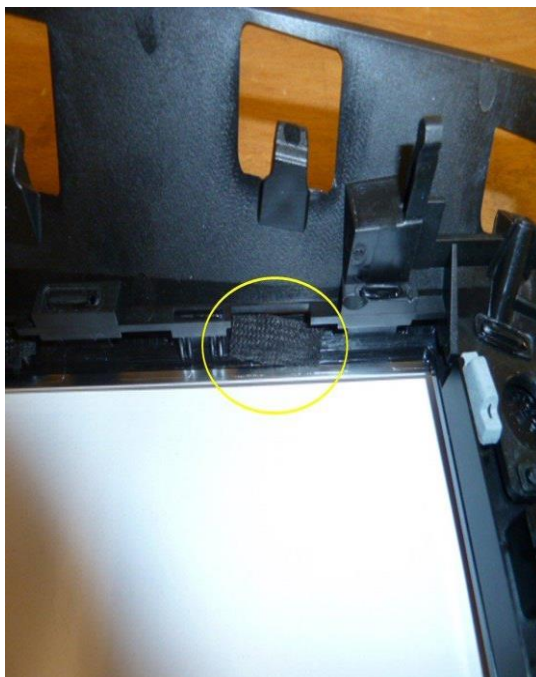
Figure 2. Close-up of Figure 1.

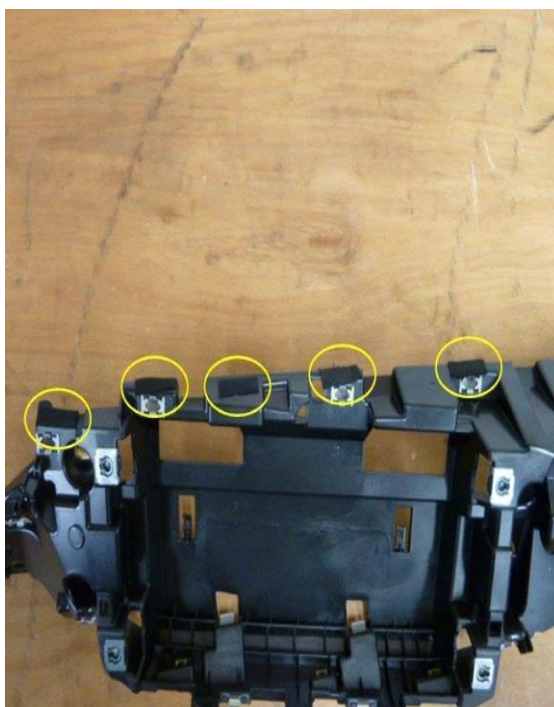
Figure 3. Apply felt strips to the circled areas.

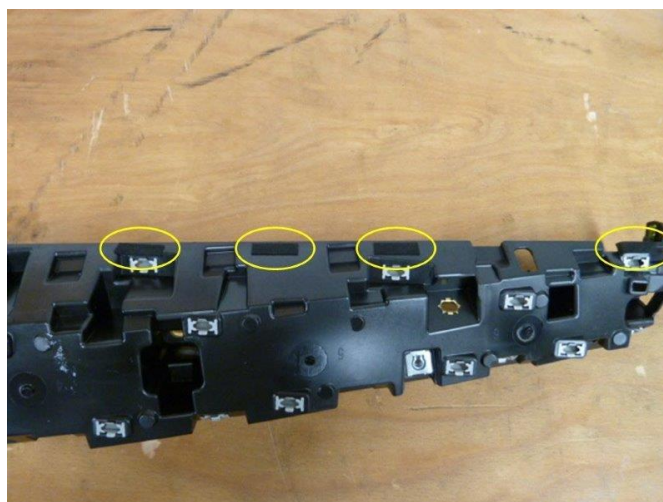
Figure 4. Apply felt strips to the circled areas.
