## Technical Information Bulletin

### E249

PACCAR MX-11 EMY17 and 18 Groove worn into EGR Cooler at Coolant Pipe Connection

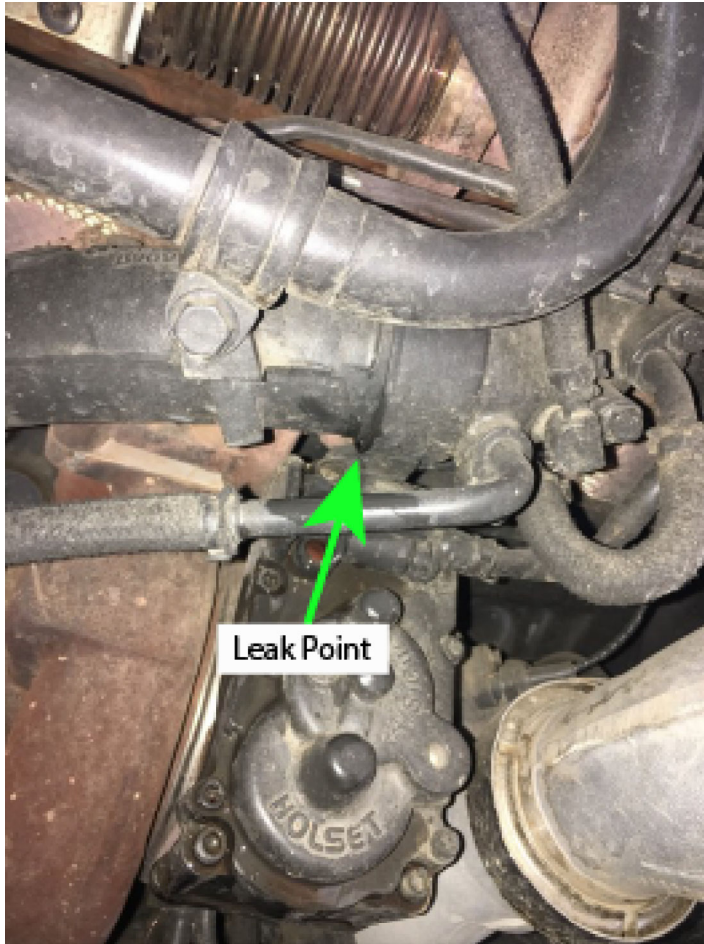
1. Inspect the cooling system for a leak between the EGR cooler and the cooler supply pipe.

Figure 1 Leak point between EGR cooler and coolant pipe

2. If the leak is verified at this point, replace the coolant pipe. The EGR cooler may have a groove worn into it as shown below. The coolant pipe has been updated with an improved seal at the EGR cooler that seals on either side of the groove. Additional bolts and a stud are included with the new parts (not noted in RMI, but are noted in Parts Online). See the figure below for bolt and stud locations.

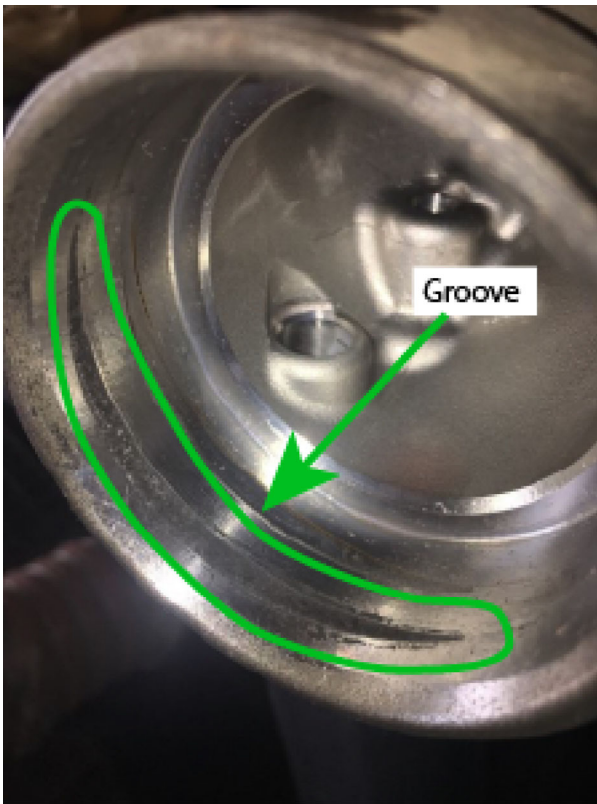
A groove may be worn into the EGR cooler where the coolant pipe is connected, possibly resulting in a coolant leak. DTCs P1560 and/or P2560 may be set.

Figure 2 Groove in EGR Cooler

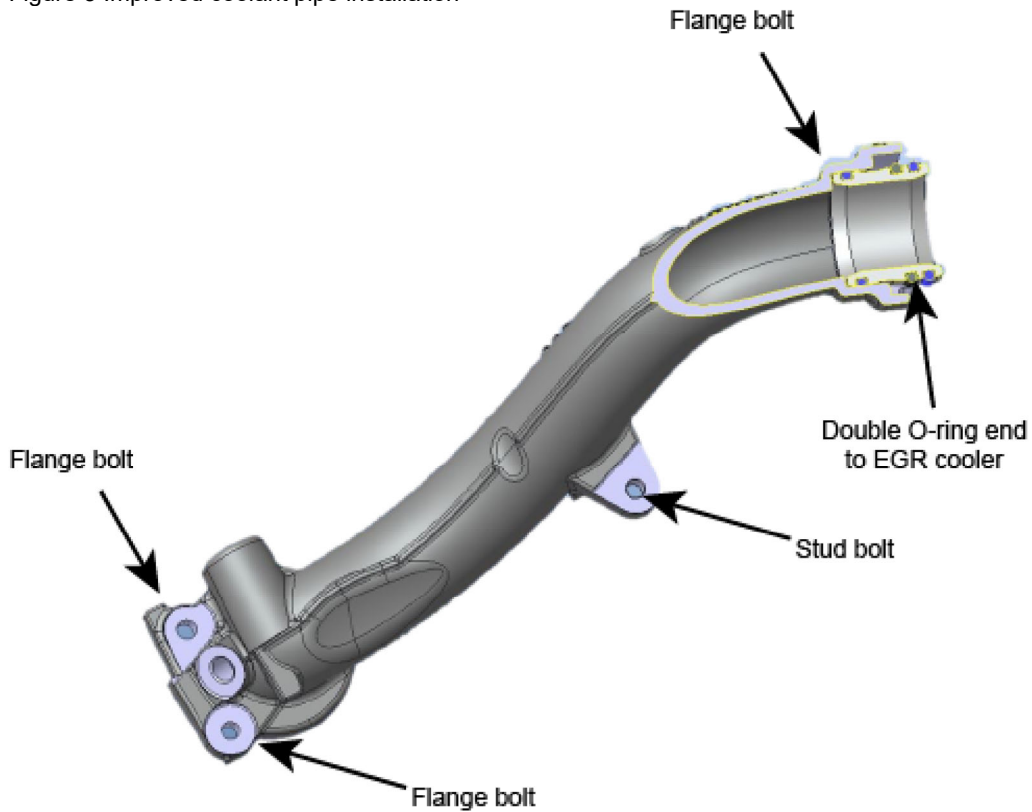
Figure 3 Improved coolant pipe installation
