Technical product information

Topic	Air supply unit exhaust noise from right hand rear - With engine running
Market area	Bentley: worldwide (2WBE),Hongkong-Macau (5HK)
Brand	Bentley
Transaction No.	2055825/1
Level	GH
Status	Approval
Release date

New Continental GT and New Continental GTC

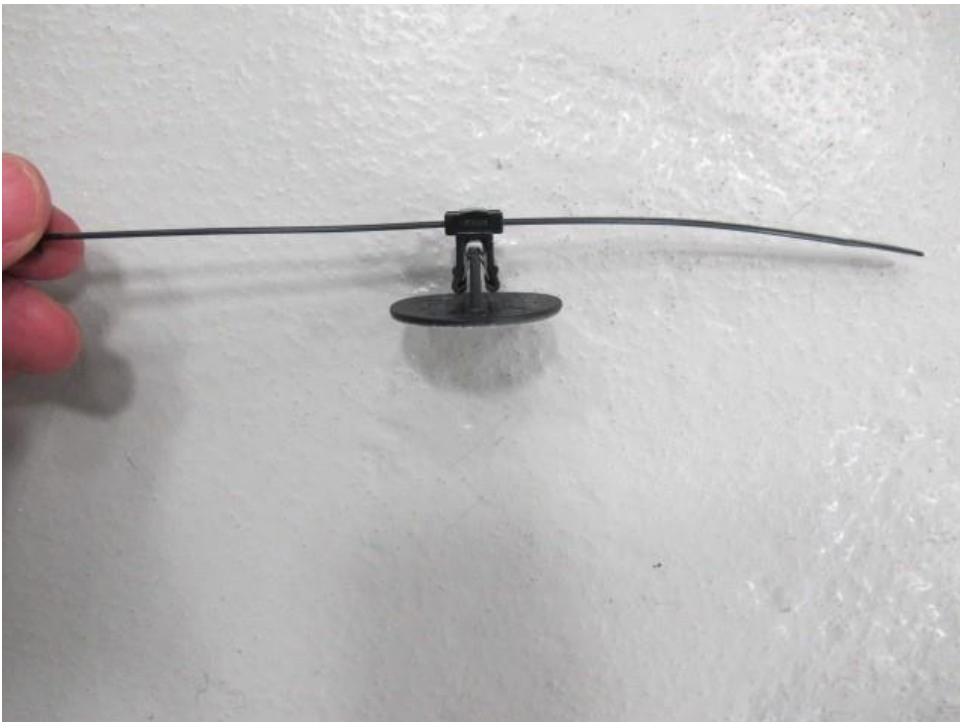
Figure 5

4) Referring to Figure 5- Attach cable tie 3D0971 838L to clip 3W0971 359

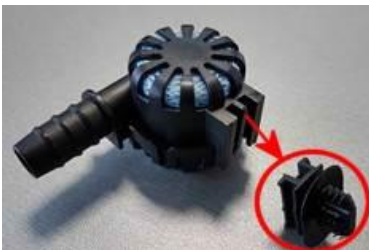
- In the event the clip shown in Figure 6 is fitted to the silencer, this should carefully be removed before fitment of the silencer
