TSB #	TSB 19-01		
Description/Title:	Dash Radio HDMI and USB Ports		
Affected Product Line(s):	Certain 2019 Model Year Freedom Elite motorhomes		
Service Campaign # :	RC000173	Released Date:	9/20/2019
Repair Codes:	Inspect: TMCTS80254Y Repair: TMCTS80254W	Document Date:	9/20/2019
Time Allowed:	Inspection: 0.1 Repair: 1.25	Document Revision:	A

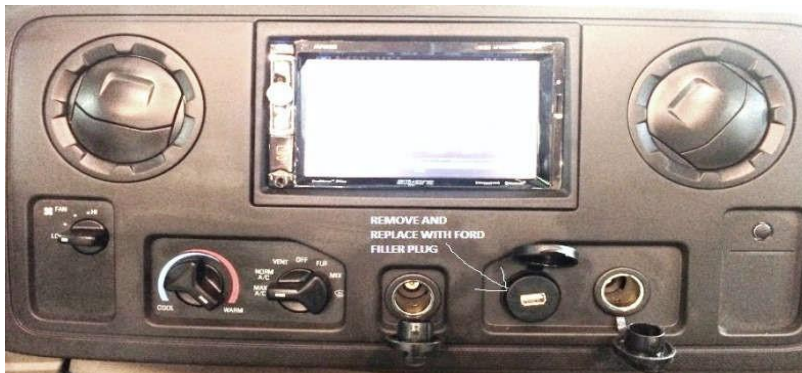
1. Pull coach in to service bay and wheel chock the front and rear of the rear wheel.
2. Verify there is a single USB port in the round Ford dash plug in center dash console. If the plug is a blank and to the right is a HDMI and USB port, motorhome is okay and inspection is complete. If it has the USB only port, continue on to step 3.

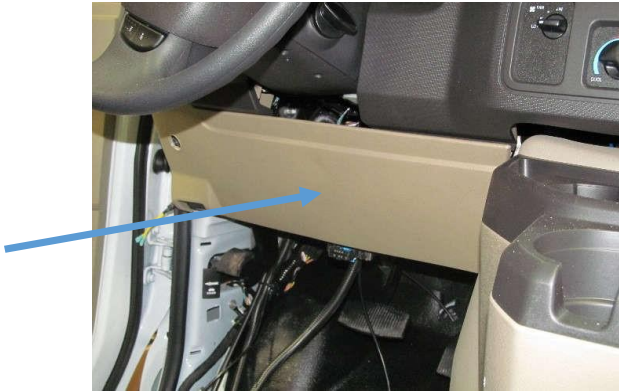
3. Remove the knee panel (snap in) on the driver side below steering wheel.

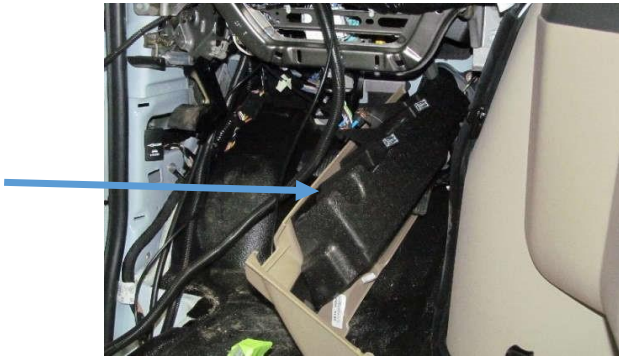
4. Twist the knee panel and rotate to position between the brake and throttle pedal.

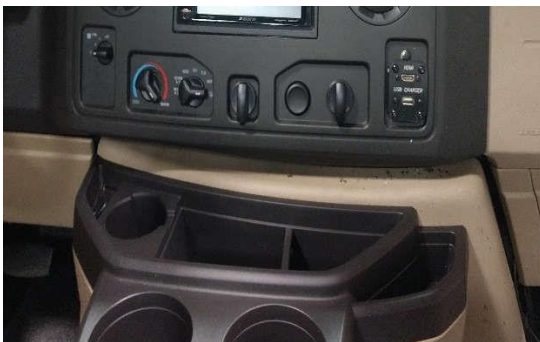
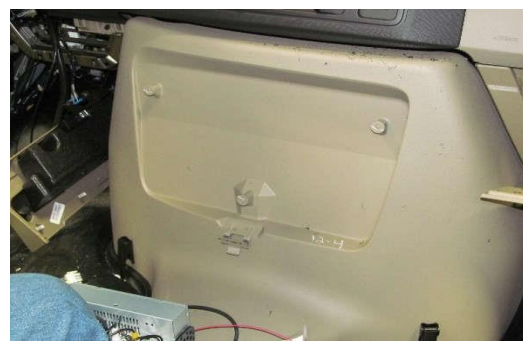
5. Remove the Drink holder off the dog house cover. (Figure 4) Grab drink tray and lift up it will unsnap from cover and set aside.

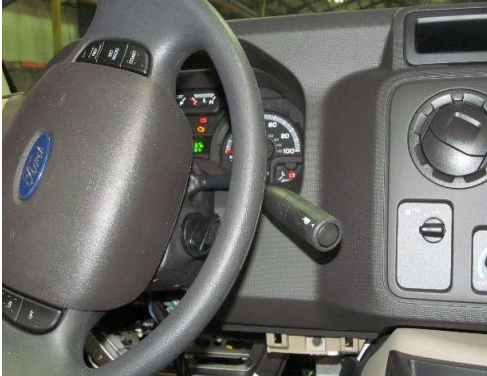
6. Turn ignition key on, but don't start engine. Put foot on the brake and lower gear shift into low gear all the way down. Pull the tilt Lever for steering wheel and tilt all the way down.

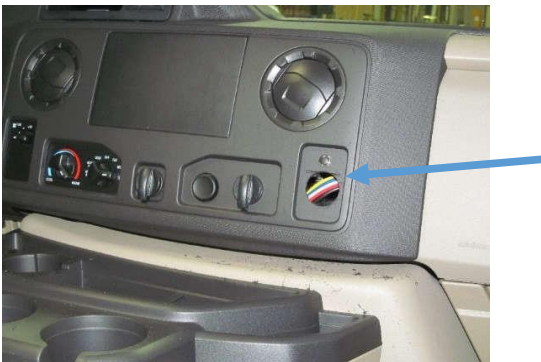
7. Locate the small square indent about four inches to passenger side of current USB port. You will use the 1 1/2" Hole Saw and make a hole. Top of hole should be at ridgeline.

NOTE: USE CAUTION NOT TO DRILL INTO THE DASH WIRES AND VACUUM LINES BEHIND IT.

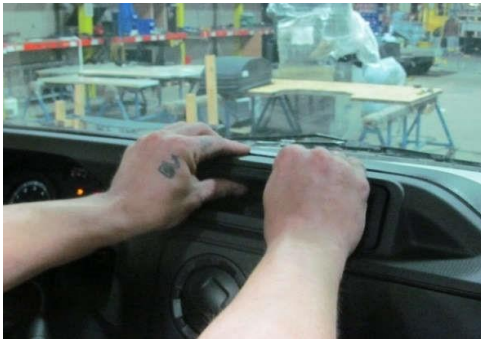
8. Grab the Bezel around dash area of the radio. Pull to pop out the Dash panel, grab over the steering wheel and pull out around dash cluster. (Figure 8)

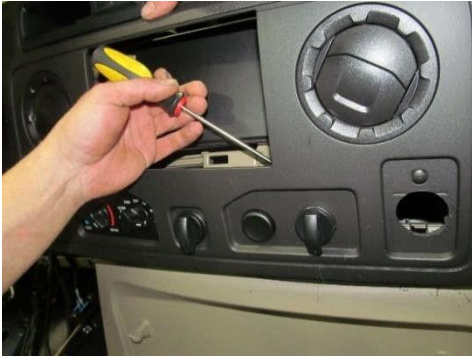
9. Pull out slightly near radio and remove the four electrical plugs. A six-inch small blade screwdriver will assist in prying off electrical plugs. The vacuum lines to dash control can remain connected.

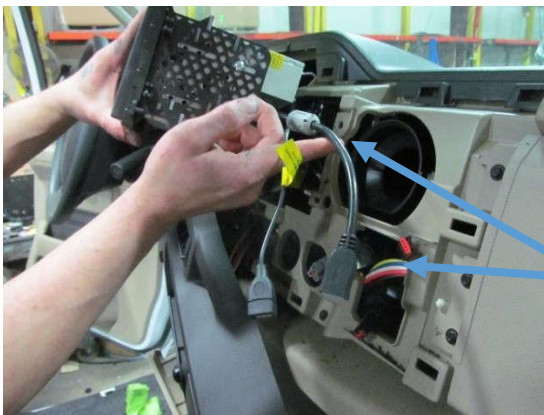
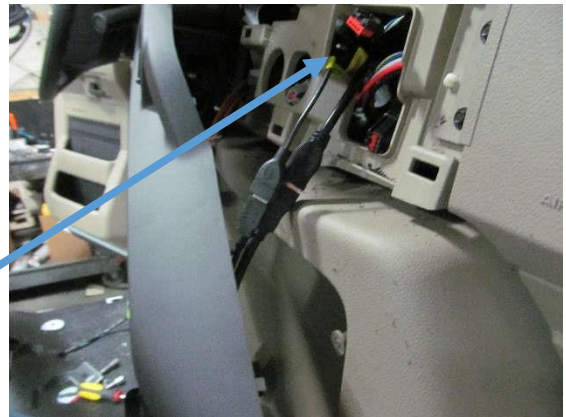
10. The current USB port in the Round filler hole of Ford dash will need removed. It should just pop out. Once removed, unplug from dash radio USB harness. Install blank filler plug supplied in kit into dash in place of removed plug.
11. Rotate the dash panel down towards where the drink tray was. This should gain access to the access hole behind where you drilled new hole. Feed the USB harness from radio through the hole.
12. Locate the HDMI plug harness on the back of the radio, should be next to the USB plug harness. Route it through the dash access hole

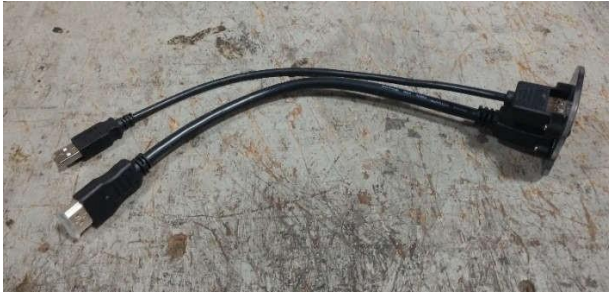
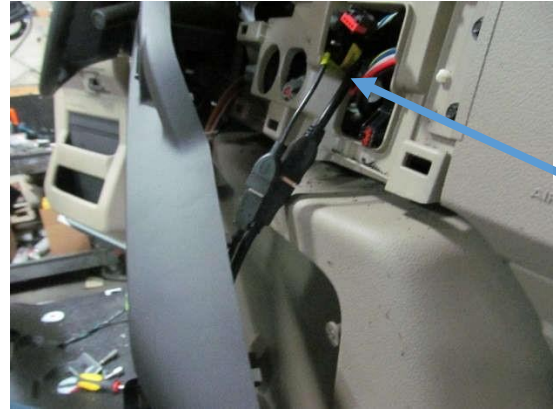
13. Plug new HDMI and USB port cables into the radio harness cable going through dash panel's new hole.

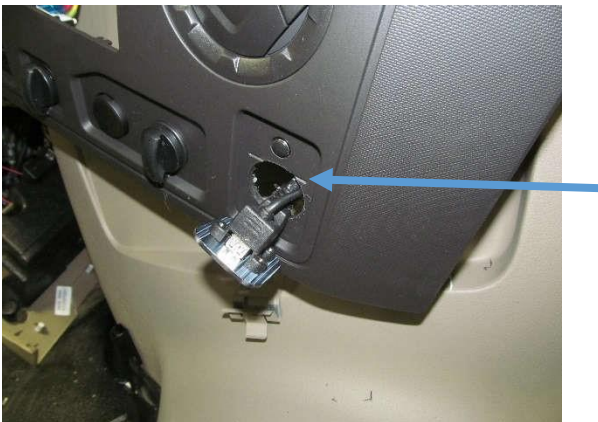
14. Rotate dash panel back into place using caution, starting with dash cluster area over steering wheel first. Once it is aligned and wires and harness are tucked in, snap dash panel into place.
15. Install knee panel back into place on driver side. Tilt steering wheel back up and put gear shift back into park. Turn off the ignition key.
16. Install new port into hole.

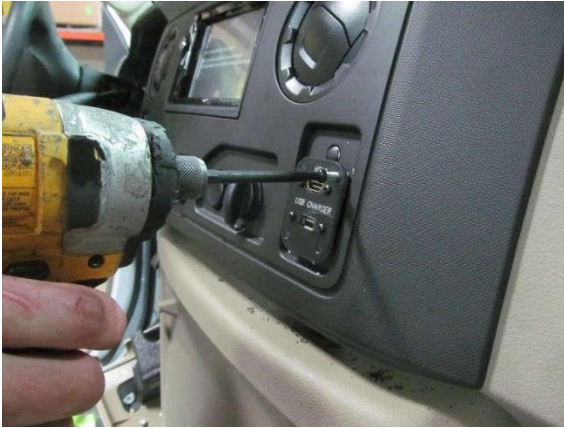
17. When installing the four screws in port, run screw gun in reverse with light pressure. Switch direction and run in with setting on very low torque and speed. If run on high speed, forward heat will turn black plastic white.

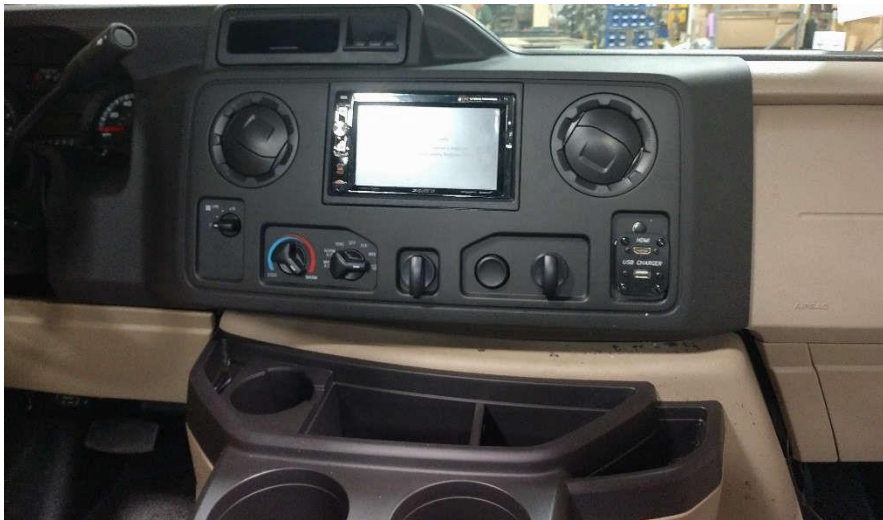
18. Install the drink tray back on the doghouse. Slip on and push down to snap into place.
