<b>Subject:</b>  <b>Stop bolt on the sofa roll-over bracket is missing.</b>					Number	<b>TSB 19-005</b>
					Date	<b>10/4/2019</b>
					Model	All Momentum FW & TT, Imagine XLS 17MKE, 19BWE, 21BHE, 24MPR & Transcend 247BH
<b>Circulate To:</b>	x	Service Manager	x	Parts Manager	Build Date	<b>7/1/19 thru 9/1/19</b>
	x	Warranty Processor		Sales Manager	Technician

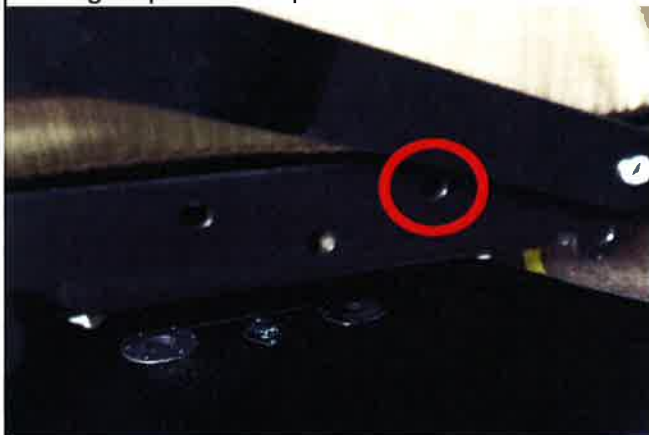
**Concern:** If the stop bolt is not in place, the back rest portion can tip below "level" when converted into a bed.

Missing Stop Bolt Example

**Remedy:** Install 8mm-1.25 x 12 8.8HCS Z bolts (x2 p/n 682605) with M8-1.25 DIN985 LN Z (x2 p/n 682306) locking nuts (1 bolt/nut on each side) to support back rest portion in a horizontal position when converted into a bed.

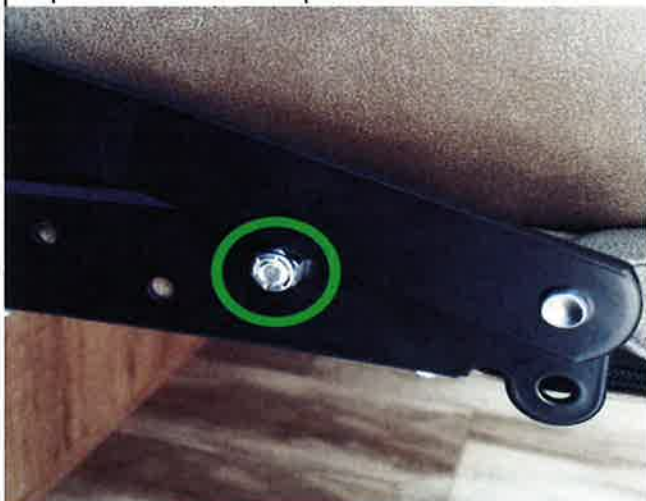
Stop Bolt Installed Example
