# SERVICE BULLETIN

AT19-004

NTB19-068

## MIL ON WITH DTC P0868 AND MAY HAVE HESITATION AND/OR LACK OF POWER

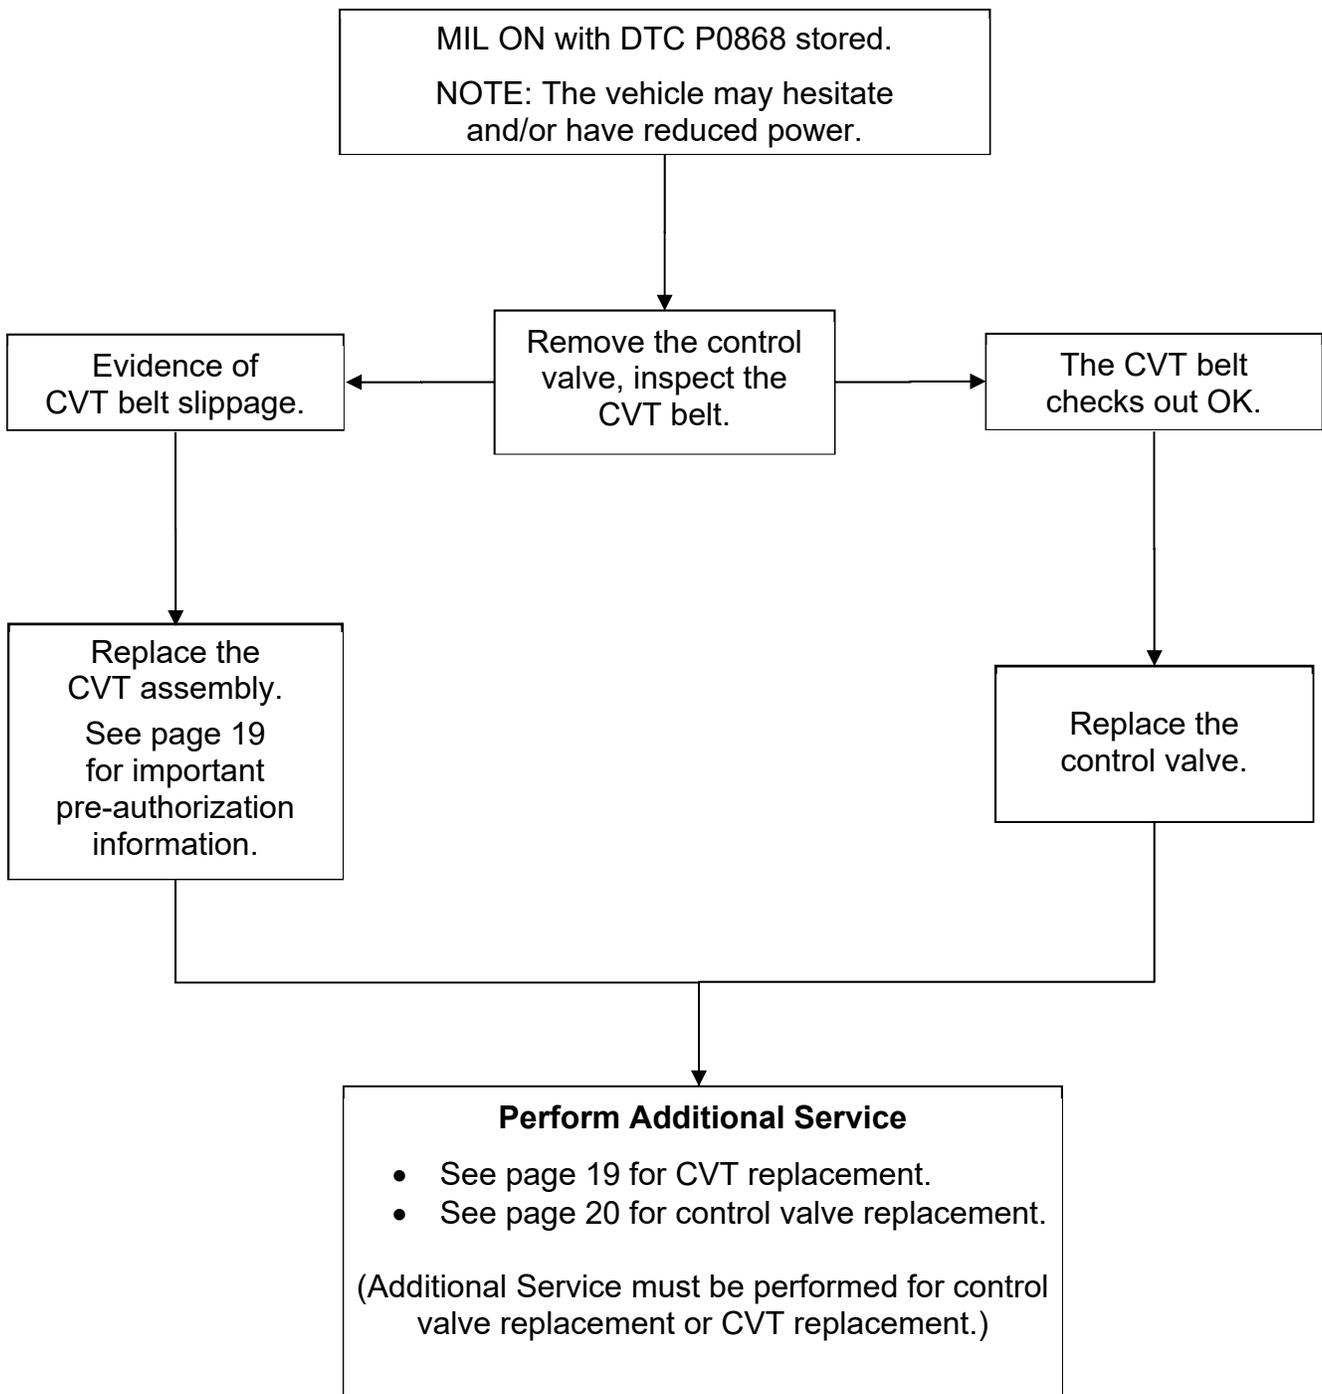
## Repair Flow Chart

Refer to the **Repair Flow Chart** on page 2 for CVT repair.

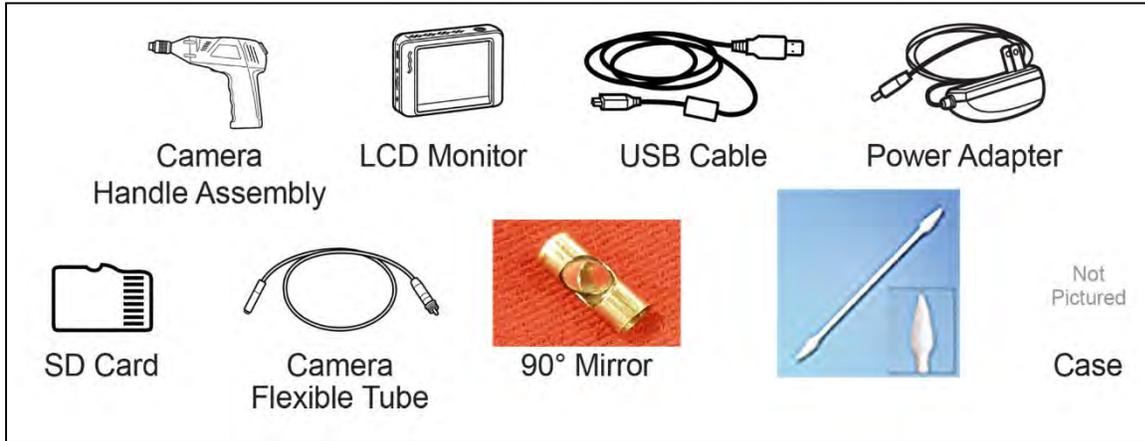
Figure 1

### Tech Cam J-51951

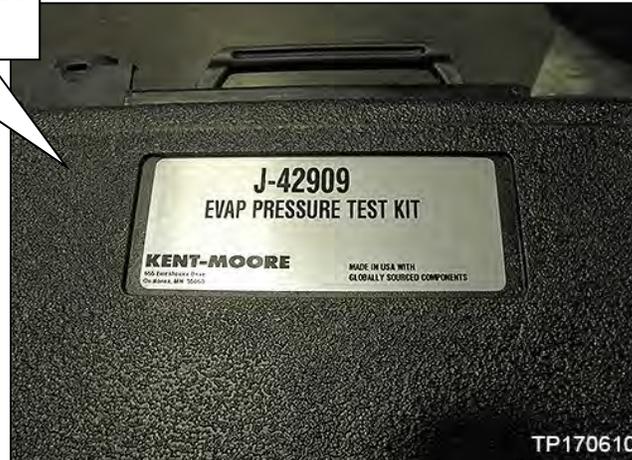
Figure 3

Evap Pressure Test  
Kit J-42909

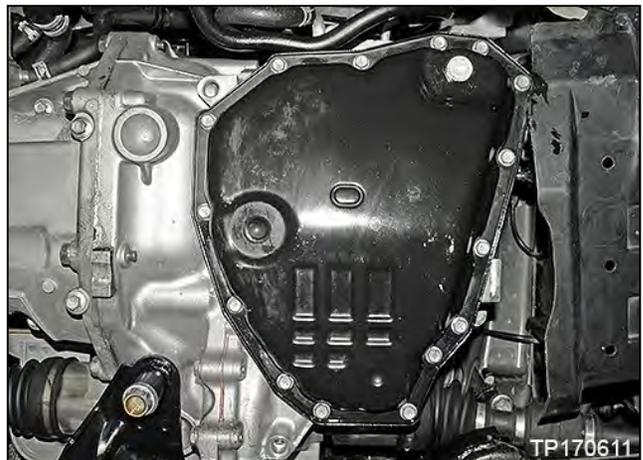
6. Disconnect the engine room harness from the CVT.
7. Remove the oil pan mounting bolts, and then remove the oil pan and oil pan gasket.
  - Do not discard the bolts. These will be reused during assembly.

- See Figure 4 on page 5.
37. Reset/reinitialize systems as needed.
  - For a listing of systems that require reset/initialization after reconnecting the 12V battery refer to the ESM: **ELECTRICAL & POWER CONTROL > POWER SUPPLY, GROUND & CIRCUIT ELEMENTS > BASIC INSPECTION > INSPECTION AND ADJUSTMENT > ADDITIONAL SERVICE WHEN REMOVING BATTERY NEGATIVE TERMINAL.**

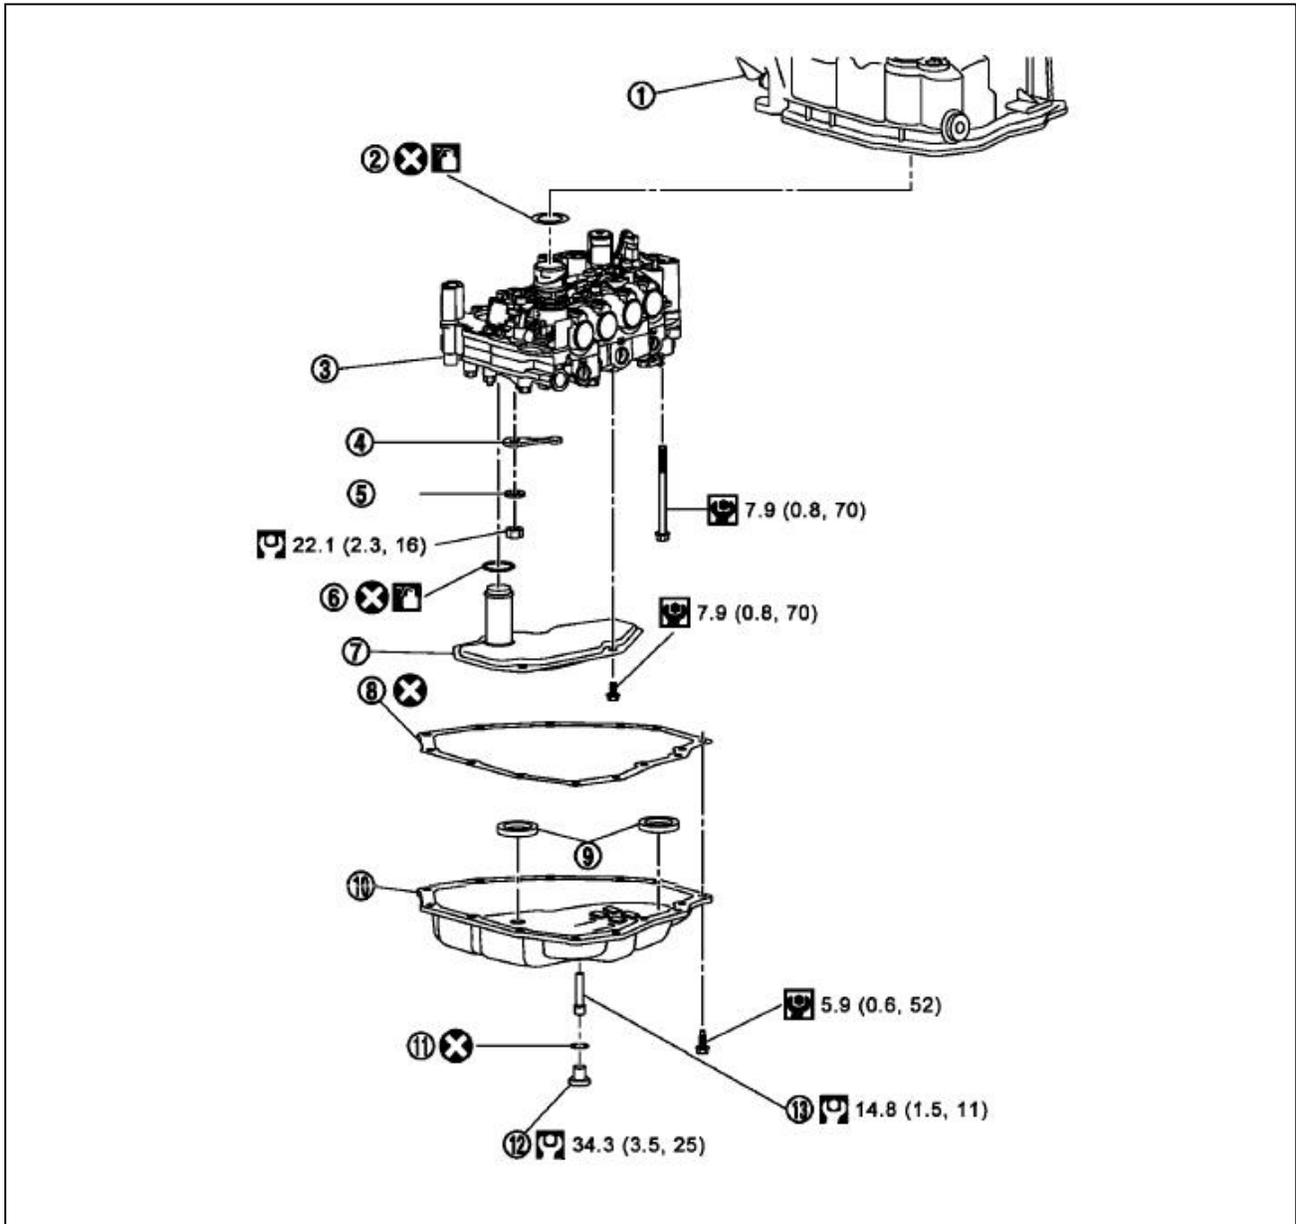
Figure 5

- 1. Transaxle assembly
- 4. Manual plate
- 7. Strainer
- 10. Oil pan

- 2. O-ring
- 5. Washer
- 8. Oil pan gasket
- 11. Drain plug gasket

- 3. Control valve
- 6. O-ring
- 9. Magnet
- 12. Drain plug

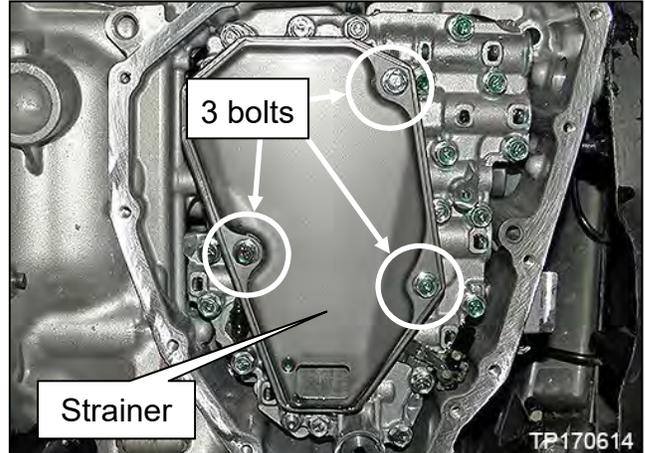
Figure 6

9. Remove the three (3) strainer bolts, and then remove the strainer from the control valve (Figure 6).

- These bolts will be reused.

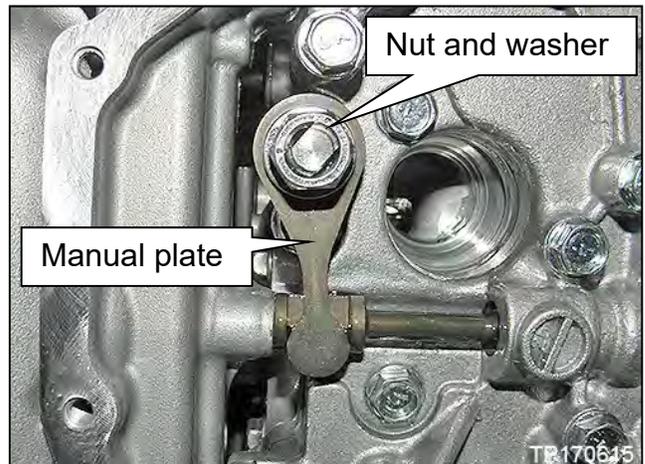
Figure 7

10. Remove the nut and washer, and then remove the manual plate shown in Figure 7.

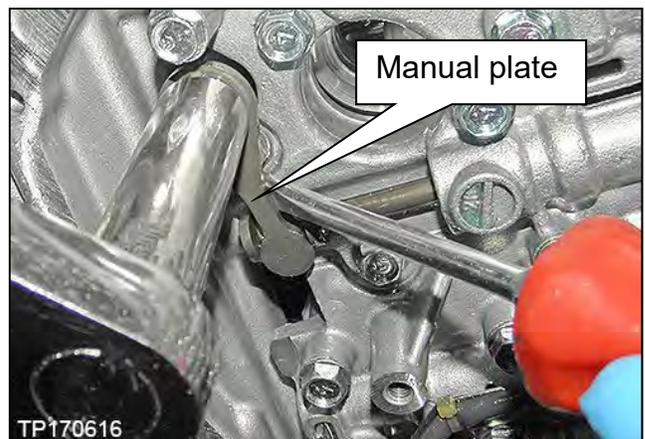
Figure 8

- Use a screwdriver to hold the manual plate (Figure 8) to keep the shaft from rotating while removing the nut.
- Do not discard the nut and washer. These will be reused during assembly.

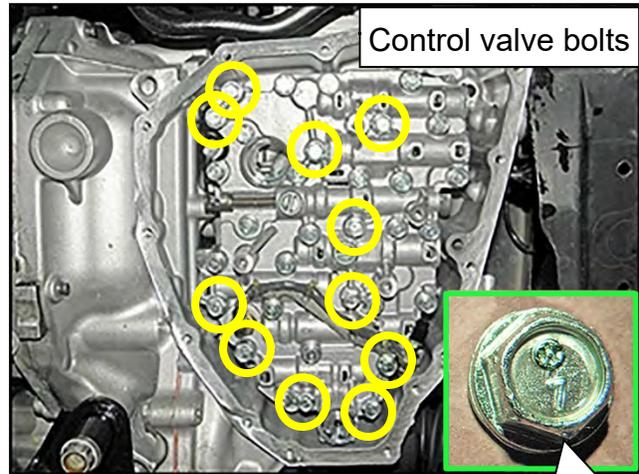
Figure 9

11. Clean around the CVT unit harness connector to prevent foreign materials from entering into the CVT case.
12. Remove ONLY the eleven (11) control valve bolts circled in yellow with markings as shown in Figure 9.
  - On this model transaxle, DO NOT remove the bolts with a single dot over the "7" (not shown).
  - The bolts removed will be reused.
13. Press the CVT unit harness connector down into the transaxle case, and then remove the control valve from the transaxle case.

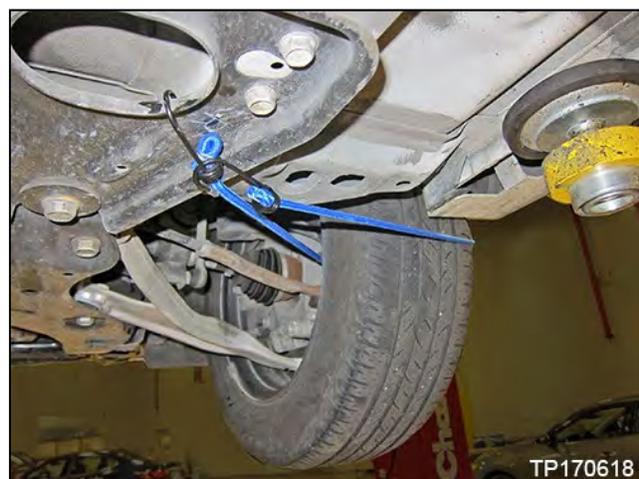
Figure 10

14. Secure the front right tire with a suitable strap (Figure 10).
  - This will assist in making the belt turn during the borescope belt inspection.
15. Mark the front left tire with a suitable marking.
  - This will assure all 360° of the belt is inspected.

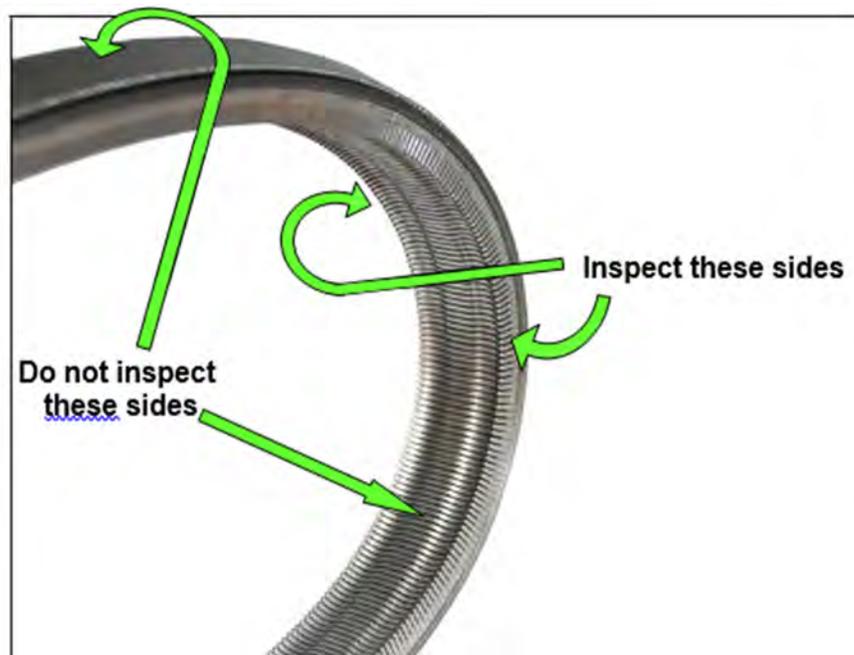
Figure 11

16. Inspect the entirety of the two sides of the belt that come in contact with the pulleys (Figure 11).

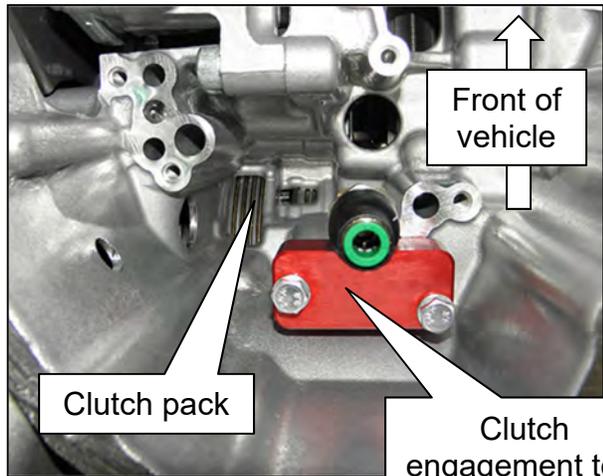
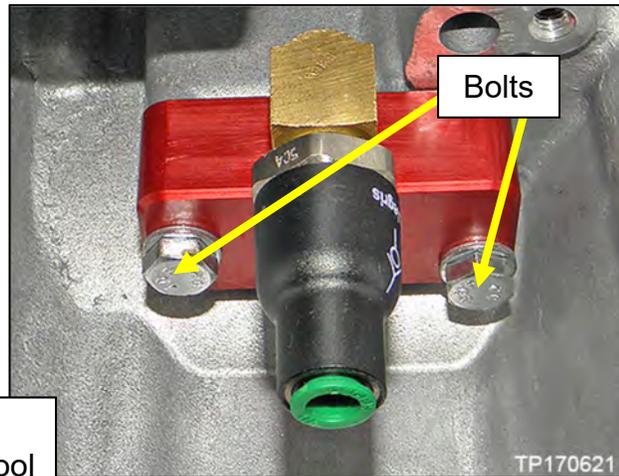
- a. Install the Clutch Engagement Tool (J-52273) to the CVT case with two bolts finger tight where shown in Figure 12 and Figure 13.
- Bolt torque not to exceed: 2.26 N•m (0.23 kg-m, **20 in-lb.**)

- Use care when tightening the bolts as damage to the bolts/CVT could occur.
- Make sure an O-ring is installed to the Clutch Engagement Tool (J-52273) before installation as this could lead to improper/incomplete testing.

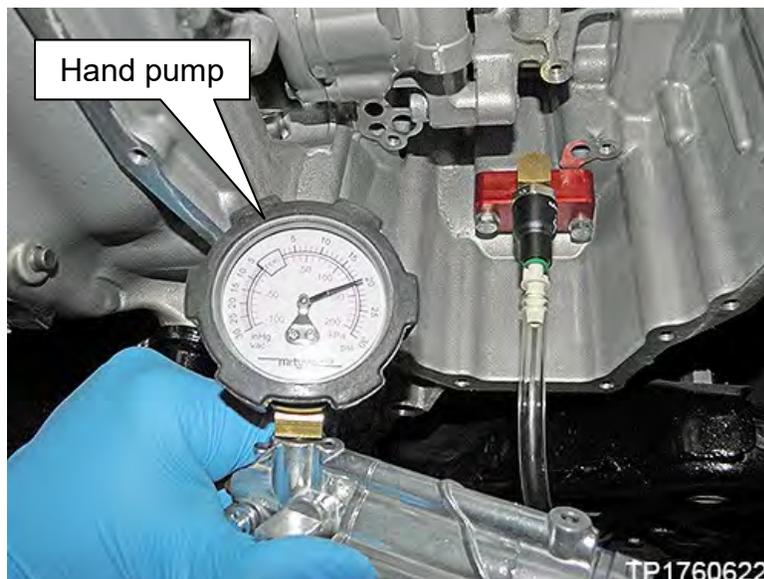
Figure 14

- b. Connect the Hand pump from Evap Pressure Test Kit (J-42909) to the Clutch Engagement Tool (J-52273) and pump to 20 PSI (Figure 14).

- Proper pressure has been achieved when the CVT belt moves while the left front wheel is rotated and the CVT is in NEUTRAL with the right front wheel secured.

- Do NOT over-pressurize the system as internal damage to the CVT could result.
- The hand pump should be removed from the Clutch Engagement Tool (J-52273) quick connect once the clutch has been engaged and the belt is observed moving with tire rotation.
- Pressure will be retained.

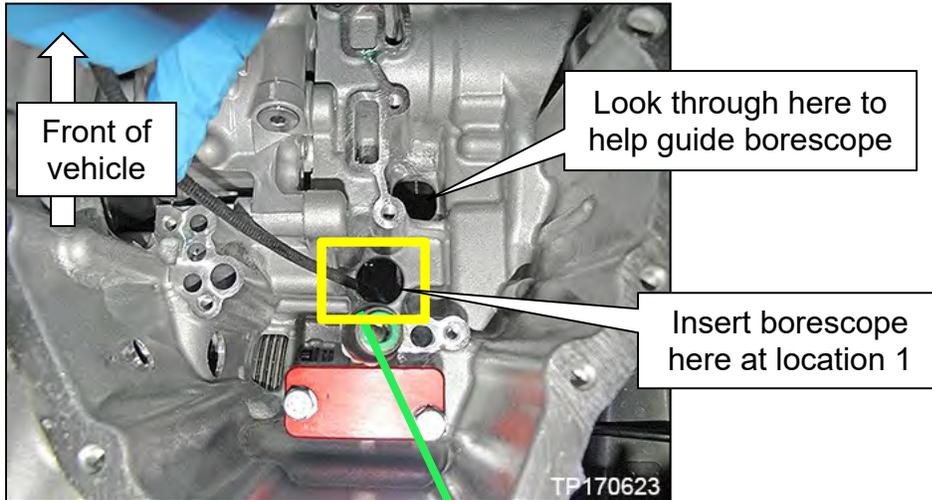
c. Insert the borescope where shown in Figure 15 as follows:

- I. Face the mirror of the borescope toward the driver's side of the vehicle (CVT side cover).
- II. Insert the lens approximately 7.5 inches from the CVT oil pan gasket surface as shown in Figure 17 on page 12.
- III. View the side of the belt that contacts the pulley.

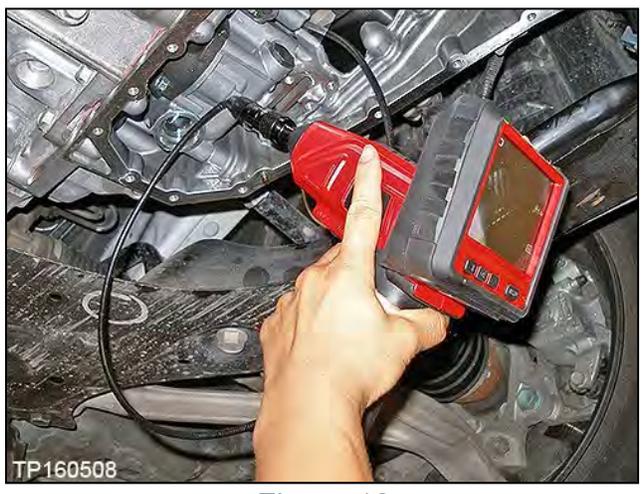
Figure 18

- Holding the borescope (camera flexible tube) with one hand allows rotation of the tire with the other hand (see Figure 18).
- If evidence of belt slip is identified as shown in Figure 27 and Figure 28 on page 18, skip to step 26 on page 19.

20. Using the mark applied to the left front tire for reference, slowly and carefully rotate the front left tire one full turn in either direction to view all of the belt.
- Holding the borescope (camera flexible tube) with one hand allows rotation of the tire with the other hand (Figure 18).
- HINT:** If the belt does not move when rotating the front left tire, supply additional air with hand pump (J-45664) to re-engage the clutch as necessary.
- Look for evidence of belt slip as shown in Figure 23 through Figure 28 on pages 16-18.
21. Remove the Clutch Engagement Tool (J-52273) from the CVT.

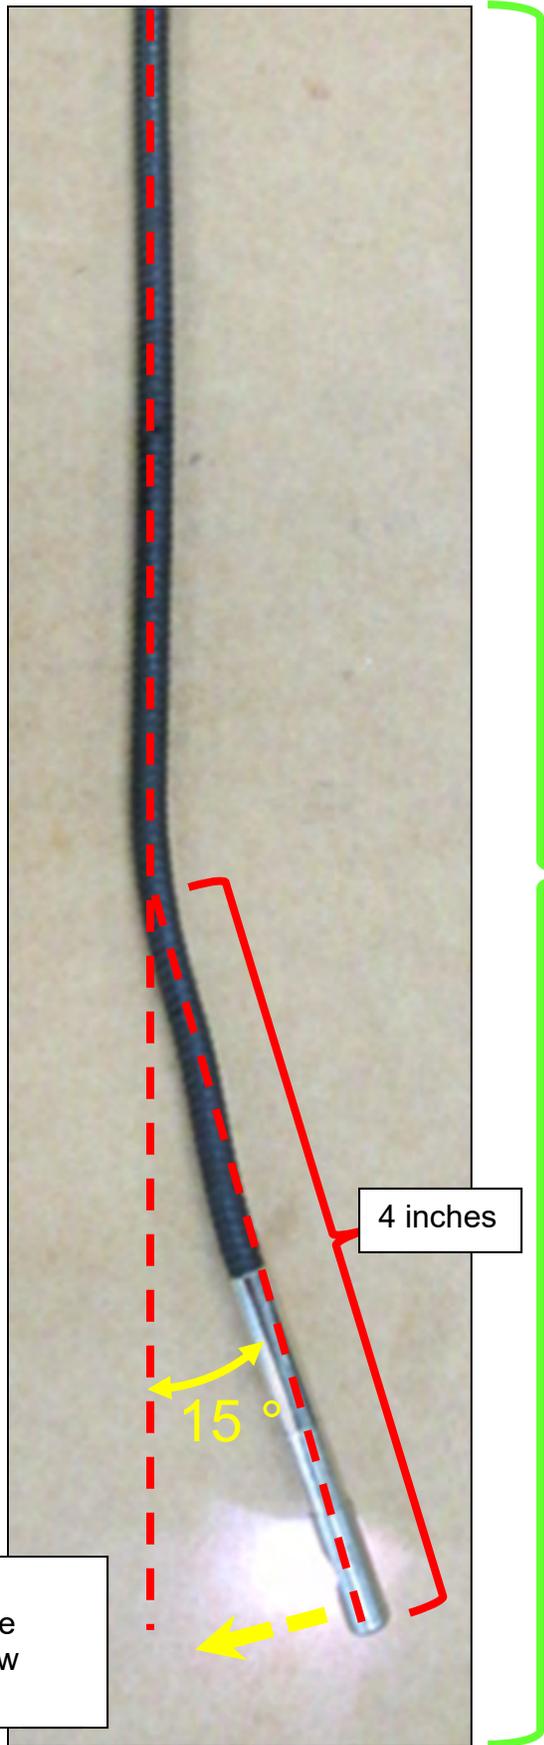
Figure 19

For the following steps print this page as a template and then shape the borescope camera flexible tube like the image in Figure 19.

- Do not shrink or enlarge the sheet size when printing.
- The template shown is actual size.

- Face the mirror in the direction of the yellow arrow.

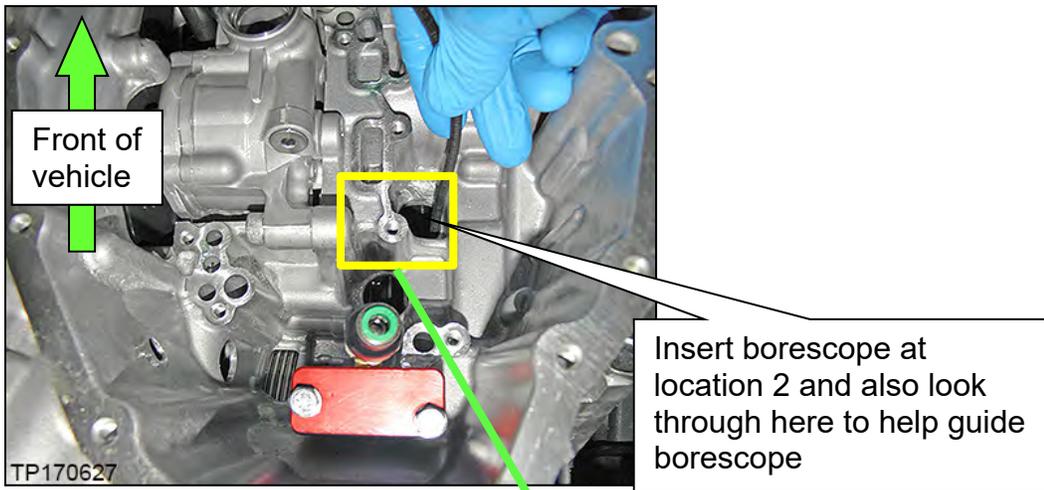
Figure 20

17. Face the mirror of the borescope toward passenger side (engine side).
18. Insert the borescope in the second location where shown in Figure 20.

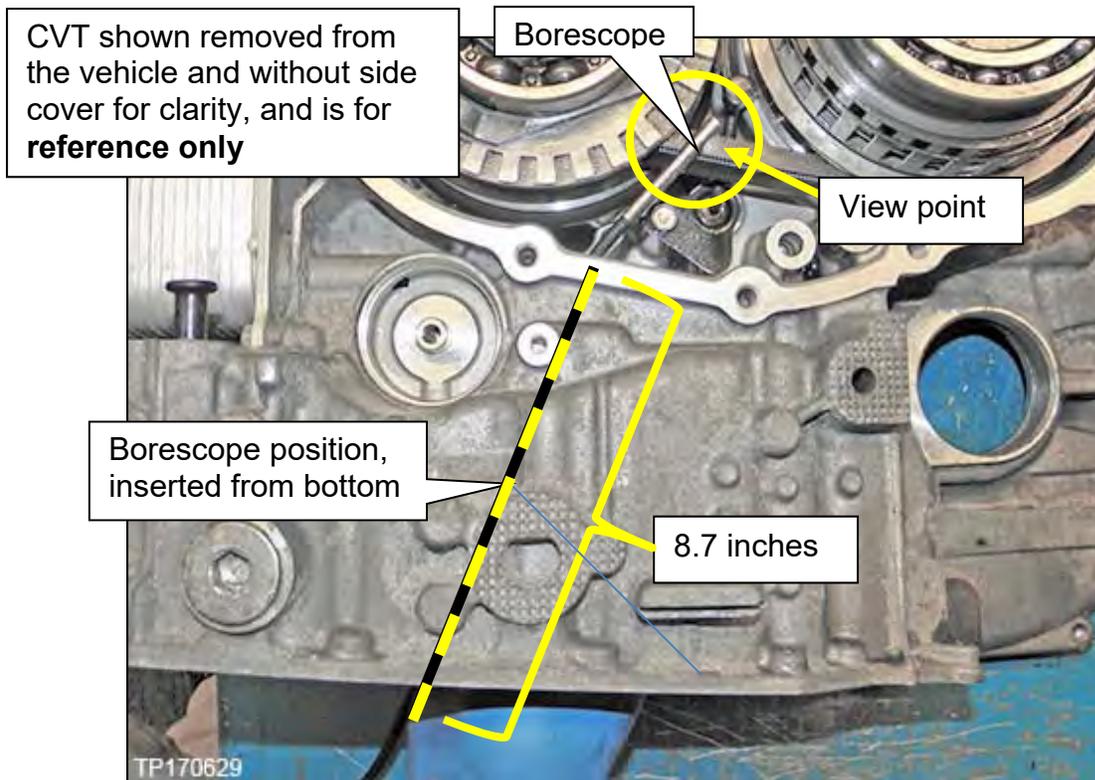
Figure 22

19. Insert the lens approximately 8.7 inches from the CVT case rim (Figure 22)
- View the side of the belt that contacts the pulley.

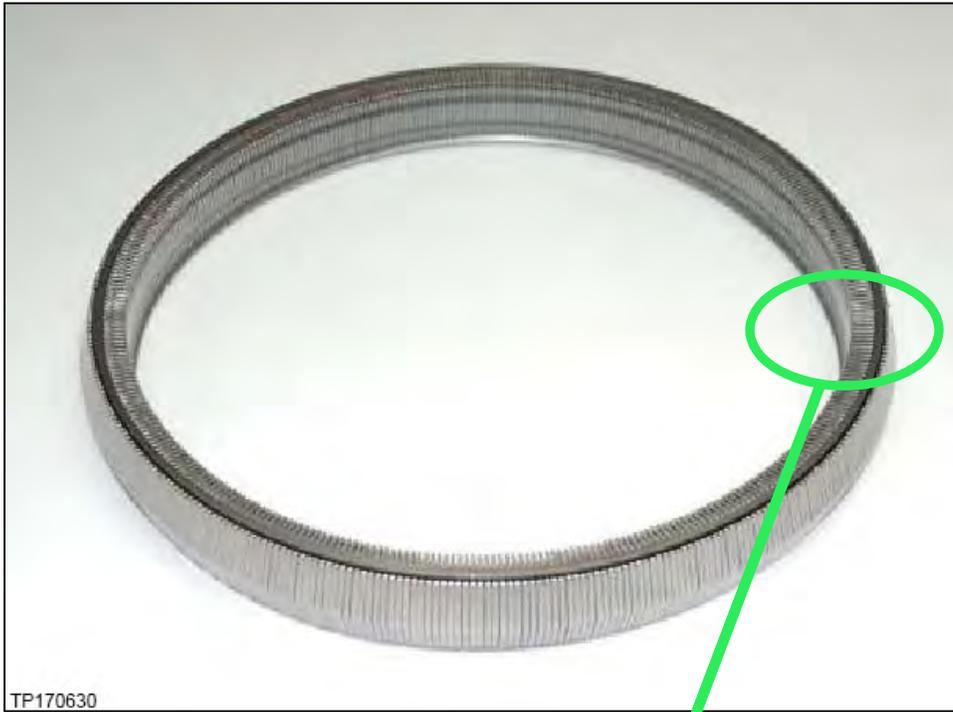
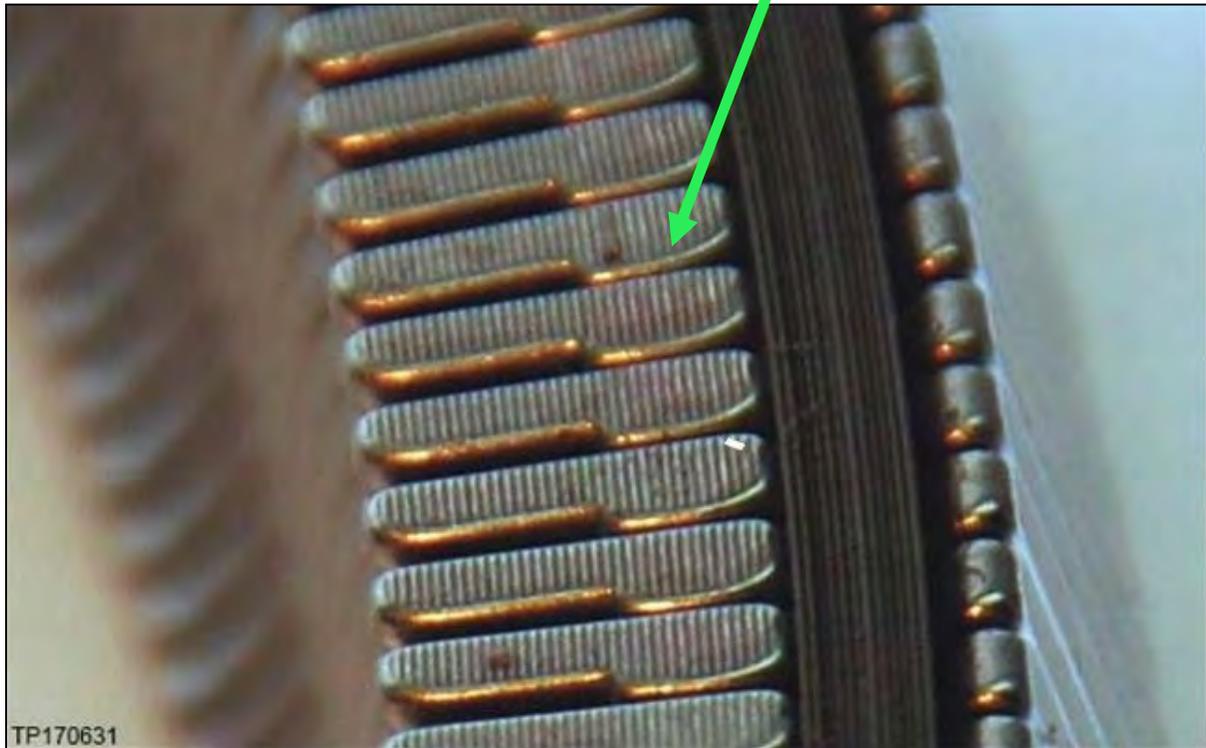
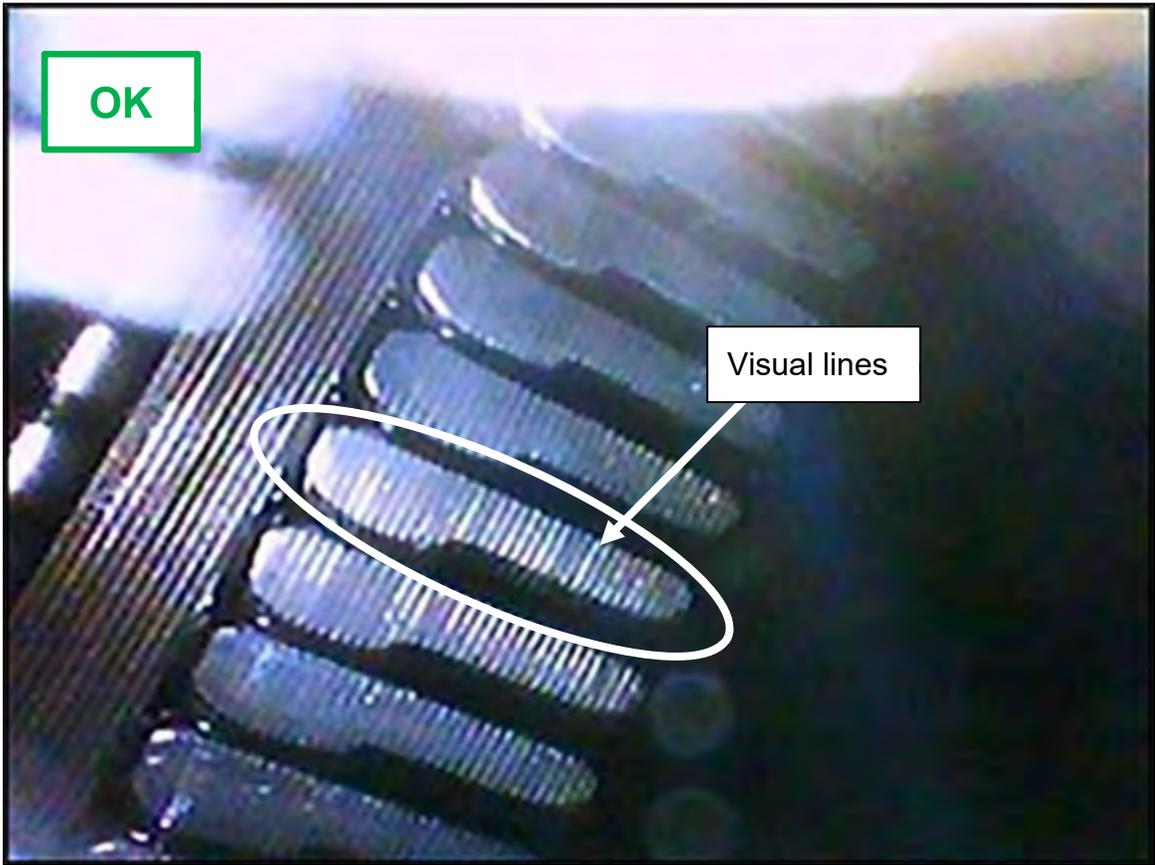
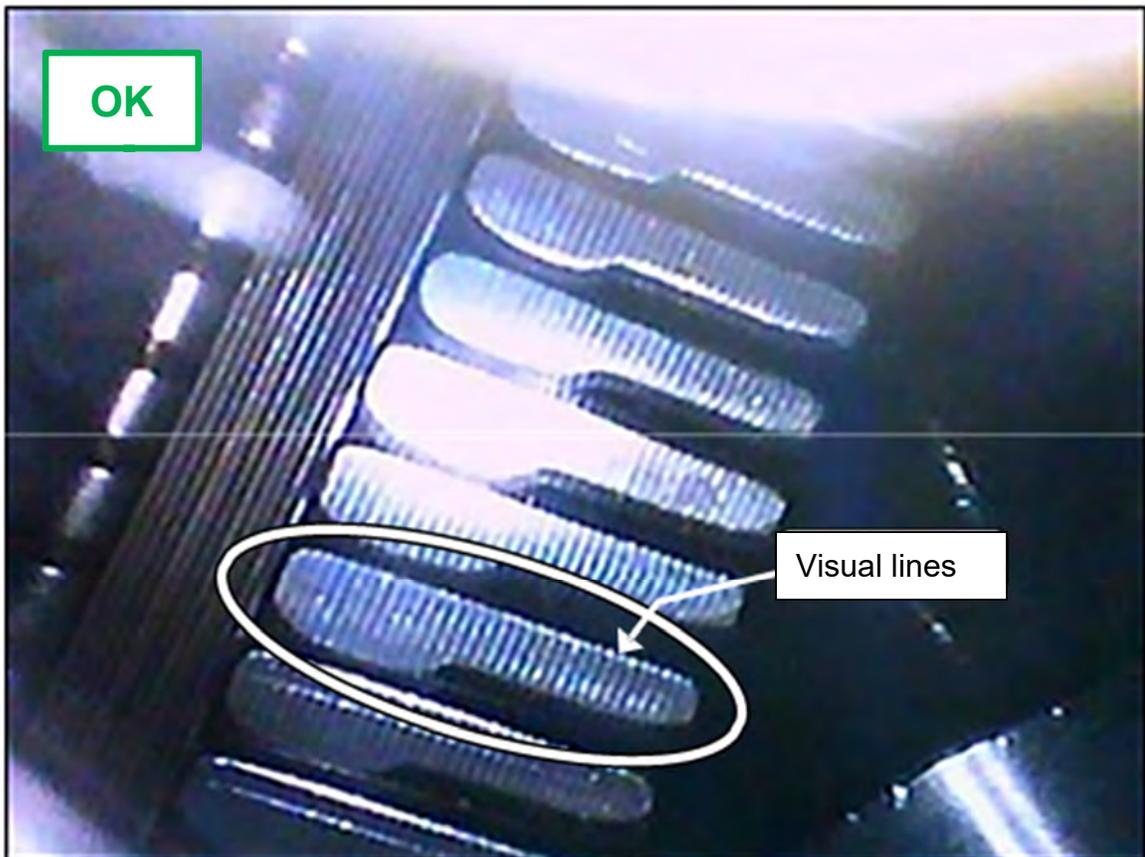
- Reference Figure 23 through Figure 28 on pages 16-18 for comparison.
- Use borescope J-51951 with mirror attachment.
- Clean the camera lens and mirror before each inspection. Use 90% isopropyl alcohol, and a lens swab from Lens Swab packet J-51963 listed in **PARTS INFORMATION** on page 21 of this bulletin.

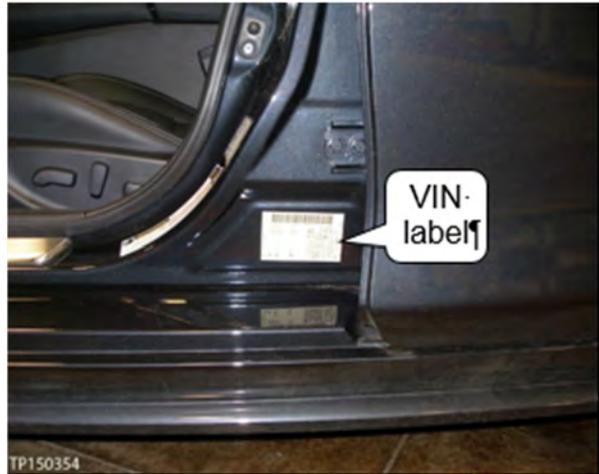
Figure 29

- Use borescope J-51951 to record a continuous video, 15 seconds or less, of the most severe evidence of belt slip and the VIN on the FMVSS certification label (VIN label).

**HINT:** This required video must be attached to the Powertrain Call Center (PCC) CVT Preauthorization Form (in ASIST) prior to calling for authorization. Failure to submit a continuous video will cause immediate denial of request for replacement.
