Subject: N192219510 - Customer Satisfaction Program  
Rear Brake Pipe Protective Sleeve

Models: 2019 Chevrolet Silverado 1500  
2019 GMC Sierra 1500

# Customer Satisfaction Program

## N192219510 Rear Brake Pipe Protective Sleeve

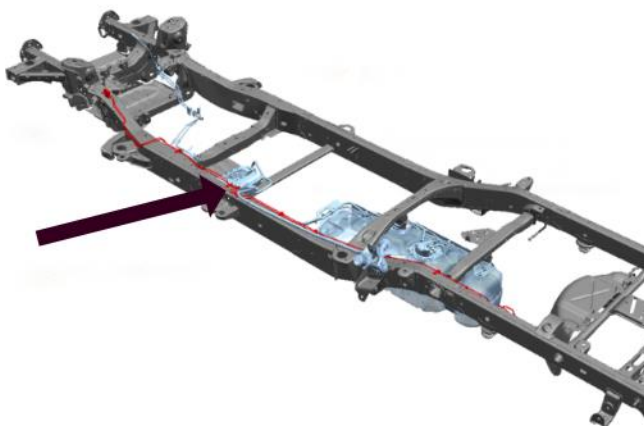
5360599

2. Locate the area of the rear brake pipes where they route around the evaporative emission canister solenoid and the evaporative emission canister.

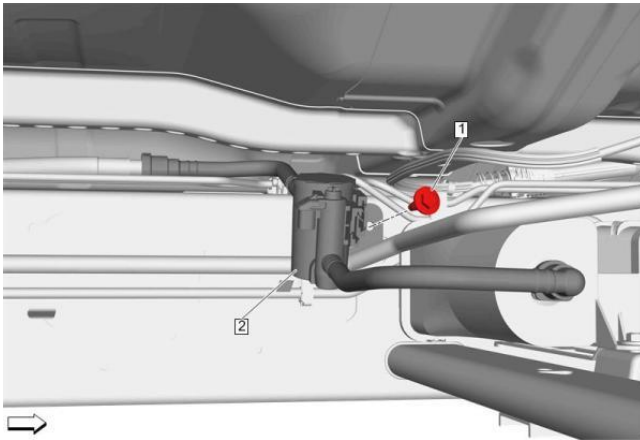
5022566

3. Remove the evaporative emission canister solenoid mounting bolt (1). Disconnect the solenoid electrical connector and hose fitting at the evaporative emission canister. Allow the solenoid to drop enough to allow access to the work area.

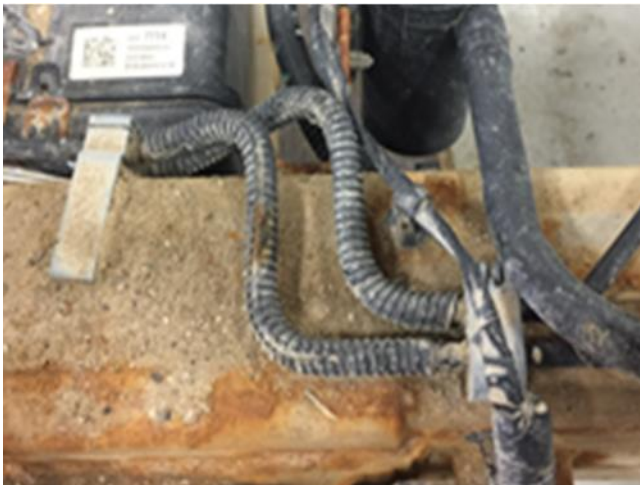
5360600

4. Locate the two corrugated plastic sleeves on the rear brake pipes, remove and discard the sleeves.

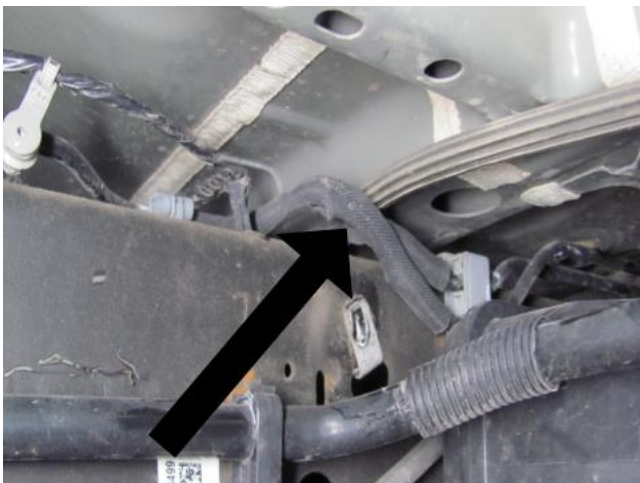
5362649

5. Install the two new fabric protective sleeves on the rear brake pipes in the same position as the original corrugated plastic sleeves.
6. Reinstall the evaporative emission canister solenoid. Tighten 22Nm (16lb ft).
7. Lower the vehicle.
