October 11, 2019

13284 Version 6

## Product Update: MDX 9-Speed Transmission Warmer (Transmission Previously Replaced for Transmission Warmer Leaking)

Supersedes 17-010, dated April 7, 2018, to revise the information highlighted in **yellow**

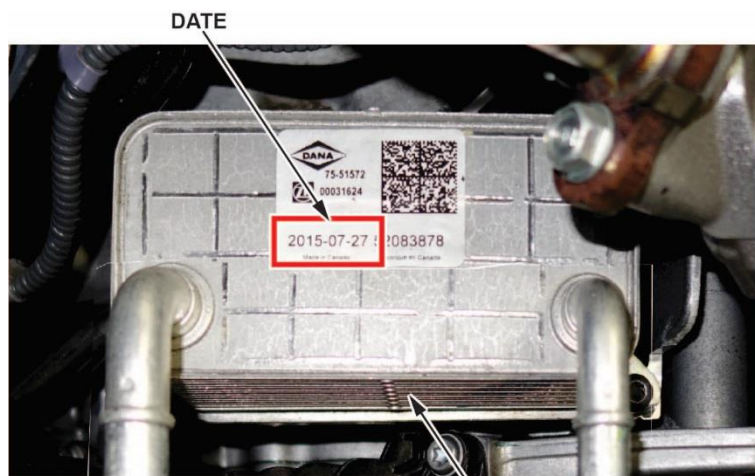
TRANSMISSION WARMER

1. Inspect the date on the transmission warmer. The affected transmission warmers were built between April 28, 2015 (2015-04-28) and July 15, 2015 (2015-07-15).
  - If the build date **is within the date range**, go to ATF WARMER INSPECTION.
  - If the build date is before or after the date range, go to step 2.

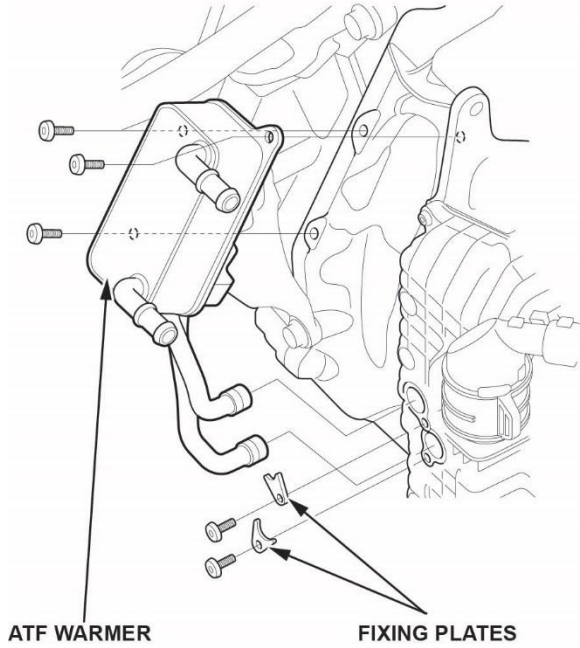
12. Remove the 3 hold down bolts and 2 fixing plate bolts to remove the transmission warmer. Place the warmer on a clean surface.

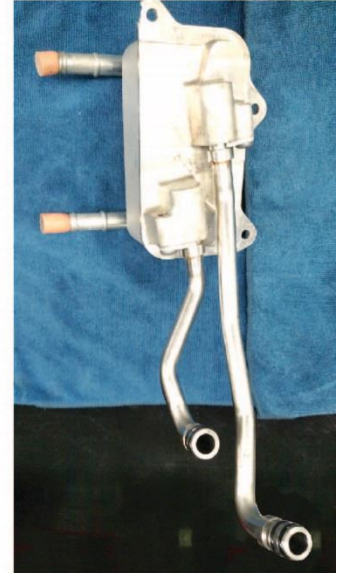
**WARMER WITHOUT  
ACCESSORY  
COOLER LINES**

13. Prepare the transmission warmer to check for leaks.

- Remove the original ATF lines from the warmer.  
NOTE: Be careful not to damage the lines as you may reuse them.
- Install the pressure check tool as shown with the fixing plates, and torque the bolts to **10 N·m (7 lb-ft)**.
- Fill a bucket with warm water.
- Connect shop air to pressurize the warmer, and adjust the pressure check tool to **70 psi**.

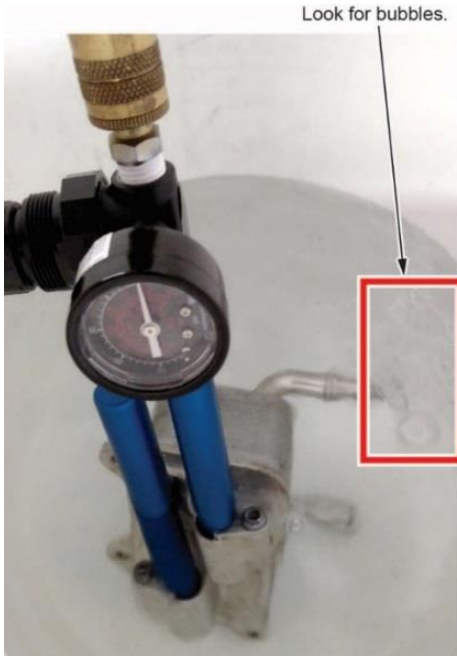
14. Check the transmission warmer for leaks by submerging the warmer completely under the water and watching for bubbles.

NOTE: Some bubbles are normal when the transmission warmer is first submerged and will come to a stop. If there is a leak, there will be a steady stream of bubbles coming from the transmission warmer.

- If there are no bubbles coming from the warmer, continue with the warmer replacement. Go to step 15.
- If there are bubbles, take photos (see Photos) and check to see if the vehicle also overheated by checking the client responses on the RO.
  - If the transmission warmer leaks but the engine did not overheat, go to [REPAIR PROCEDURE C](#).
  - If the transmission warmer leaks and the engine overheated, go to [REPAIR PROCEDURE D](#).

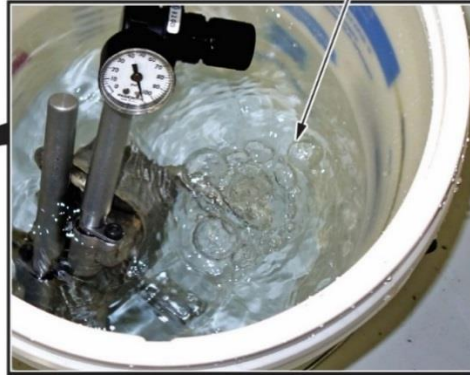
BUBBLES

If there are bubbles because of a leaking transmission warmer, take photos of the bubbles during the pressure test, the transmission warmer serial number, and the VIN.

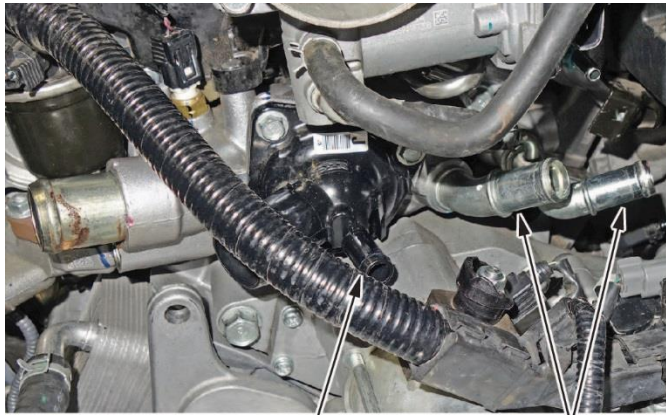
8. Using the three colored plugs from the flush kit, cap off both heater hoses and the ATF transmission warmer line as shown.

ATF TRANSMISSION  
WARMER LINE

HEATER HOSES

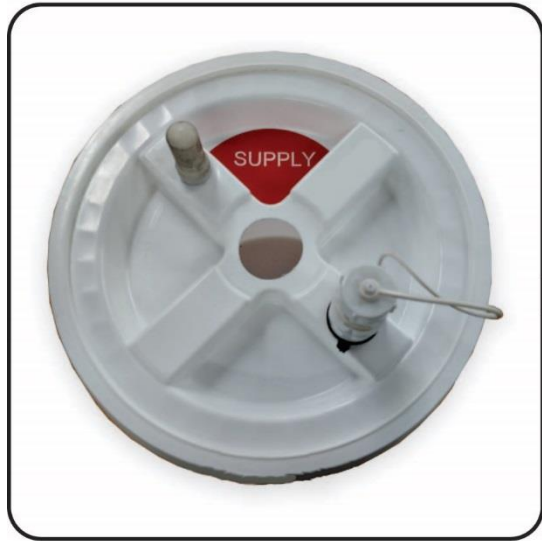
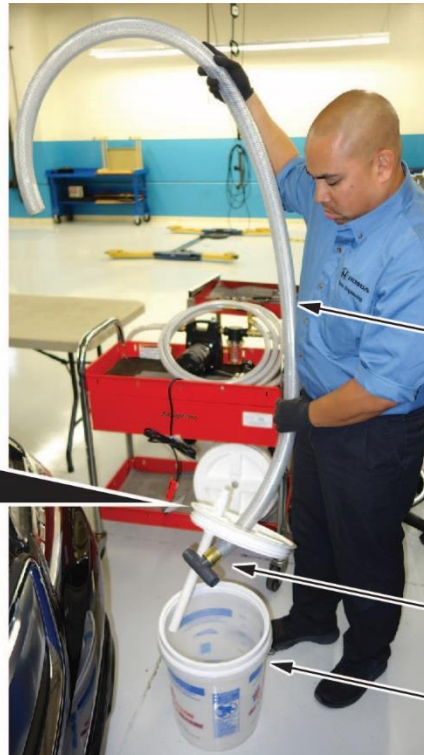
10. Remove the lid from the SUPPLY bucket, and install the large (1.5 in.) return hose with the T-fitting through the hole in the lid as shown.

ENGINE RETURN HOSE

T-FITTING

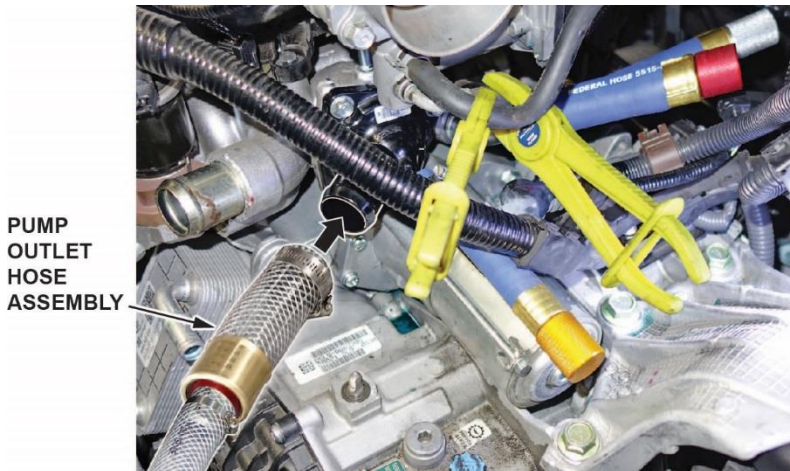
PUMP  
OUTLET  
HOSE  
ASSEMBLY

12. Install the pump outlet hose onto the thermostat housing.

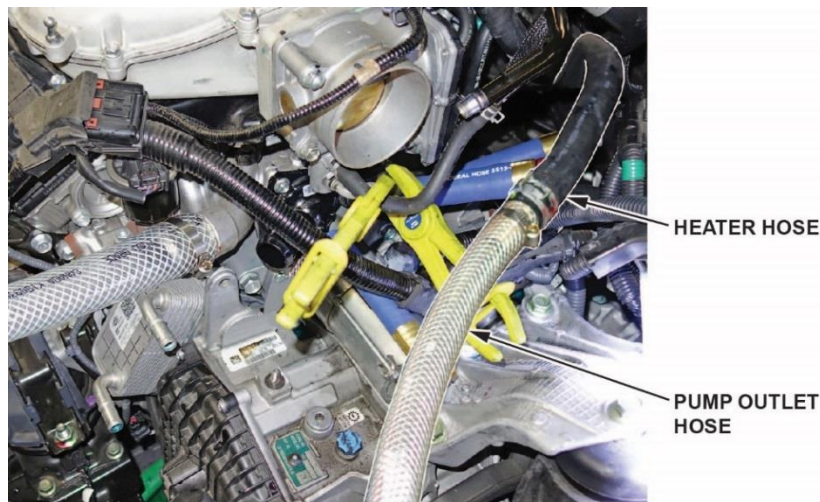
22. Connect the pump outlet hose to the heater hose as shown.

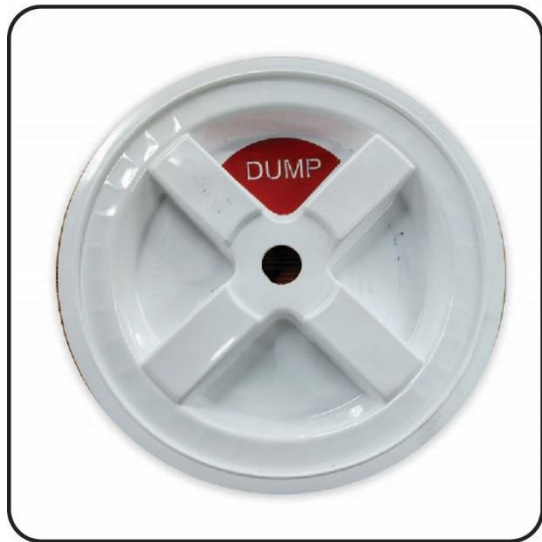
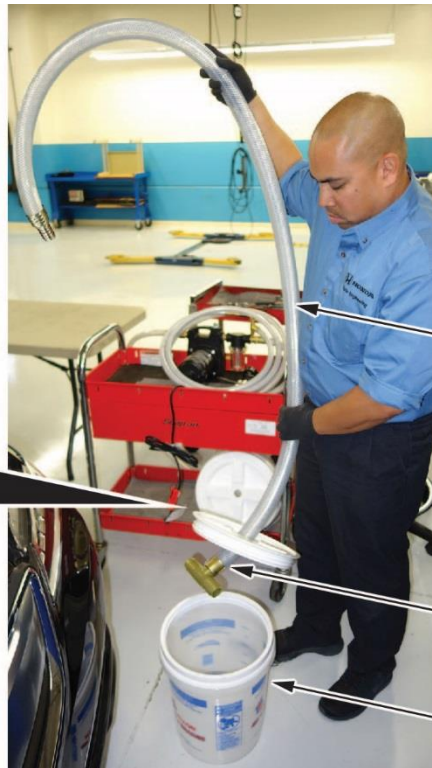
23. Disconnect the return hose from the engine. Install the heater core return hose through the DUMP bucket lid.

HEATER CORE RETURN HOSE

T-FITTING

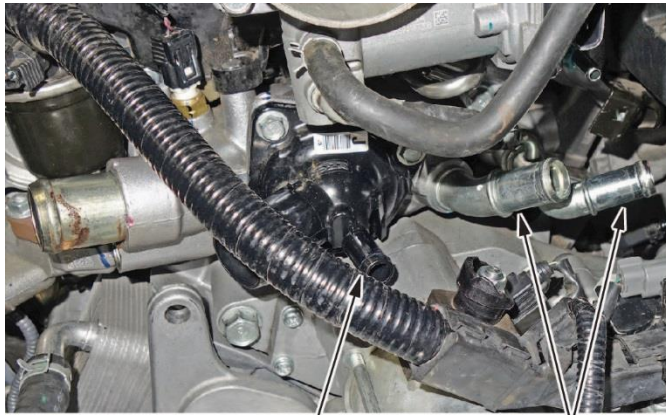
9. Using the three colored plugs from the flush kit, cap off both heater hoses and the ATF transmission warmer line as shown.

ATF TRANSMISSION WARMER LINE      HEATER HOSES

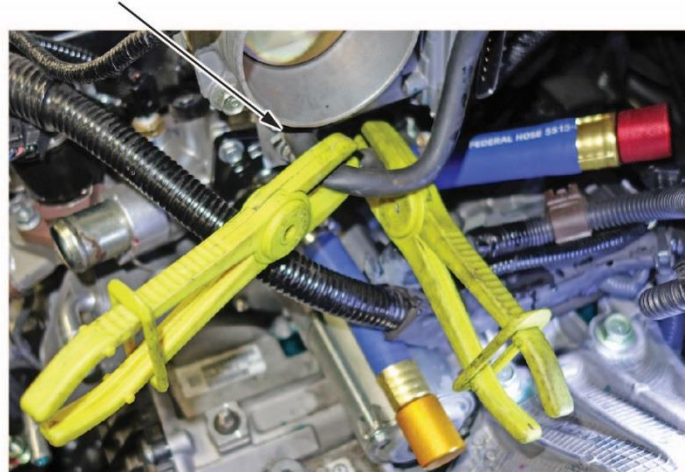
10. Using commercially-available clamps, clamp the throttle body coolant lines as shown.

Clamp both of the throttle body coolant lines.

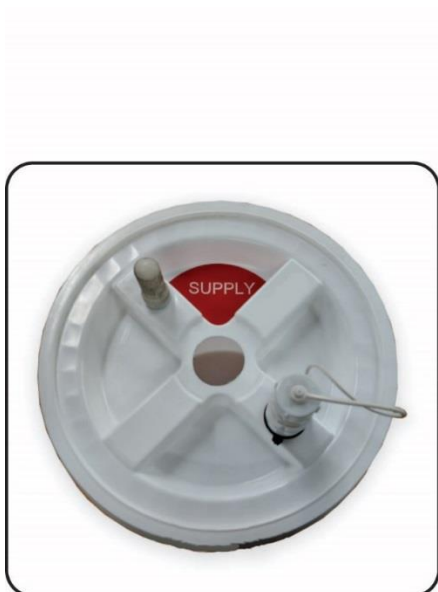
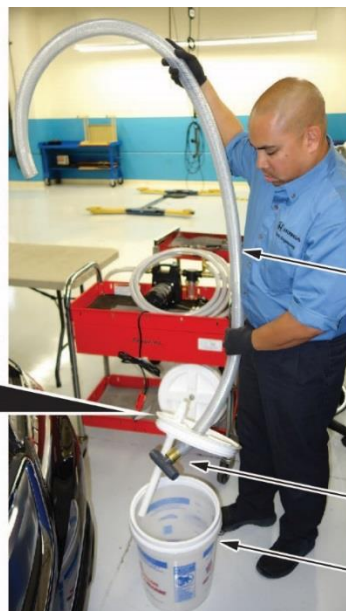
11. From the bucket marked SUPPLY, remove the lid and install the large (1.5 in.) return hose with the T-fitting through the hole in the lid as shown.

ENGINE RETURN HOSE

T-FITTING

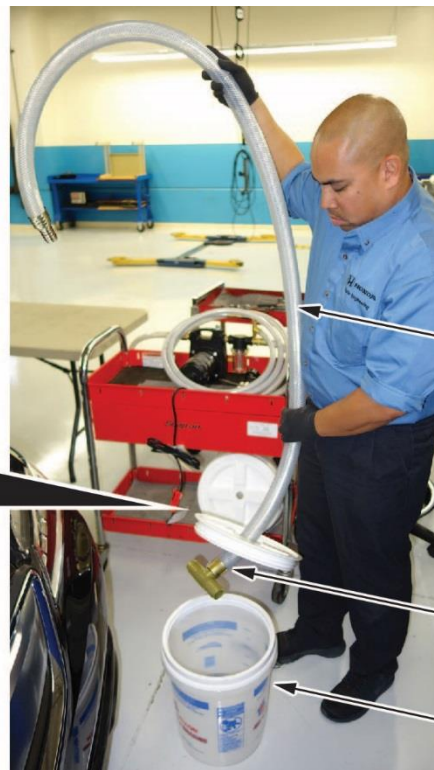
23. Install the heater core return hose through the DUMP bucket lid.

HEATER CORE RETURN HOSE

T-FITTING
