# Special Parts Collection - USA

## Code: 69V8

<b>Subject</b>	<b>Driver &amp; Front Passenger Seat-Mounted Side Airbags</b>
<b>Release Date</b>	October 11, 2019
<b>Revision Summary</b>	<b>The special parts collection program is expanded to applicable vehicles registered &amp; located within the 48-contiguous United States.</b>
<b>Affected Vehicles</b>	<b>U.S.A.: Certain 2009 MY Volkswagen Tiguan</b> <i>Check Campaigns/Actions screen in Elsa on the day of repair to verify that a VIN qualifies for repair under this action. Elsa is the <u>only</u> valid campaign inquiry &amp; verification source.</i> <ul style="list-style-type: none"><li>✓ Campaign status must show "open."</li><li>✓ If Elsa shows other open action(s), inform your customer so that the work can also be completed at the same time the vehicle is in the workshop for this campaign.</li></ul>
<b>69V8 Special Parts Collection Program</b>	In coordination with the National Highway Traffic Safety Administration (NHTSA), Volkswagen is conducting a special parts collection program involving Takata driver and front passenger seat-mounted side airbags from selected 2009 MY Volkswagen Tiguan vehicles. Under this program: <ul style=

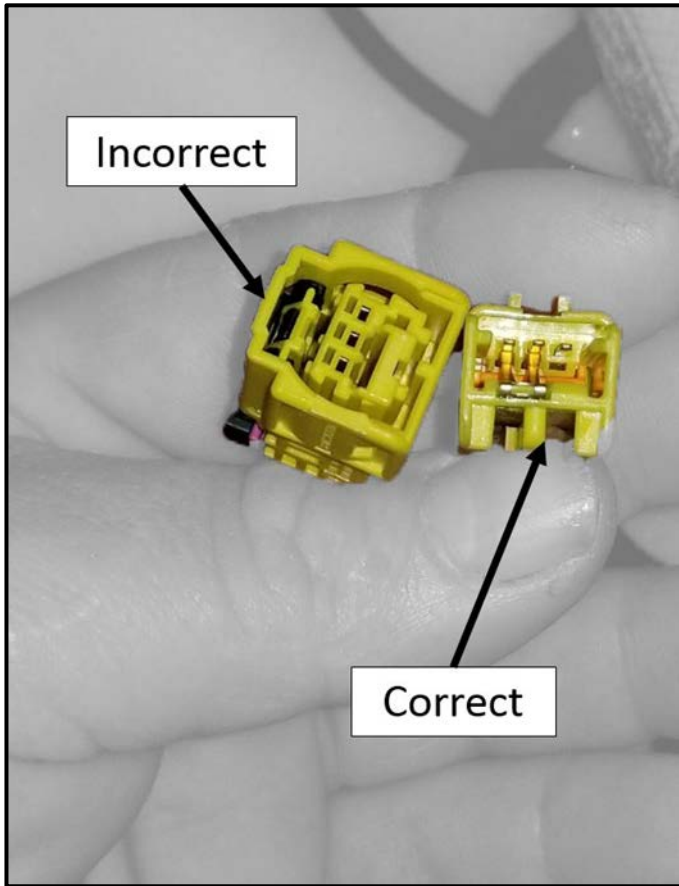
The new side airbag may come with an incorrect connector housing and with female pins instead of male pins.

- If necessary, install new connector housing with new pins.
- Butt connectors must be staggered.
- Gold plated terminals must be replaced with gold plated terminals.
- Silver plated terminals must be replaced with silver plated terminals.
- DO NOT mix silver and gold plated terminals.
- Original harness length must be maintained.
- Ensure the wire orientation is maintained from the old to the new connector housing.
- For more information, see ELSA Repair Manual: *Repair Manual > Electrical System > Electrical Equipment General Information > 97 Wiring > Wiring Harness and Connector Repairs > Wiring Harnesses, Repairing*
