Service Action

Code: 1903

Subject Coolant Bottle

Problem Description The coolant bottle may leak coolant into the electrical connector for the coolant level sensor.

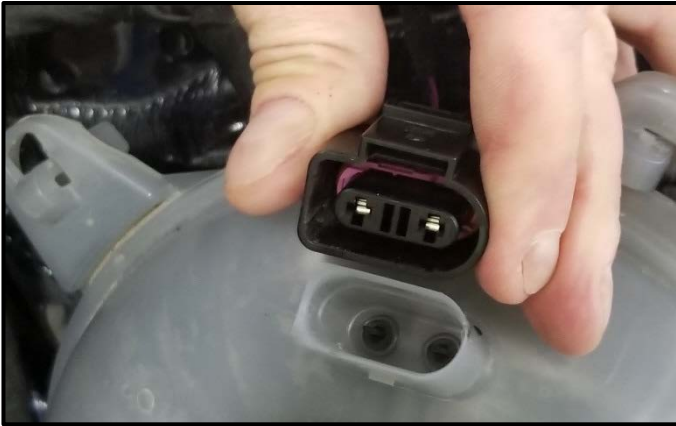
- Check coolant bottle for coolant migration.

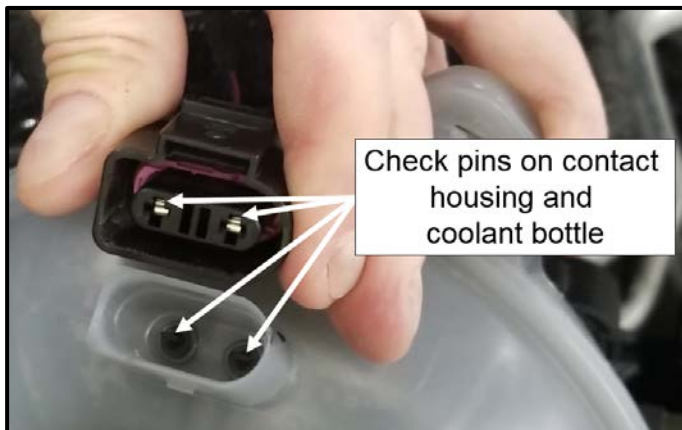
Inspect coolant level sensor wiring connector and coolant bottle connector housing:

- If coolant or corrosion **IS FOUND** at the coolant level sensor wiring connector and coolant bottle connector housing:
 - Coolant bottle requires replacement.
 - Coolant bottle connector and connector pins require inspection.
 - -J519- requires inspection.
 - TIGUAN ONLY: Ambient temperature sensor requires inspection.
 - **Proceed to Section C.**
- If coolant or corrosion **IS NOT** found at the coolant level sensor wiring connector and coolant bottle connector housing:
 - Reconnect the coolant level sensor connector to the coolant bottle.
 - No further work is required.
 - **Proceed to Section E.**

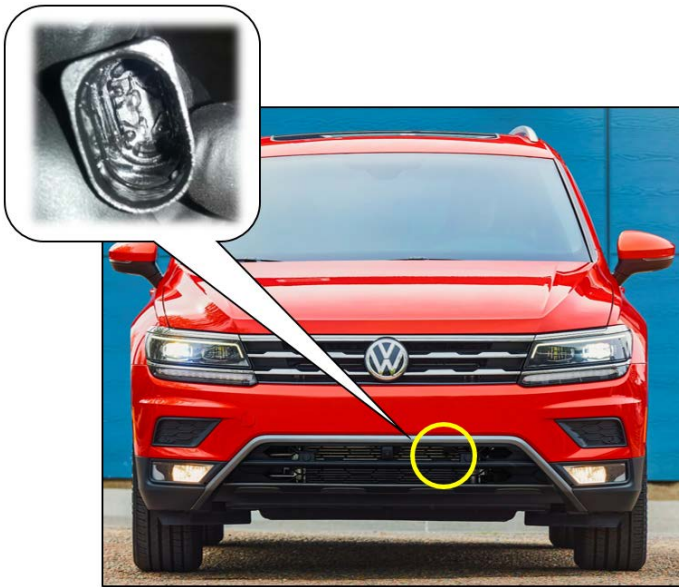
TIGUAN ONLY - Inspect ambient temperature sensor for coolant migration:

- Connector and sensor will be inspected.
- If NO liquid coolant or corrosion is found:
 - Reconnect connector to sensor.
- If corrosion is found on the connector or sensor pins:
 - Ambient temperature sensor must be replaced.
 - Corroded connector pins must be replaced.
- If only liquid coolant is found at the sensor, but there is NO corrosion:
 - Ambient temperature sensor connector and pins should be cleaned with a dry, lint free cloth.
 - Ambient temperature sensor connector and pins should also be cleaned with compressed air.
