Export SAFETY RECALL BULLETIN

Subject: **Safety Recall D19R5 DD15TC High Pressure Fuel Lines**

Detroit Diesel Corporation (DDC) has determined that certain Heavy Duty Engine Platform DD15TC EPA07/ADR80/03 engines sold in Australia and New Zealand will require inspection and possible replacement of the two high pressure fuel rail feed lines and supporting hardware from the high pressure fuel pump to the fuel rail.

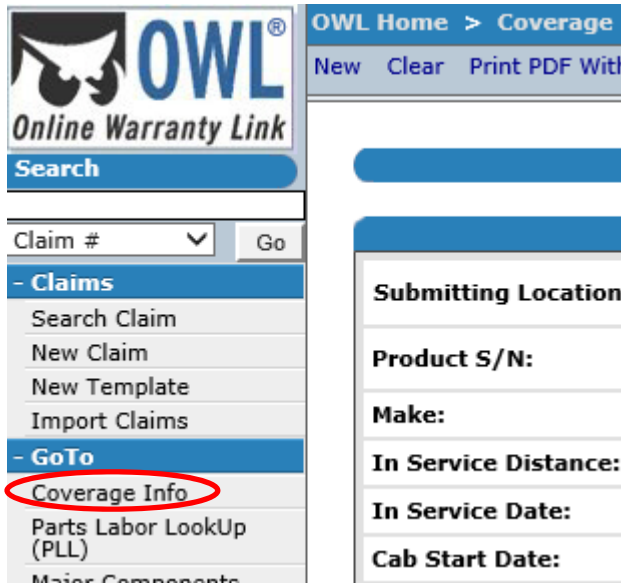
Figure 1

1. Record the Engine Serial Number for the vehicle.
2. Refer to OWL to determine if the unit is in Group A or Group B.
3. Go to OWL and select “**Coverage Info**”. See Figure 1.

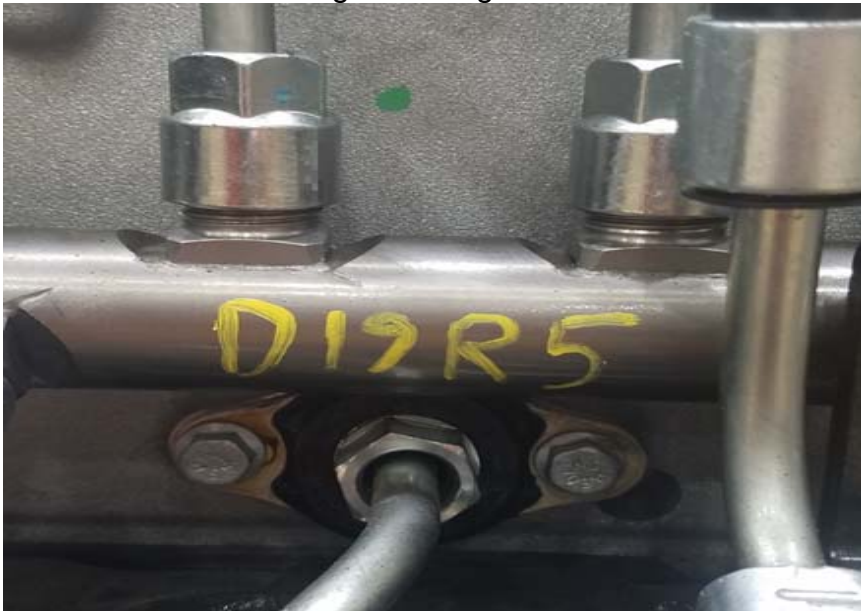
Figure 4 – D19R5 Identification on Fuel Rail

1. Apply the parking brake, disconnect the batteries, chock the wheels, and perform any other applicable safety steps.
2. Replace the two High Pressure Fuel Rail Feed Lines and supporting hardware using service kit P/N A4720709132 and follow the procedure set forth in **Installation of the High Pressure Fuel Rail Feed Lines - Two-Filter System** in EPA07/10/GHG14 Fuel Manual (DDC-SVC-MAN-0082)
3. Using a paint pen, write the campaign number "D19R5" on the Fuel Rail under the High Pressure Fuel Feed Line fittings. See Figure 4.

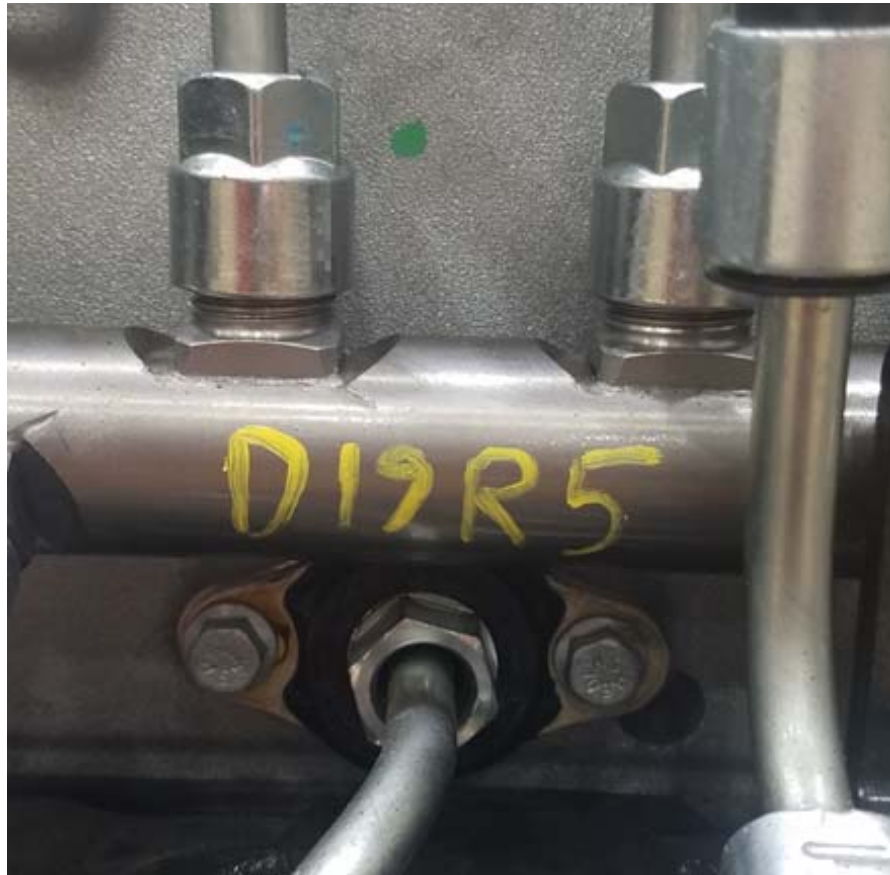
Figure 10 – D19R5 Identification on Fuel Rail

6. Using a paint pen, write the campaign number "D19R5" on the Fuel Rail under the High Pressure Fuel Feed Line fittings. See Figure 10.
