Model Designation on Doors

Concern: **Retrofitting**

Model Year: **As of 2019**

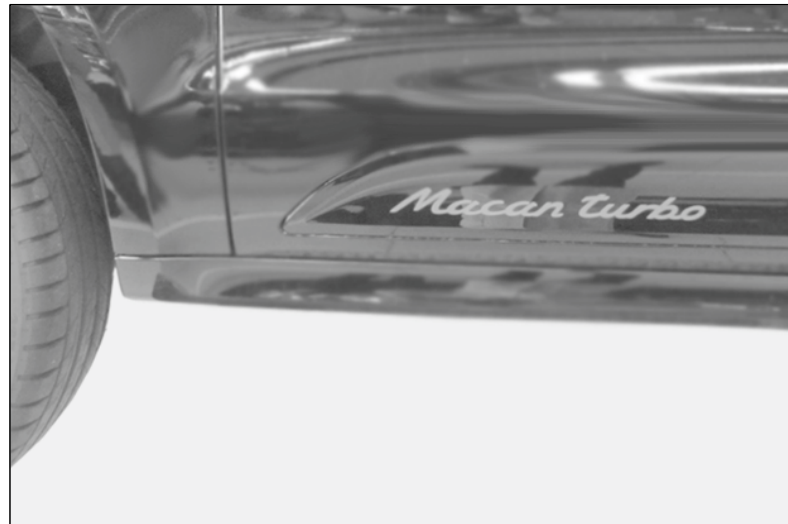
Figure 1

Information: The model designation can be applied as a logo on the doors of the new Macan. The logo is available in Black, Red, Silver and Gold and with different model designations.
