# Product Upgrade Bulletin 190723REV

**UPGRADE BULLETIN:**  
**190723REV**

Fleetwood Brand:  
2018 Surge  
2018 Axon  
2019 – 2020 Flair

**SUBJECT:**  
Inspection/Correction of Longitude™ Awning Components and Mounting

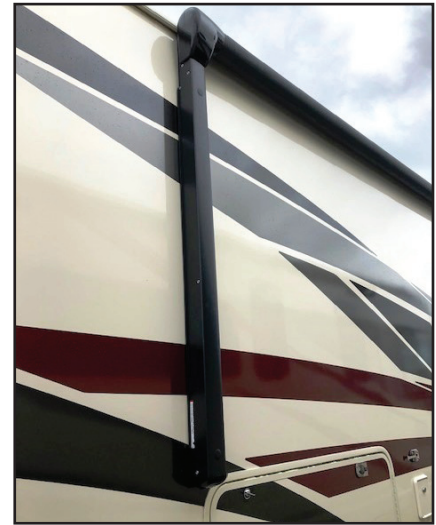
Carefree Longitude™ Awning

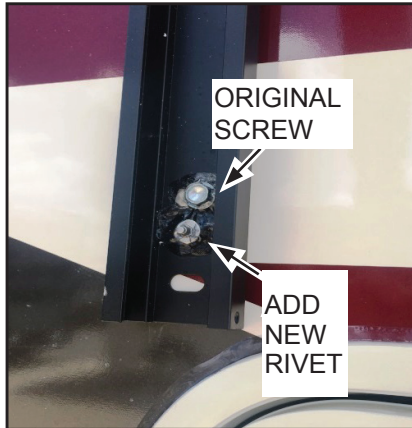
**Figure 1**  
Lower Mounting Point

On affected motorhomes manufactured 9/5/2017 - 6/27/2019, incorrect fasteners may have been used to secure the Carefree Longitude™ awning legs to the sidewall. If this condition exists, there is a possibility of premature failure of the awning and/or its components. This issue will be referenced in the following procedures as “Scenario A”.

8. Using a drill and 7/32" bit with a drill stop set at 3/4", (as to ensure **NOT** drilling all the way through the sidewall), bore holes through the center of the awning arm at the locations shown in Figures 1-4. Clean each newly drilled hole and surrounding area of any chips or debris. Install 3/16" Molly/Oscar rivets in the holes and secure with a rivet gun. Measure the location of the new rivets for reference and replication on the rear arm.

**NOTE:** It is very important that a new hole is drilled through the awning arm and into the sidewall for each new rivet. Do not install any rivets in an existing hole or slot.

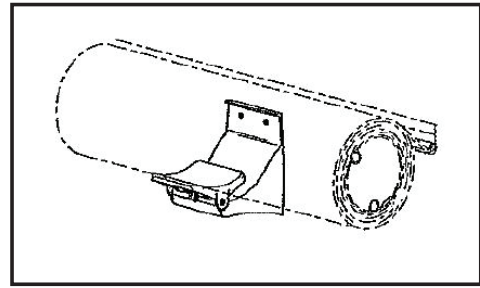
**Figure 5**  
**Check for center support brace**

On affected motorhome manufactured 9/11/2017 - 7/23/2019 and equipped with a Carefree Longitude™ awning 20 feet or longer (measured from the center of the awning legs), the required center awning support brace may have been omitted during awning installation at the factory. Without this support brace, there is a possibility of premature failure of the awning and/or its components. This second issue will be referenced in the following procedures as “Scenario B”.

12. With the patio awning fully retracted, inspect the center area of the awning fabric roll tube to see if a center support brace is present. See Figure 5 for clarifying details.

13. If the bracket is present, submit a claim using flat rate code 6086-11, Inspected/Not Defective. If there is no bracket present, proceed to Step 14.
