Service Bulletin

02-154

Model 520 Right Hand Stand-Up Vehicles Washer Fluid Leak at Vent Hose

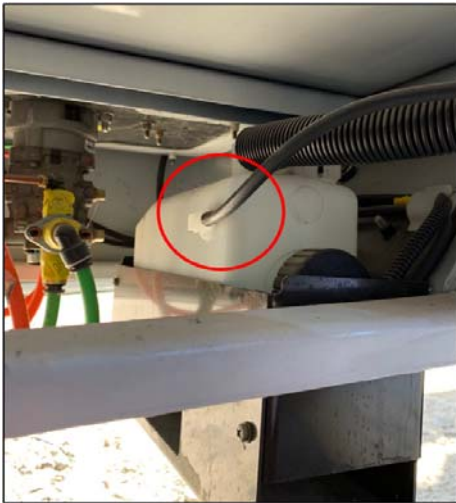
The current vent line in model 520 right hand stand-up vehicles may be too short and allow fluid to leak from the hose connection to reservoir. To correct this issue, replace the current hose as documented in the procedure section.

1. Remove the current vent line hose.
