HONDA

Service Bulletin

19-110

Center Console Trim Piece Comes Loose

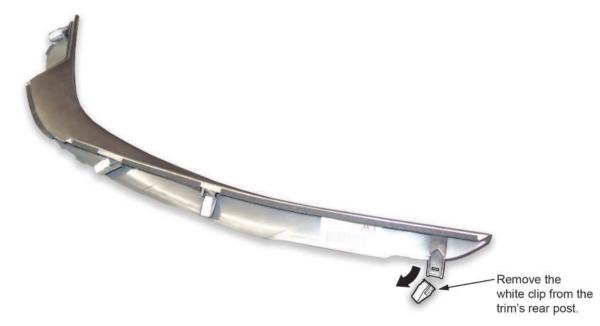
3. Remove the white clip from the trim's rear post as shown.

- Gently pry both sides of the clip at the same time with a small screwdriver or plastic trim tool.
- Improper handling and removal of the trim may cause the clip to break. If it does, replace it. (P/N 90666-SDA-A01)

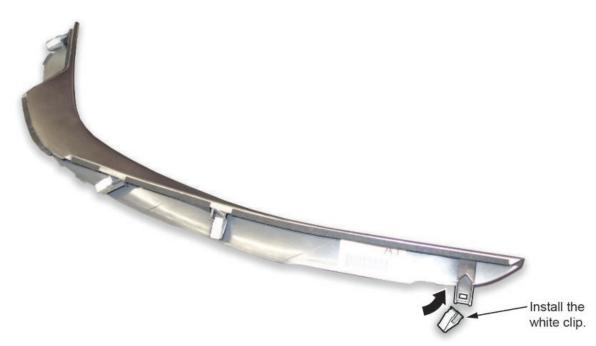
4. Insert the file into the clip cutout as shown.

- 5. File off 1 to 1.5 mm of material so the cutout is 3 to 3.5 mm wide.
- 6. Install the white clip.

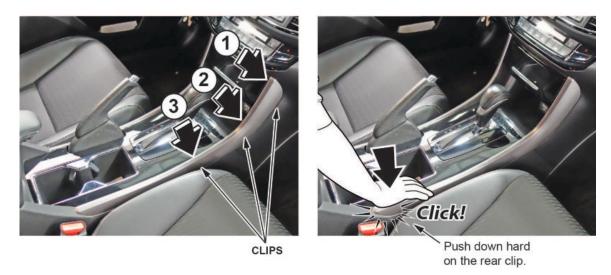
7. Install the trim. Starting from the top, push towards the front of the vehicle, and gradually work your way back. When you get to the final clip, use two hands and press firmly right above the clip until you hear a click.

If the clip will not fully engage, file off a bit more material from the cutout. Be sure not to remove more than **2 mm** of material. The cutout must not be larger than **4 mm**.
