Technical Service Bulletin

60 Water entry into cabin with an open sunroof

60 19 36 2056944/1 October 25, 2019.

Model(s)	Year	VIN Range	Vehicle-Specific Equipment
Q3, Q8, and Audi e-tron quattro	2019 - 2021	All	Not Applicable

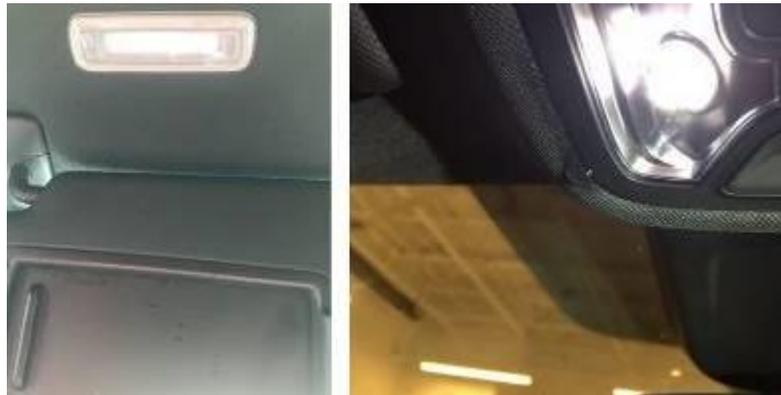
- They see water drip from the headliner area (Figure 1).

Figure 1. Water intrusion near the headliner.

Make no repairs for this condition. The sunroof mechanism and its drainage system are functioning normally. Ask the customer if it is at all possible that the sunroof was open in any way (vented position or open position) during rain, carwash, or when standing water was on top of the vehicle such as after it has rained. Please explain to the customer that the sunroof panel should never be opened until both the vehicle and the weather conditions are dry.

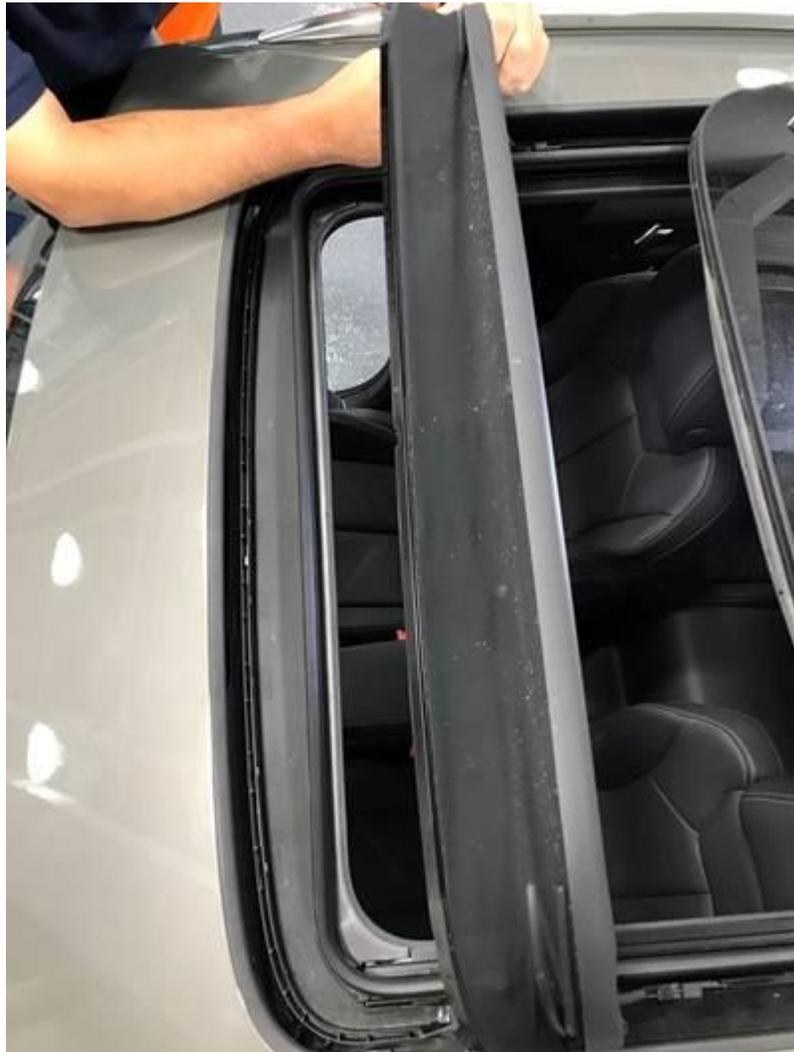
If the sunroof panel is opened in any way while the vehicle is exposed to water (rain, car wash, or standing water on the roof panel) for however brief a period of time. It is possible for water to enter the sunroof opening that is not designed for exposure to water, breach the normal water channeling, and leak into the cabin area. This water intrusion may not manifest itself immediately but may appear after a driving period when the water migrates to the underside of the headliner area (Figure 2-4).

Figure 2. Front sunroof opening with drainage exposed.

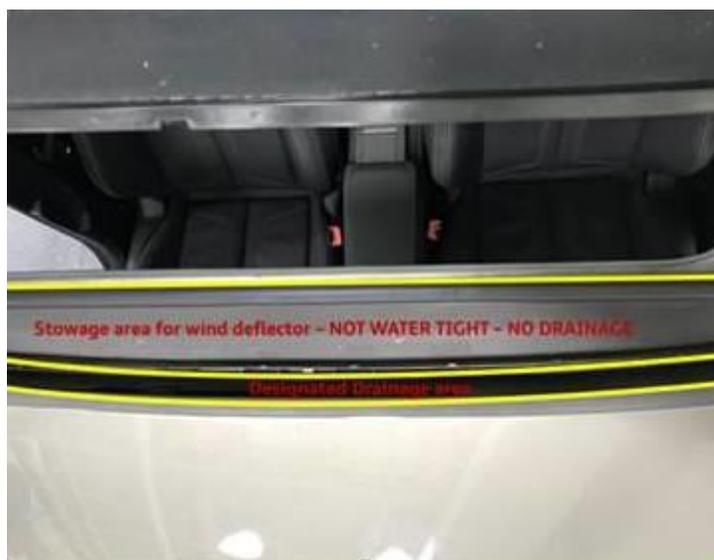
Figure 3. Areas of sunroof opening water elimination capabilities.

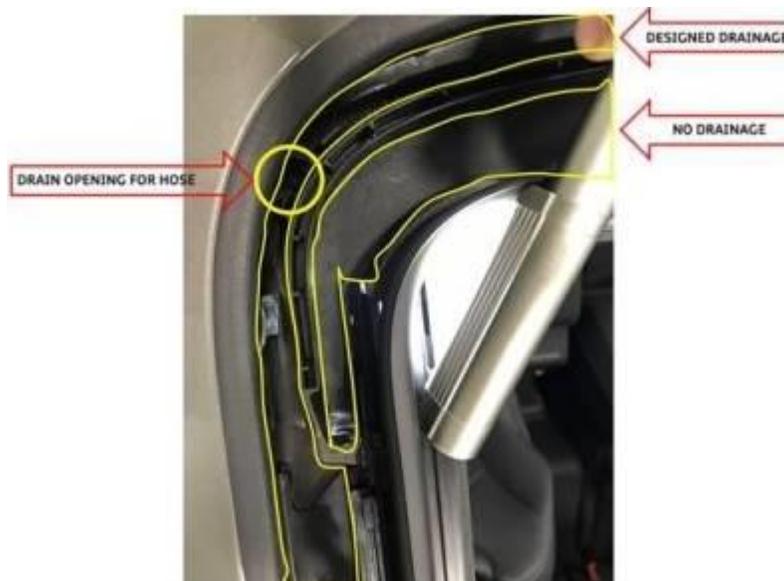
Figure 4. Sunroof water channeling diagram.
