GROUP Emissions Service Campaign	MODEL Multiple Models
	NUMBER SC169	DATE October 2019
VOLUNTARY EMISSIONS SERVICE CAMPAIGN		
SUBJECT: ENGINE OIL FILLER CAP INSPECTION AND/OR REPLACEMENT (SC169)

This bulletin provides the procedure to inspect and, if necessary, replace the oil filler cap on some vehicle models listed below. The engine oil filler cap may contain a misprint of SAE Engine Oil Viscosity Number. Follow the procedure outlined in this bulletin to replace the oil filler cap.

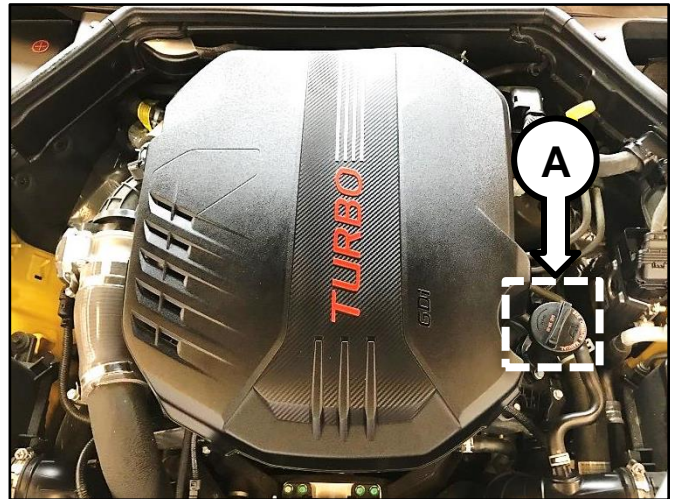
1. Inspect the engine oil filler cap (A).
 - If the cap states, "5W-30", no further action is required.
 - If the cap does not state "5W-30", proceed to the replacement procedure below.

Stinger (CK) 3.3T engine is shown above for demonstration purposes only. Location of engine oil filler cap may vary on different models.

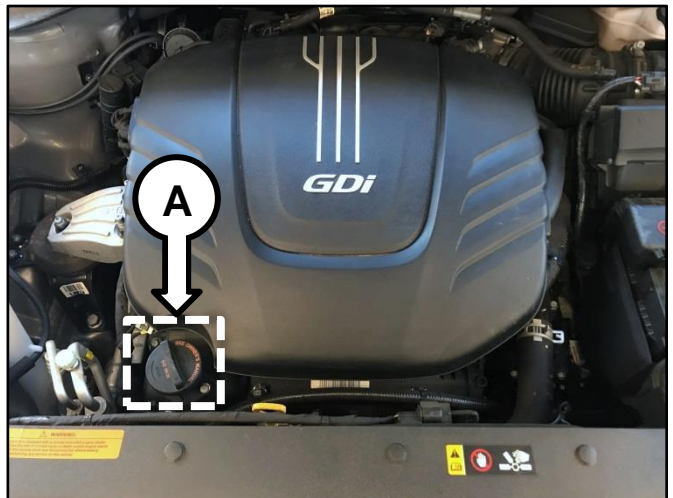
Sorento 3.3L engine is shown above for demonstration purposes only. Location of engine oil filler cap may vary on different models.

1. Replace the engine oil filler cap (A) with a new correctly printed cap, according to the table on page 1 of this bulletin.

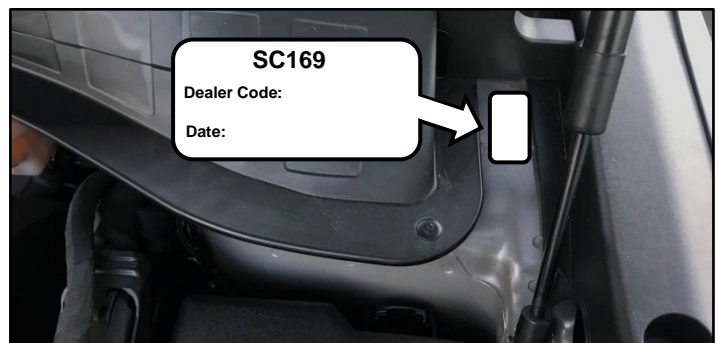
Apply SC169 Campaign Completion Label onto the body in the area next to the shock tower, as shown. **NOTE: Be sure to clean the mounting surface to ensure proper label adhesion.**

The dealer must fill in the Dealer Code and Date information fields on the Campaign Completion Label. Once complete, affix the campaign completion label under the hood of the vehicle, as shown below.
