Preliminary Information

PIT5660A HVAC Mode Does Not Move to the Correct Position / Unable to Reach Certain Mode Positions / Mode Door Stuck / No Related HVAC DTCs

Brand:	Model:	Model Years:	VIN:		Engine:	Transmissions:
			from	to		
Chevrolet	Silverado 1500 (New Model)	2019	All	All	All	All
GMC	Sierra 1500 (New Model)	2019	All	All	All	All

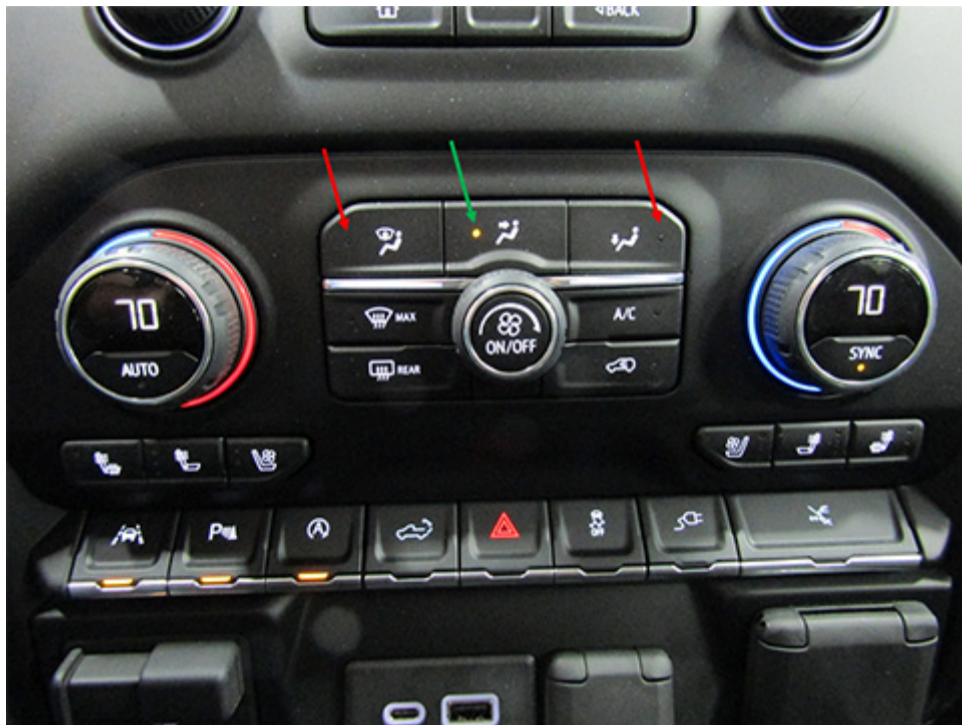
1. Open all of the panel vent outlets (front dash panel vents and rear seat vents)
2. Start the engine
3. Set the HVAC blower to the lowest speed
4. Select full panel vent mode by verifying the "Panel/Vent" button LED is on and the "Floor" and "Defrost" button LEDs are OFF, example shown below. Then, wait 15 seconds before performing the next step.
5. Press the HVAC "MAX Defrost" button on the HVAC control panel and then wait another 15 seconds before performing the next step.
6. Repeat step 4.
7. Set the blower speed to a higher setting and cycle between each of the HVAC modes to verify the vehicle has been repaired.

If a customer comes in for any of the conditions listed above, inspect the front and rear vent outlets for being closed off. If the mode door actuator loses its position, it can be corrected by performing the following procedure to relearn the mode door actuator position:
