November 5, 2019

Version 2

Buzzing or Whining When Adjusting Front Seat Forward and BackwardSupersedes 19-029, dated November 4, 2019, to revise the information highlighted in **yellow**.**AFFECTED VEHICLES**

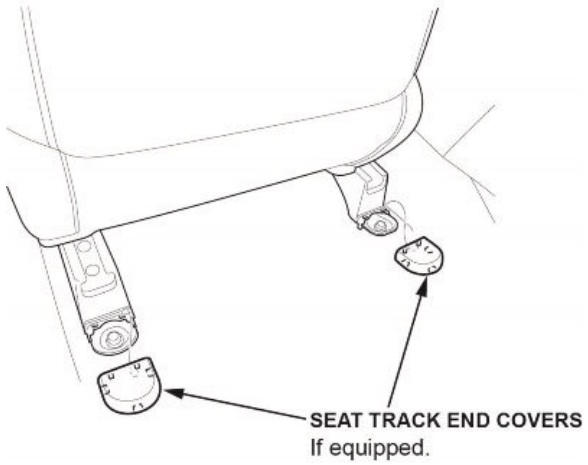
1. Remove the seat track end covers to expose the rear seat mounting bolts.

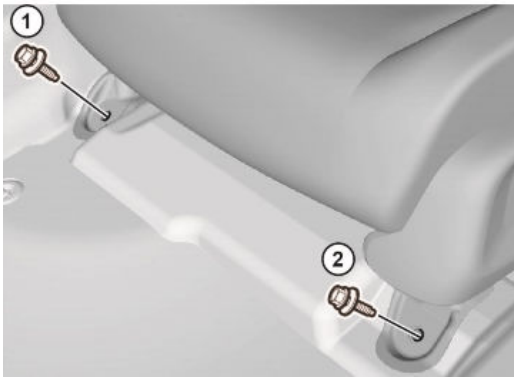
FRONT SIDE

2. Remove the four seat mounting bolts.

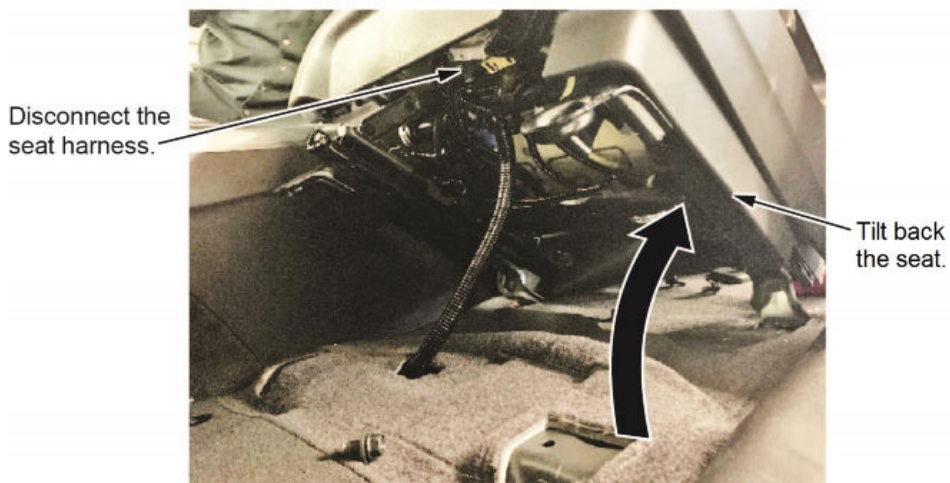
6. Tilt back the entire seat and disconnect the seat harness.

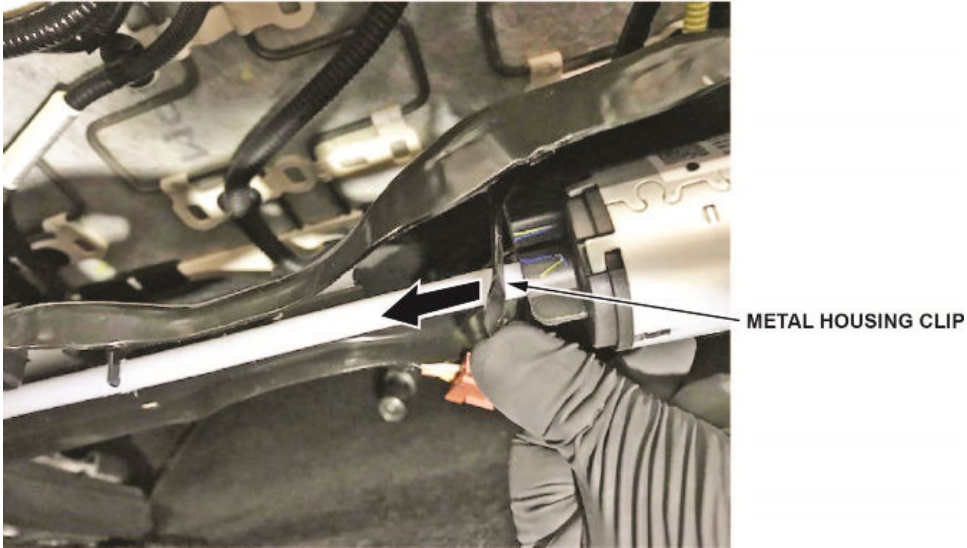
9. Gently push the metal housing clip on the front of the motor. Push upward at the cable end of the motor to allow removal of the flex cable.

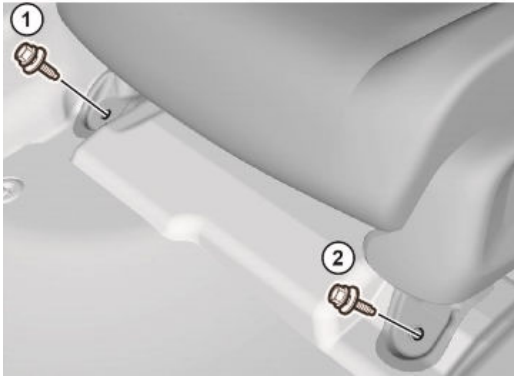
FRONT SIDE

18. Torque the bolts to specification as shown.

- 2013 -17 Accord (ALL): **41 N·m (30 lbf·ft)**
- 2018 -19 Accord (ALL): **43 N·m (32 lbf·ft)**
