GROUP <b>CAMPAIGN</b>	NUMBER <b>19-01-030H</b>
DATE <b>OCTOBER 2019</b>	MODEL <b>IONIQ HYBRID (AE HEV)</b>

**SUBJECT:** NVLD AIR FILTER KIT REPLACEMENT  
(SERVICE CAMPAIGN T4C)

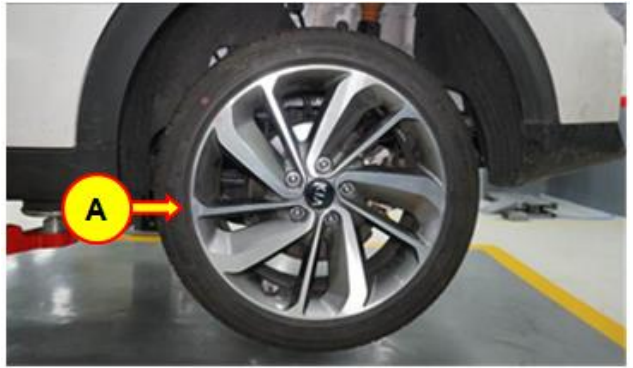
1. Lift the vehicle and remove the rear LH tire & wheel (A).

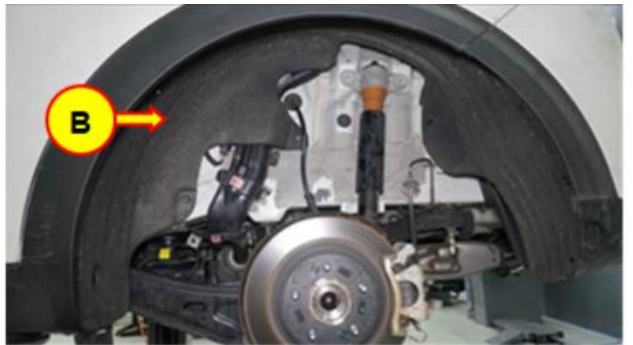
2. Remove the rear LH wheel guard (B).

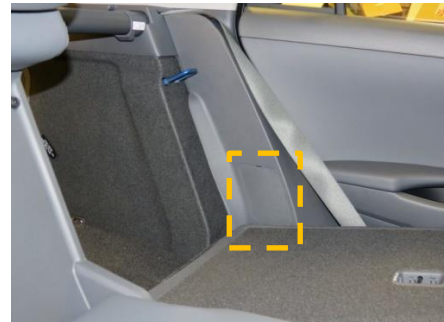
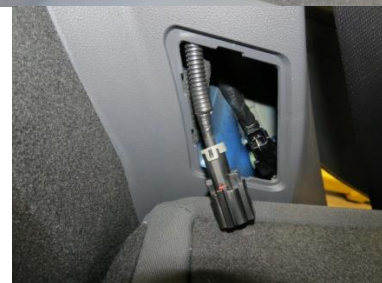
Pull forward the driver's side rear seat to locate the 12V battery service disconnect plastic panel as shown.

Pull out the panel and disconnect the 12V battery service disconnect as shown.

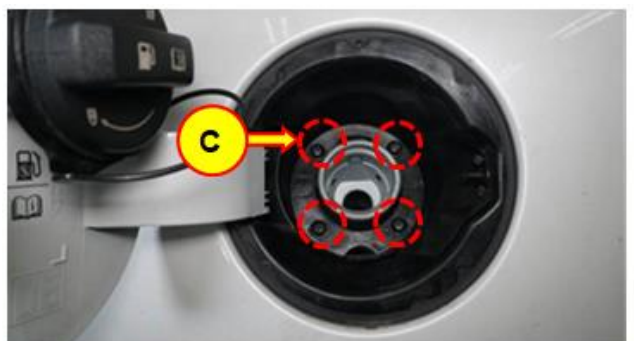
4. Open the fuel filler door and loosen the filler neck mounting bolts (C).

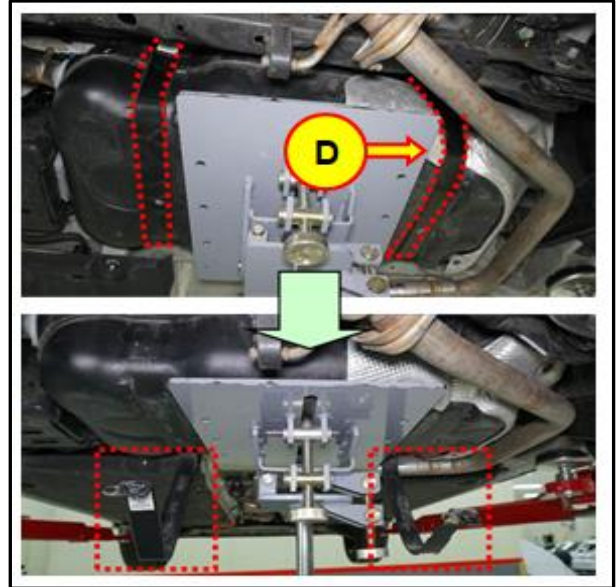
- Loosen the fuel tank band (D) mounting nuts.

*Use a jack stand to support the fuel tank.*

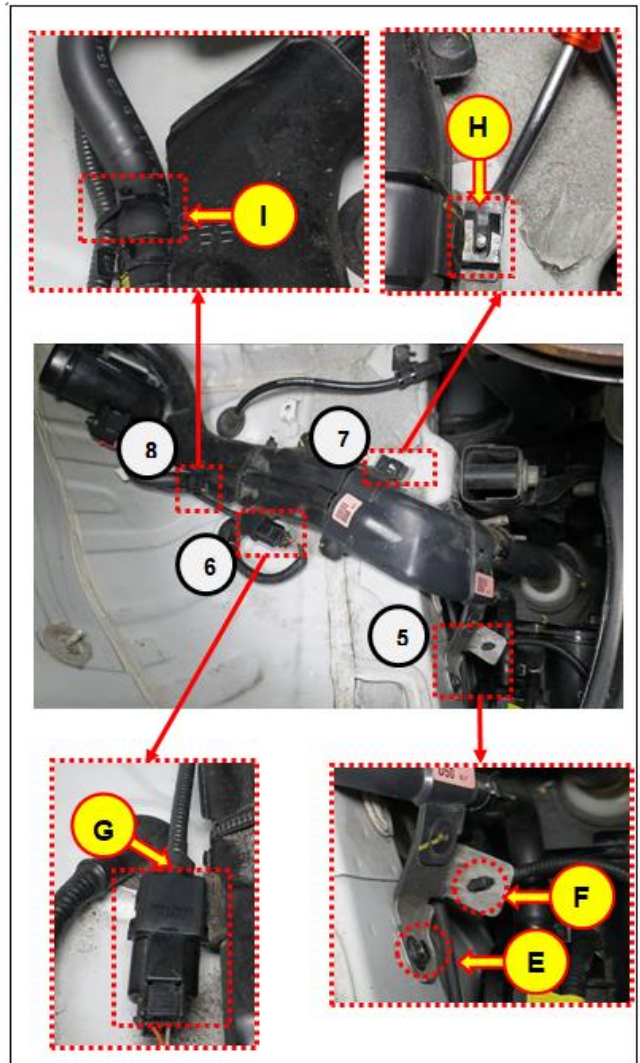
- Loosen the mounting bolt (E) and the mounting clip (F) of the filler neck assembly.
- Disconnect the connector (G).
- Disconnect the mounting clip (H).
- Disconnect the mounting clip (I).

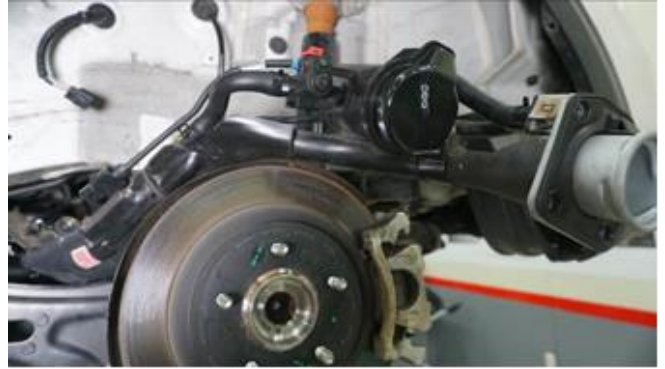
10. Separate the filler neck assembly as shown.

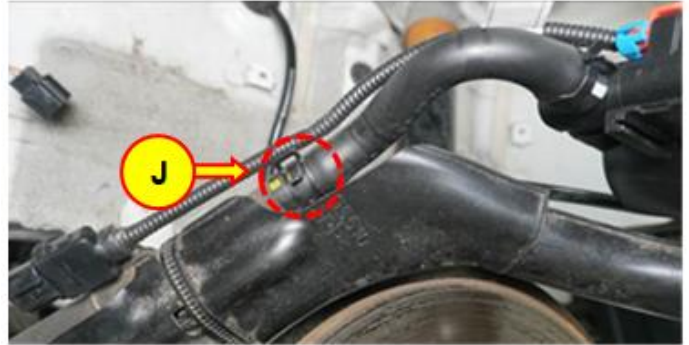
11. Release the mounting clamp (J) of the filler neck assembly to disassemble the hose.

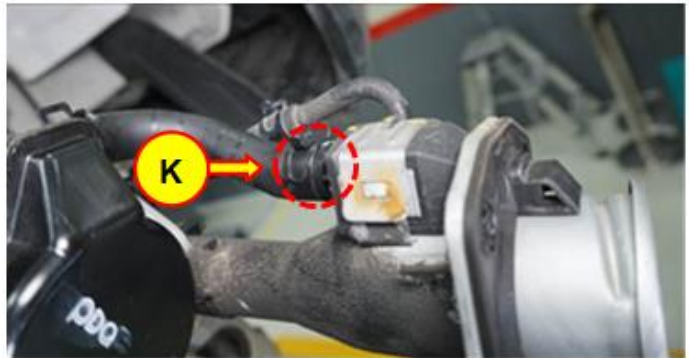
12. Release the air filter hose clamp (K), and disconnect the air drain case.

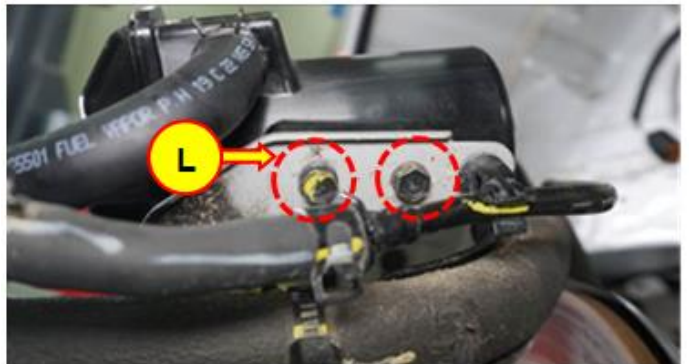
13. Remove the 2 mounting bolts (L) from the air filter assembly.

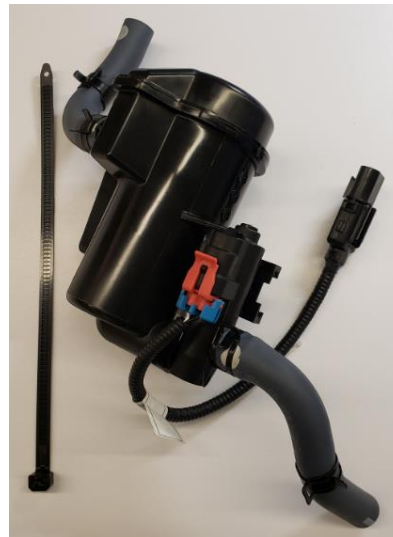
14. Replace with the new Air Filter Kit.

- Replacement Air Filter Kit includes CCV, extension wire and upper & lower hose

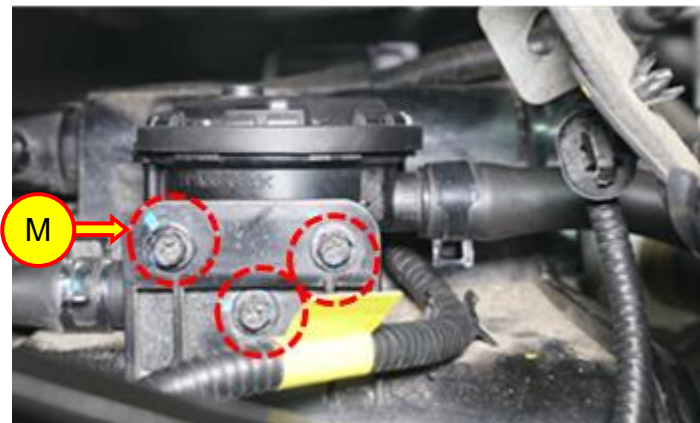
1. Loosen the 3 bracket mounting bolts (M) from the NVLD.

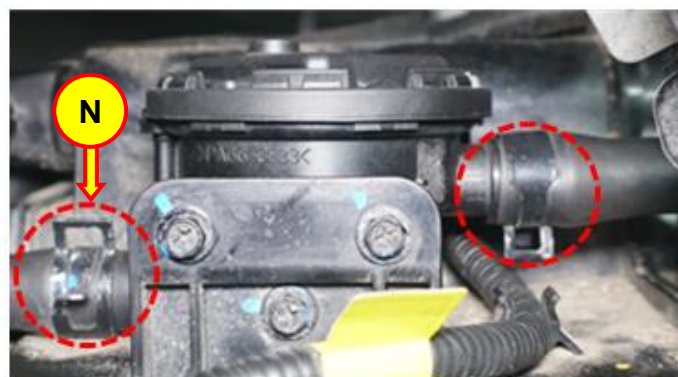
2. Release the upper and lower hose clamps (N) of the NVLD to disconnect the hoses.

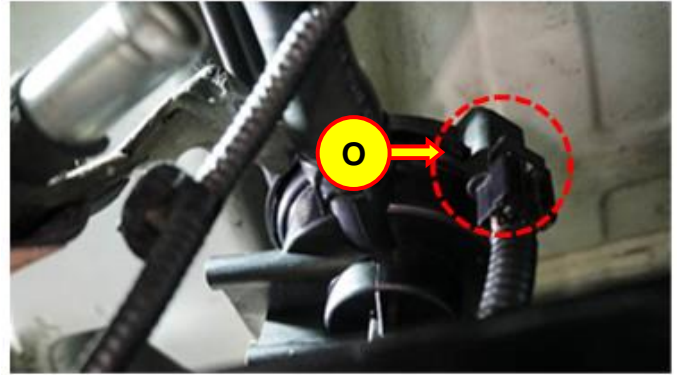
3. Disconnect the NVLD connector (O) to detach the part.
4. Replace the NVLD.
