SIM 71 01 19

SERVICE ACTION: REPLACE UNDERHOOD EMISSIONS LABEL

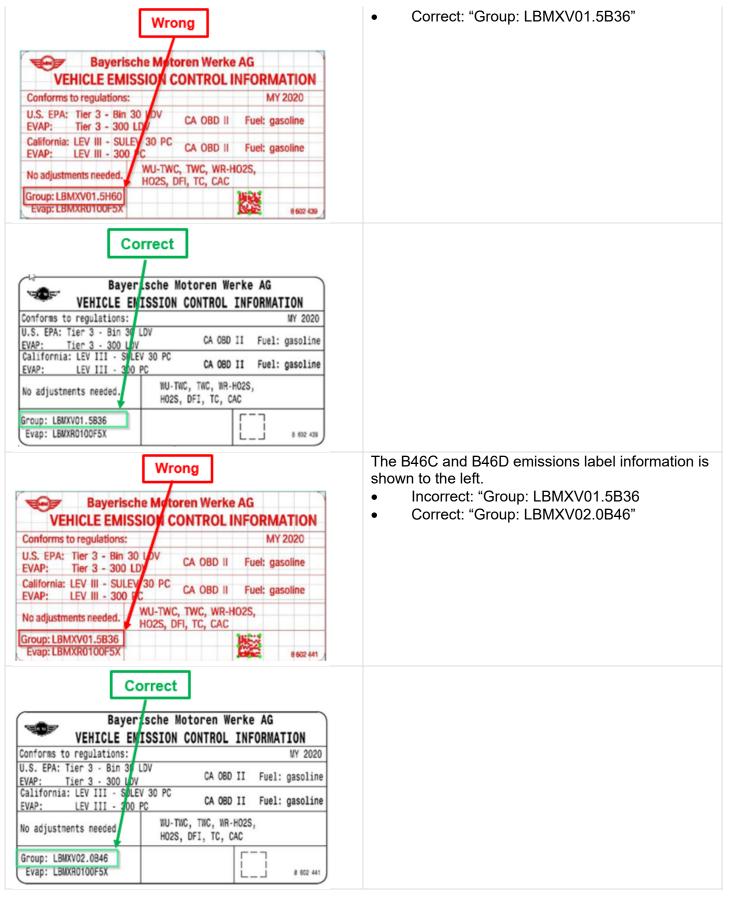
An incorrect "Group" number may be listed on the underhood emissions label for certain model year 2020 vehicles.

For all affected vehicles:	
	1. Access the engine compartment area.
	2. Locate the under-hood emissions label.
	3. Remove the label. Clean off any glue residue from the surface area with BMW Group Cleanser R2 or equivalent.
	4. Apply the corrected 2020 emissions label.
	+. Apply the confected 2020 emissions label.
	 Press firmly over the entire label surface for maximum adhesion
	The B36C emissions label information is shown to the left.
	 Incorrect: "Group: LBMXV01.5H60"

Incorrect: "Group: LBMXV01.5H60"

Replace the current emissions label with a corrected emissions label.
