Buzzing or Whining When Adjusting Front Seat Forward and Backward

AFFECTED VEHICLES

| Year | Model | Trim | VIN Range |
|---|---|---|---|
| 2016-19 | Pilot | ALL | ALL |
| 2017-19 | Ridgeline | ALL | ALL |

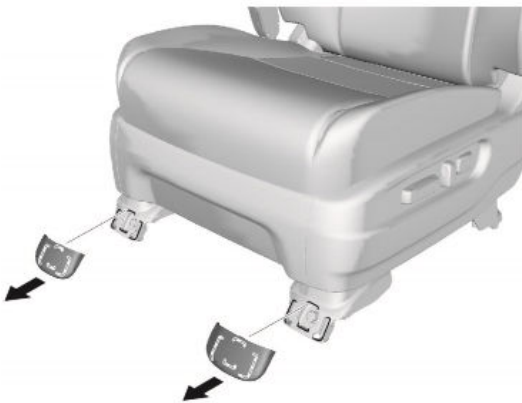
FRONT SIDE

1. Remove the seat track end covers to expose the seat mounting bolts.

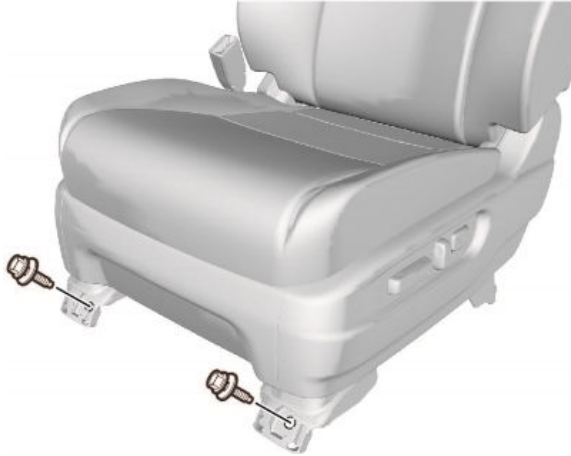
FRONT SIDE

2. Remove the four seat mounting bolts.

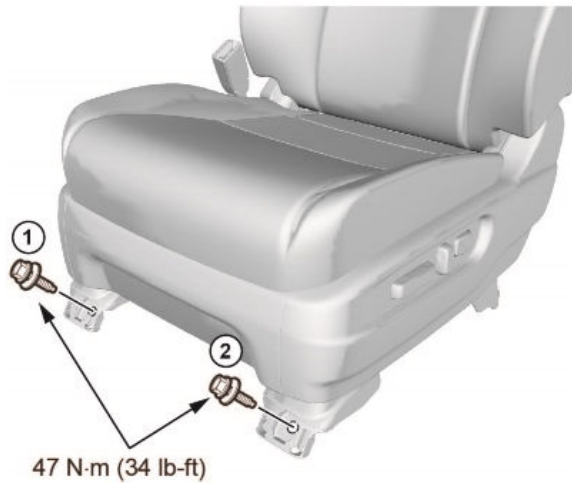
FRONT SIDE

17. Torque the bolts to specification as shown.
