Technical Service Bulletin

HEADLIGHTS NOT AS BRIGHT AS THEY HAD PREVIOUSLY BEEN

Bulletin No.: 09-038/19

2014-2015 Mazda6 (with discharge type front combination light)

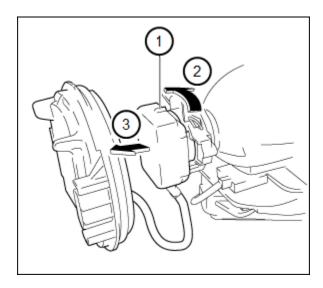
5. Rotate the igniter (1) in the direction of the arrow (counterclockwise) (2) to remove it in the direction of the arrow (outward) (3).

NOTE: For later in the repair procedure, try assembling the igniter to remember the feeling of the locked position.

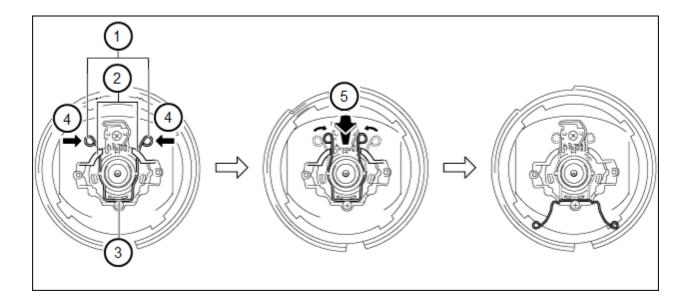
6. Move section (1) of the bulb retaining wire (3) in the direction of the arrow (squeeze) (4), then pull it in the direction of the arrow (outward) (5), and detach the bulb retaining wire (3) and hook (2).

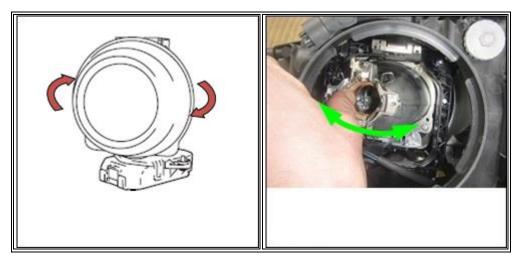
To avoid damage, move the swivel actuator slowly when needed for accessing the screw.

- 8. Attach the bulb retaining wire to the hook.
- 9. Remove the fixing screws for the reflector following the notes below.

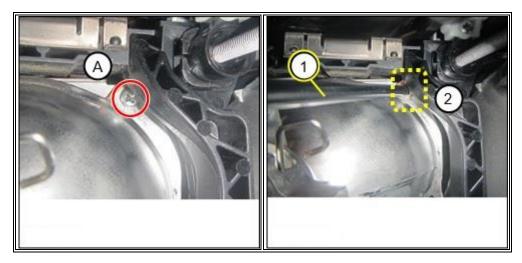
- To avoid damaging the screw head, properly align the screwdriver to the screw so the torque is applied on the screw head.
- Use special care for screw 'A' as the inner frame (2) interferes with the screwdriver (1).

Remove the loosened screw with a magnetic tip screwdriver, taking care not to drop it in the combination light.

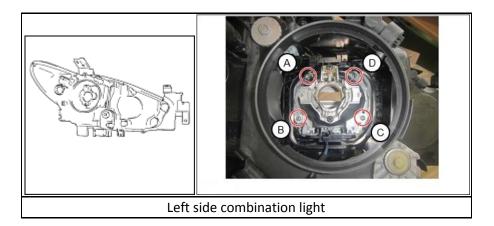
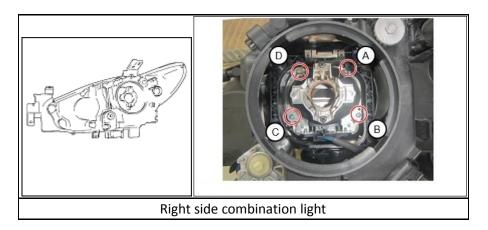
Loosen the screws in the order of A, B, C and D as shown below.

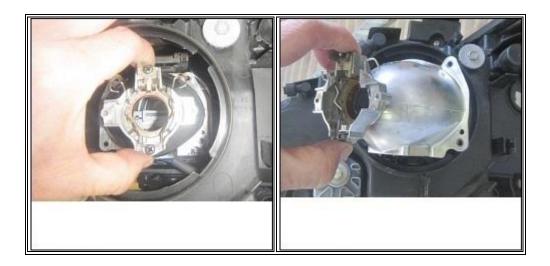
10. After removing all of the screws, hold the bulb mount and pull out the reflector.

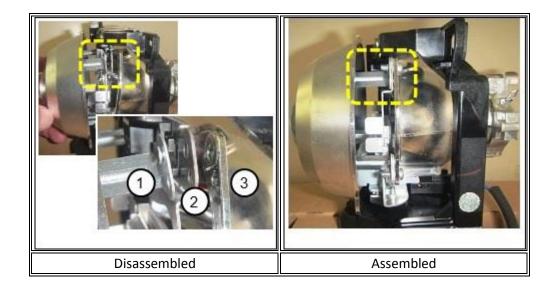
Internal structure of the combination light

The concerned section consists of three parts, Inner Lens (1), Shade (2) and Reflector (3). The Inner lens (1) has a threaded hole and holds the shade (2) between it and the reflector (3).

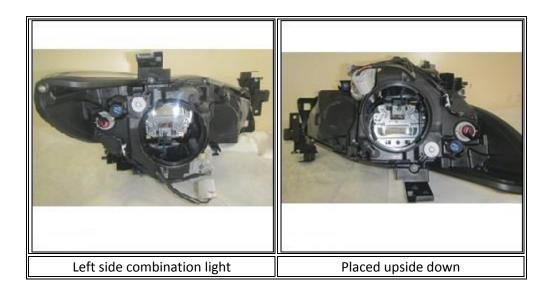
11. Place the combination light upside down on a soft cloth.

12. Hold the combination light in the air and lightly shake it so that the four holes for the inner lens and shade are aligned. Slowly place the combination light in an upside down position.

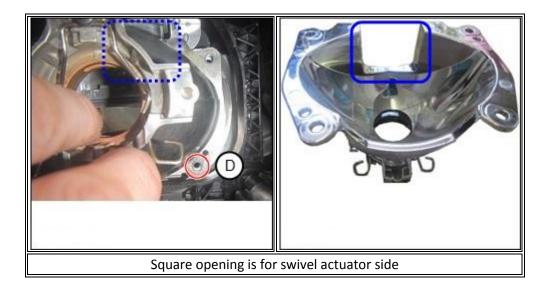
13. Hold the bulb mount of the new reflector and place it in the combination light, then align the screw hole of the reflector to the holes of the inner lens and the shade.

NOTE: Due to the weight of the inner lens, screw holes B and C will not completely align at first. When tightening screw D, the inner lens will move to the shade and screw holes C, B and A will be aligned.

14. Attach a new screw on the magnetic tip of the screwdriver, then taking care not to drop it in the combination light, insert the screw at the screw hole D and lightly tighten the screw until seated so that the reflector can be moved to align the other screw holes.

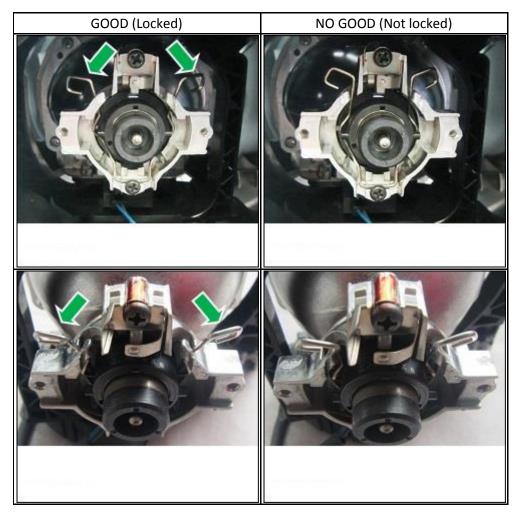
19. In the reverse order of removal, install the headlight HI/LO bulb, the igniter and the discharge headlight control module to the front combination light.

NOTE: When assembling, extend the bulb retaining wire until completely locked.

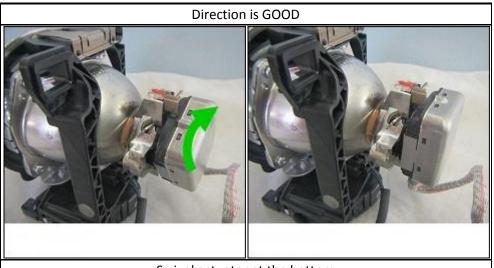
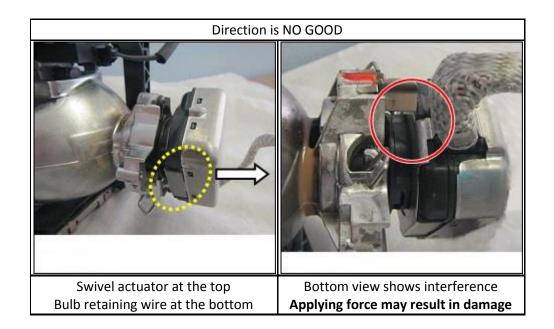
NOTE: When installing the igniter, rotate clockwise. If it does not go to the locked position with light force (as confirmed when disassembling), confirm if the combination light is upside down. If the combination light is upside down, the igniter will touch the reflector and will not go to the locked position with light force. Realign and lock the igniter in place as shown.
