## **Subject: Vehicle Updates to Prevent Damage Due to Mis-Installed Headlamp Bulbs**

**Models Affected: All Freightliner New Cascadia vehicles built in  
model years 2017 through 2020 with optional halogen headlamps**

## Work Instructions

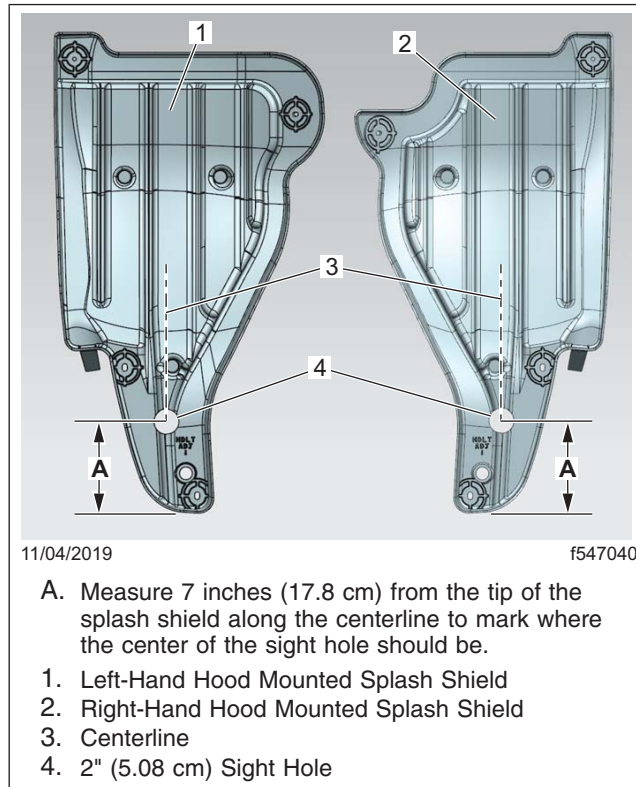
**Fig. 1, Hood-Mounted Splash Shields Hole Locations**

3. Using a hole saw, cut a 2" (5.08 cm) sight hole in each of the hood-mounted splash shields. This is to enable easier viewing of the outboard (low-beam) bulbs and to help with verifying proper installation. See [Fig. 1](#) and [Fig. 2](#).

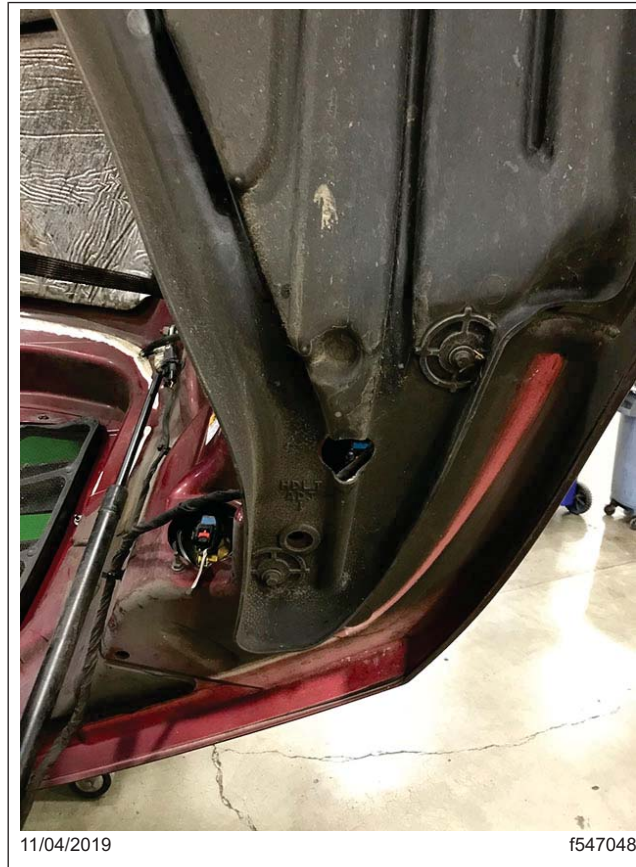
**Fig. 2, Right-Hand Splash Shield With Sight Hole**

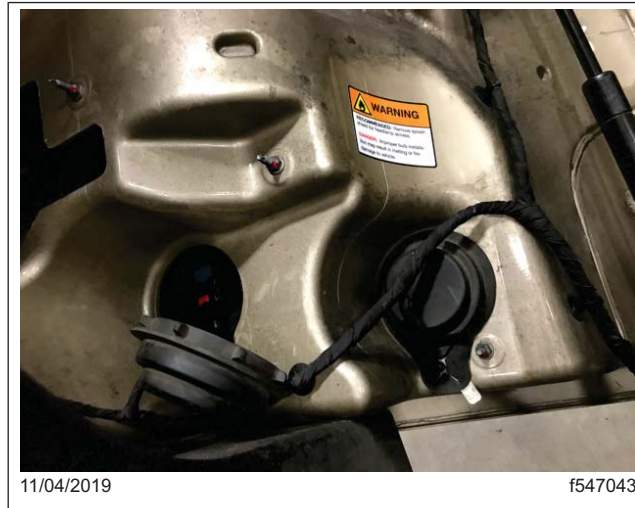
**Fig. 3, Lamp Cavity Covers**

4. For each of the four headlight bulbs, replace the rubber boot with a foam grommet (part number 66-19944-000).
  - 4.1 Remove the covers from the lamp cavities in the hood. See Fig. [Fig. 3](#). Let them hang on the harness.

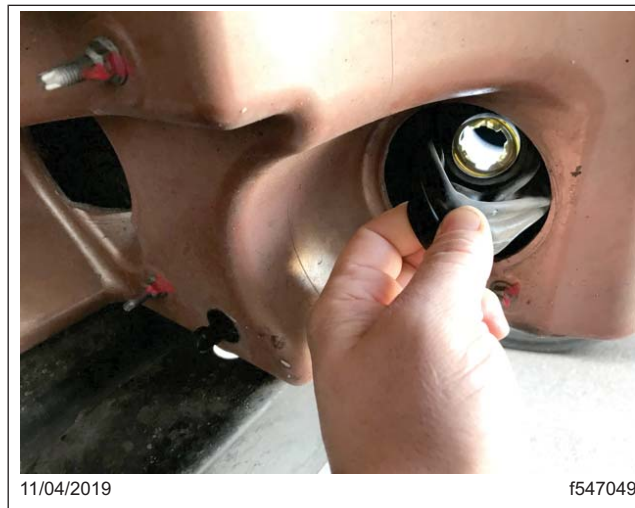
**Fig. 4, Removing a Rubber Boot**

- 4.2 Without unplugging the harness, remove the bulbs and set them aside.
- 4.3 Remove the rubber boots from the headlamp housings and discard them. See [Fig. 4](#) and [Fig. 5](#).

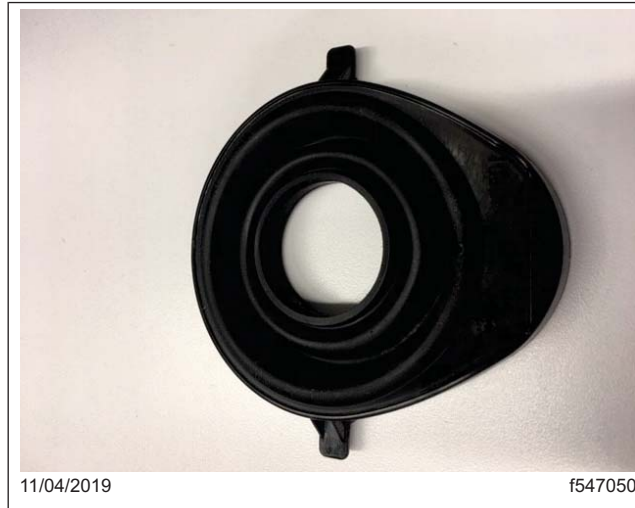
**Fig. 5, Removed Rubber Boot**

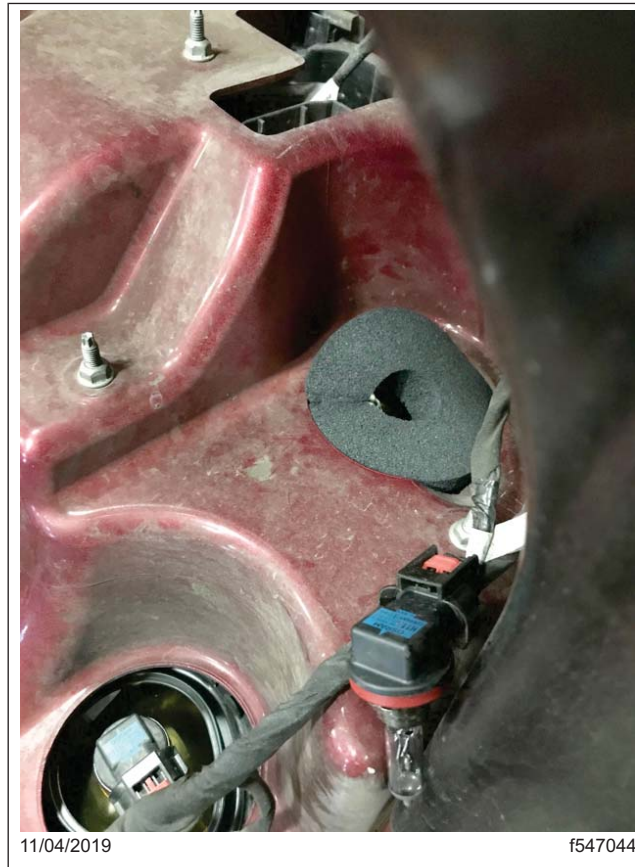
**Fig. 6, Inserting the Foam Grommet**

- 4.4 Insert the foam grommets into the headlamp housings. Push all edges inside the housing and ensure the foam does not interfere with the bulb mounting interface. See [Fig. 6](#) and [Fig. 7](#).

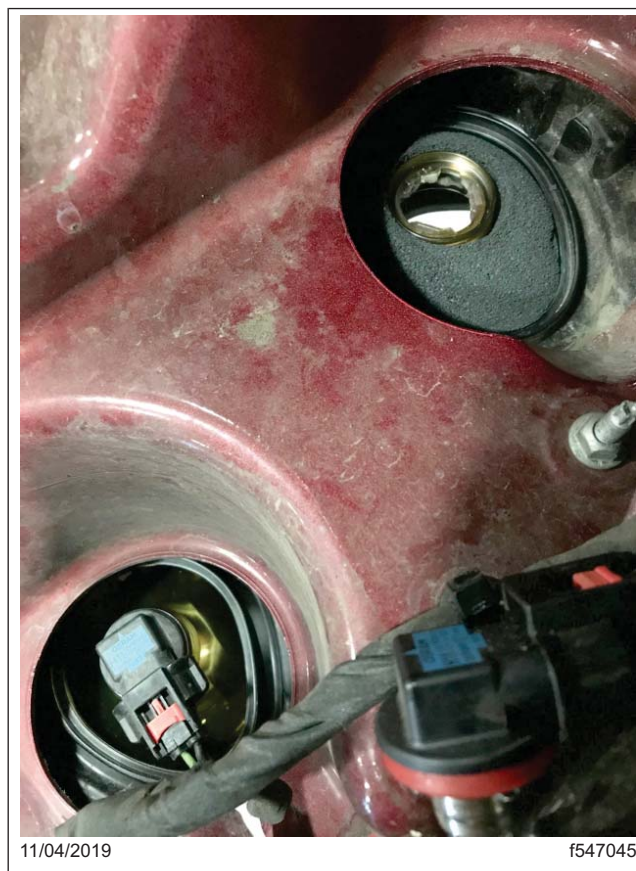
**Fig. 7, Foam Grommet in Place**

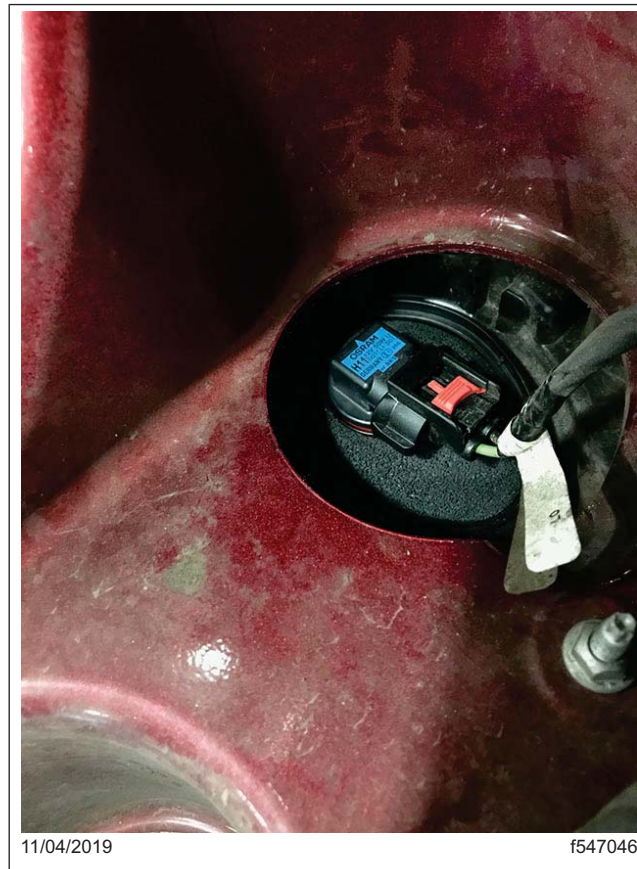
**Fig. 8, Bulb Installed with Foam Grommet**

- 4.5 Install all four bulbs. See [Fig. 8](#).

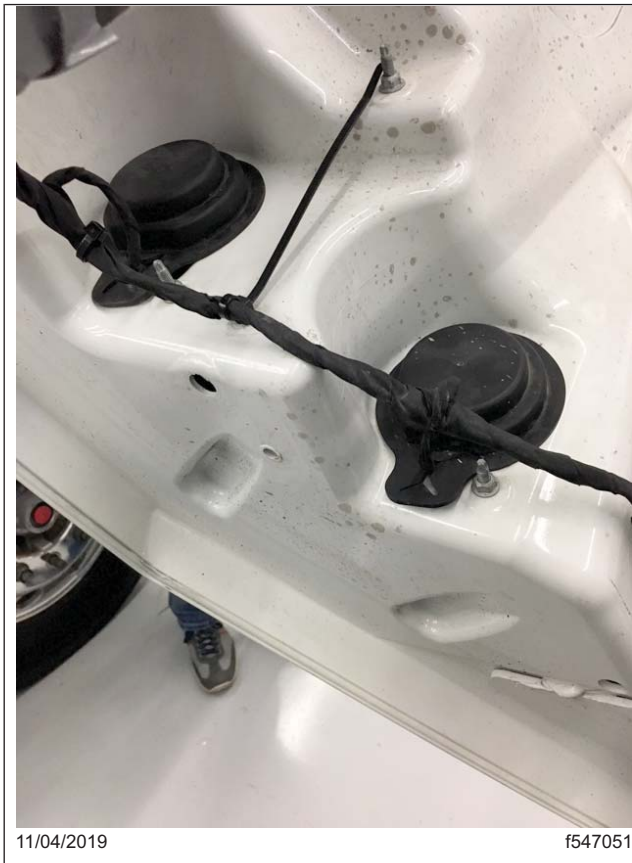
**Fig. 9, Lamp Cavity Covers Properly Installed**

- 4.6 Look through the sight holes cut in the splash shields to verify each bulb's alignment.
- 4.7 Install all four lamp cavity covers in the hood. See [Fig. 9](#).

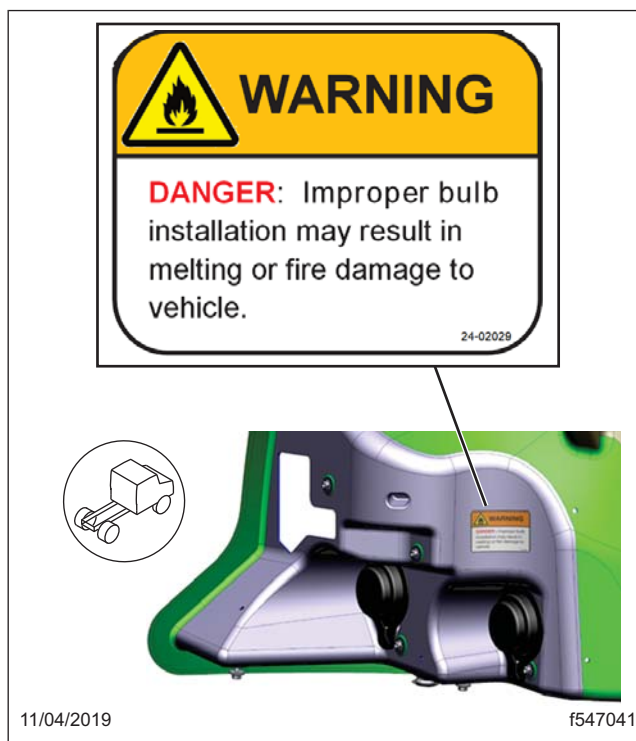
**Fig. 10, Left-Hand Warning Label and Location (Right-Hand Similar)**

5. Clean two spots and install the warning labels (part number 24-02029-000) on each side of the hood. See [Fig. 10.](#)

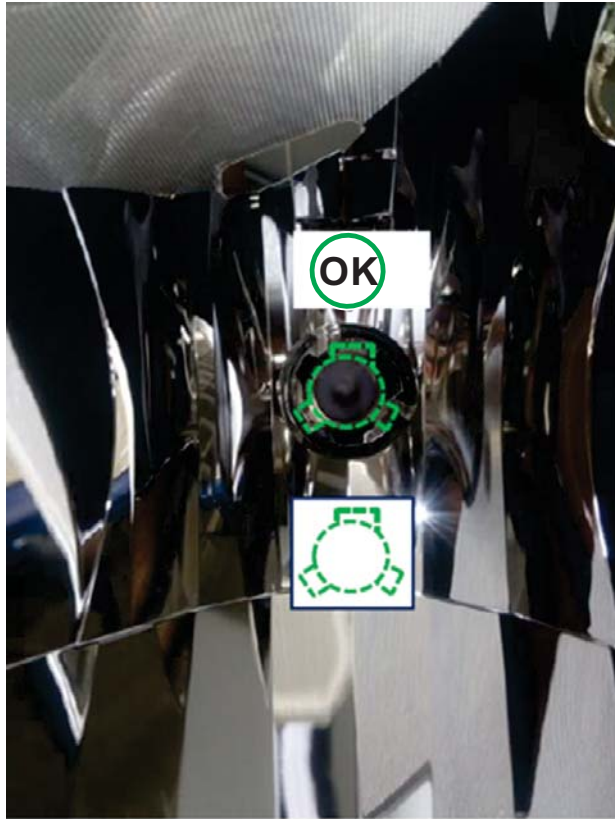
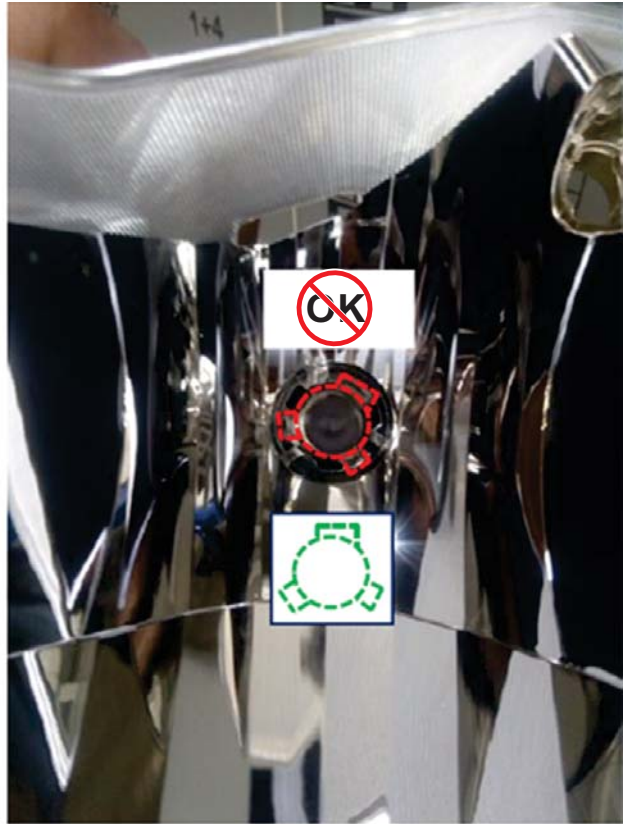
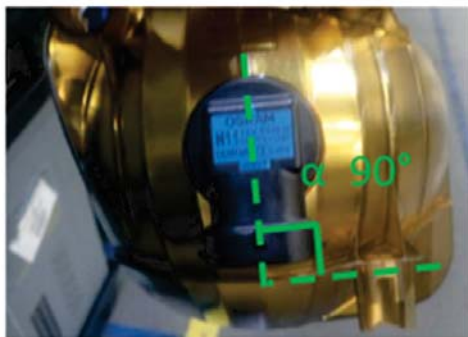
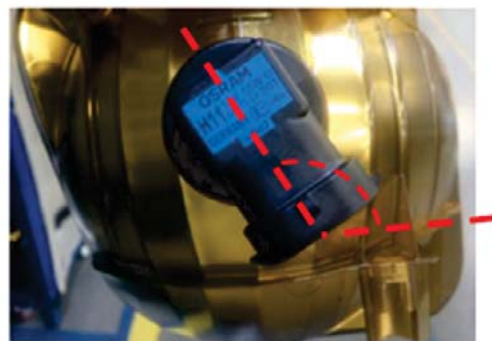
Fig. 11, View Through Headlamp Lens to Verify Bulbs are Fully Seated

6. Close the hood.
7. Verify all four bulbs are fully seated in their sockets by looking through the headlamp lens. See [Fig. 11](#) to see what proper installation should look like.
