Inspect HV Battery Positive Contactor Fasteners

Classification	Campaign Bulletin	Section/Group	16 - HV Battery System	Country/Region	United States, Canada
Year	2018	Model	Model 3	Version	All

Certain Model 3 vehicles might have too few HV battery positive contactor mounting nuts installed, which can allow movement that might affect the conductivity of the contactor terminals.

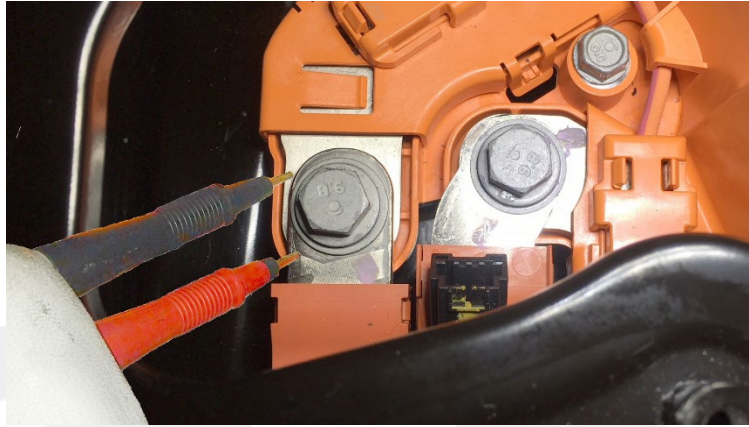
Figure 1

- Use the Hioki resistance meter to measure the resistance at the HV joint between the DC input negative busbar and the fast charge contactor negative input (Figure 1).

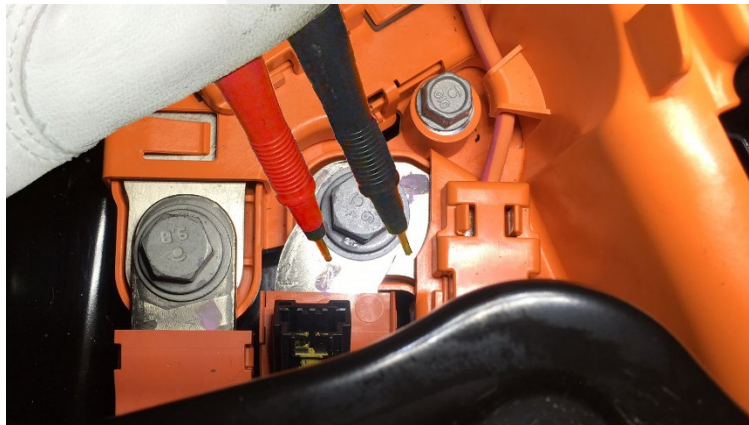
Figure 2

- Use the Hioki resistance meter to measure the resistance at the HV joint between the DC input positive busbar and the fast charge contactor positive input (Figure 2).

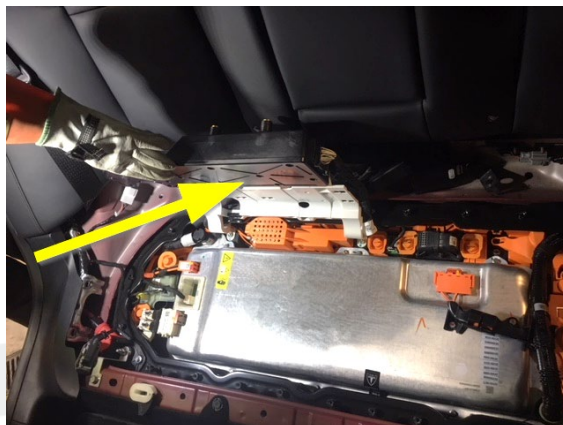
Figure 3

13. Raise the high voltage controller to a vertical position (Figure 3).

32. Install the insulator caps onto the HV battery positive contactor (Figure 4).
33. Lower the high voltage controller (Figure 3), and then skip to step 36.

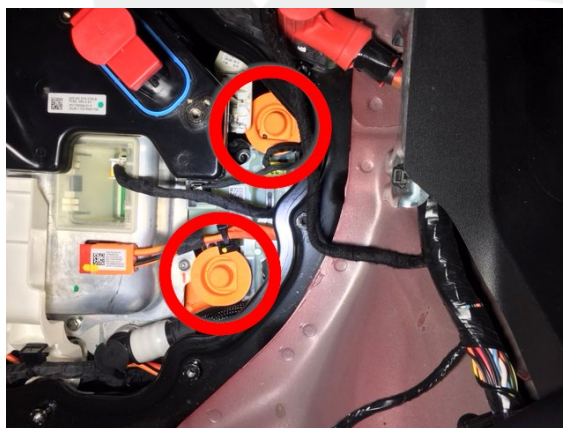
Figure 4

14. Remove the insulator caps from the HV battery positive contactor (Figure 4).

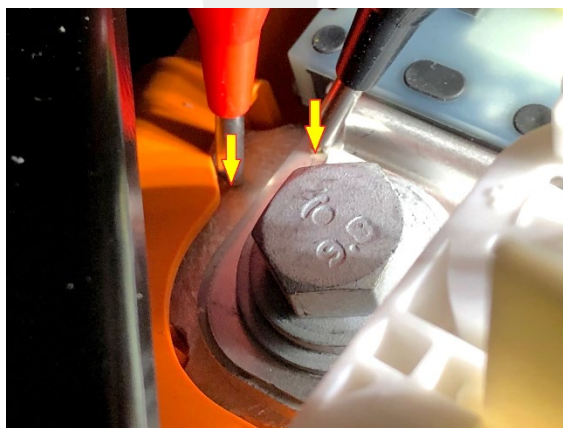
Figure 5

15. Use the Hioki resistance meter to measure the resistance at the HV joint between the HV battery positive contactor and the positive DC busbar (Figure 5).

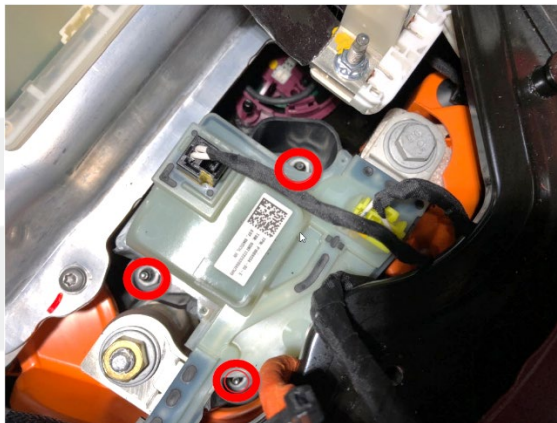
Figure 6

17. Verify that all fields of the Penthouse HV Joint Resistance Measurements webpage are correctly filled out, and then click **Submit**.
18. Visually inspect the nuts that attach the HV battery positive contactor to the penthouse floor (Figure 6).
 - If there are 3 nuts installed, skip to step 32.
 - If there are less than 3 nuts installed, describe which nuts are missing in the Cause Narrative field of the Repair Order, and then continue to the next step.

19. Remove and discard the nuts that attach the HV battery positive contactor to the penthouse floor (Figure 6).
20. Install 3 new nuts to attach the HV battery positive contactor to the penthouse floor (torque 8 Nm) (Figure 6), and then mark the nuts with a paint pen after they are torqued.
21. Visually inspect the positive DC busbar and insulator near the HV battery positive contactor, and where the busbar attaches to the contactor, for any signs of damage (Figure 7).
 - If damage is seen, take photographs of the damage. Create a Toolbox session, attach the photos to the session, and indicate Toolbox Article #44198 as the problem. Escalate the session, and wait for further instruction.
 - If damage is not seen, continue to the next step.

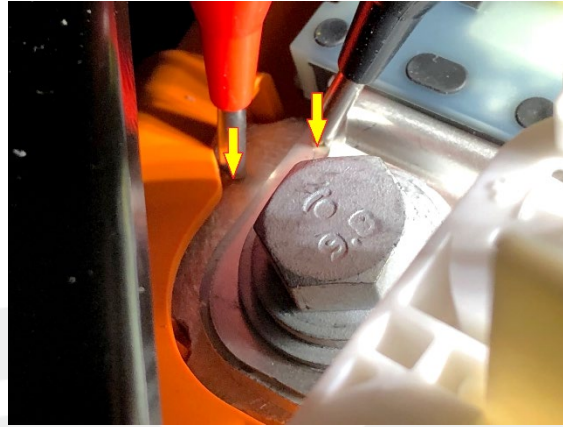
Figure 8

22. Use the Hioki resistance meter to measure the resistance again at the HV joint between the HV battery positive contactor and the positive DC busbar (Figure 8).

23. If the resistance at the HV joint between the HV battery positive contactor and the positive DC busbar:

- Is 0.06 mOhms (60 μ Ohms) or less, skip to step 27.
- Is greater than 0.06 mOhms (60 μ Ohms), continue to the next step.

24. Remove and discard the bolt, install a new bolt (torque 9 Nm), and then mark the bolt with a paint pen after it is torqued.

25. Use the Hioki resistance meter to measure the resistance again at the HV joint between the HV battery positive contactor and the positive DC busbar (Figure 8).

26. If the resistance:

- Is 0.06 mOhms (60 μ Ohms) or less, skip to step 27.
- Is still greater than 0.06 mOhms (60 μ Ohms), record the resistance in the Cause Narrative field of the Repair Order, and then skip to step 34.

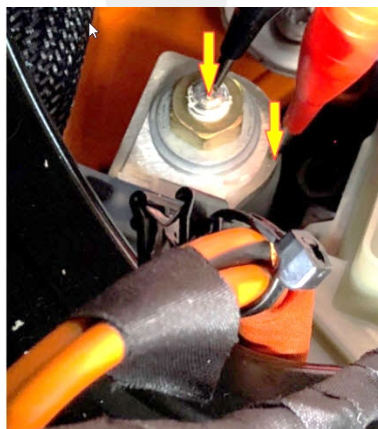
Figure 9

27. Use the Hioki resistance meter to measure the resistance at the HV joint between the HV battery positive contactor and the center of the HV battery positive terminal (Figure 9).

28. If the resistance:

- Is 0.11 mOhms (110 μ Ohms) or less, skip to step 32.
- Is greater than 0.11 mOhms (110 μ Ohms), continue to the next step.

29. Remove and discard the nut, install a new nut (torque 9 Nm), and then mark the nut with a paint pen after it is torqued.
30. Use the Hioki resistance meter to measure the resistance again at the HV joint between the HV battery positive contactor and the center of the HV battery positive terminal (Figure 9).

31. If the resistance:
 - Is 0.11 mOhms (110 μ Ohms) or less, skip to step 32.
 - Is still greater than 0.11 mOhms (110 μ Ohms), record the resistance in the Cause Narrative field of the Repair Order, and then skip to step 34.
