87-18-06 - Air Conditioning, Cleaning of the Refrigerant Circuit (U.S. Only)

Release date: 11/7/2019

Debris can be dispersed throughout the refrigerant circuit after A/C system component damage. In order to maintain A/C operating efficiency, it is important to flush the refrigerant circuit after A/C component repairs.

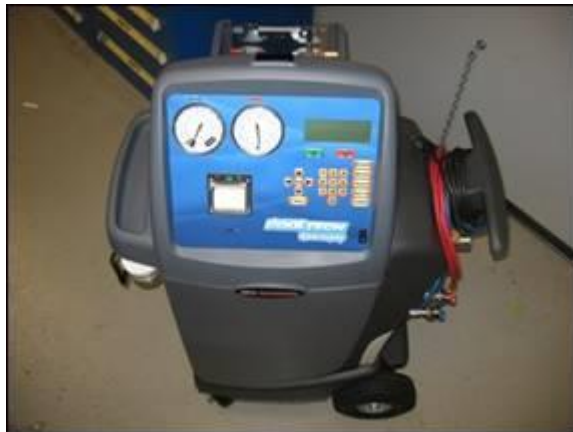
Figure 1. The ROB134APF Air Conditioning Service System with VAS 6337/1A Air Conditioning System Flushing Device.

- Use the **ROB134APF Air Conditioning Service System with VAS 6337/1A Air Conditioning System Flushing Device** (Figure 1) Used for effective refrigerant handling and air conditioning circuit flushing after air conditioning component failure.
- Now air conditioning system refrigerant recovery, evacuation, recharge and refrigerant circuit cleaning after component failure can be performed with a single servicing station.

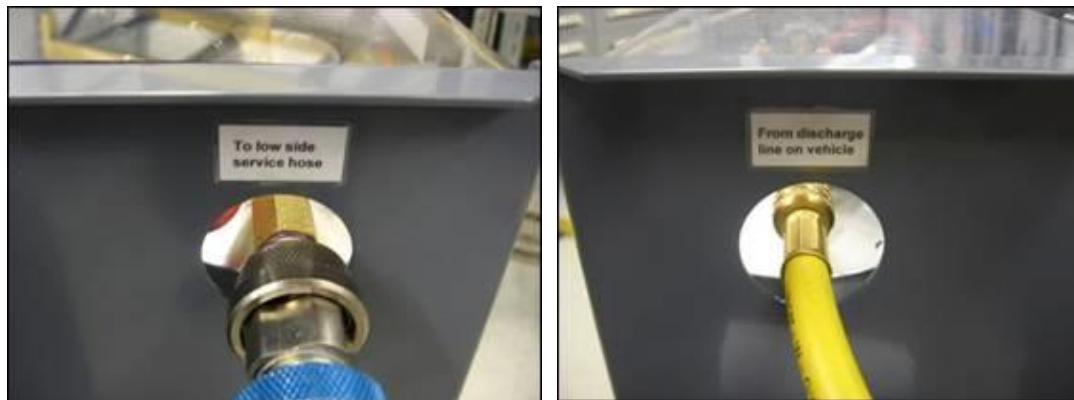
Figure 2. Example of a flushing attachment port.

3. Disconnect the service hoses. The VAS 6338/1 adapters will be used to bypass the following:

- Compressor.
- Receiver-drier.
- Expansion Valve/ Restrictor (if equipped).

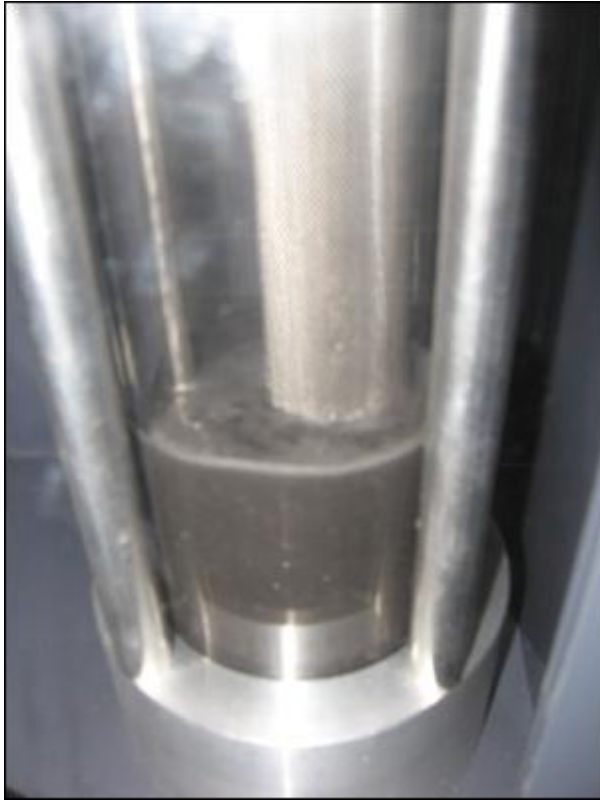
- The flush program will begin with an evacuation of the system and a rate of rise test. This is necessary to test the integrity of the connections before the flush cycles begin. If the rate of rise test passes, the program will proceed into the flush cycles. (Figures 4 – 6). These cycles will occur automatically in succession.

Figure 4. The first cycle.

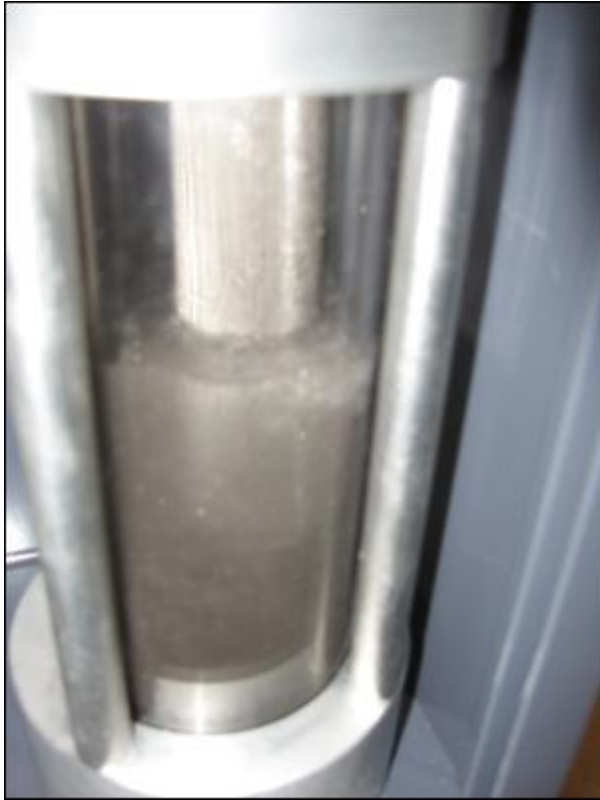
Figure 5. The second cycle.

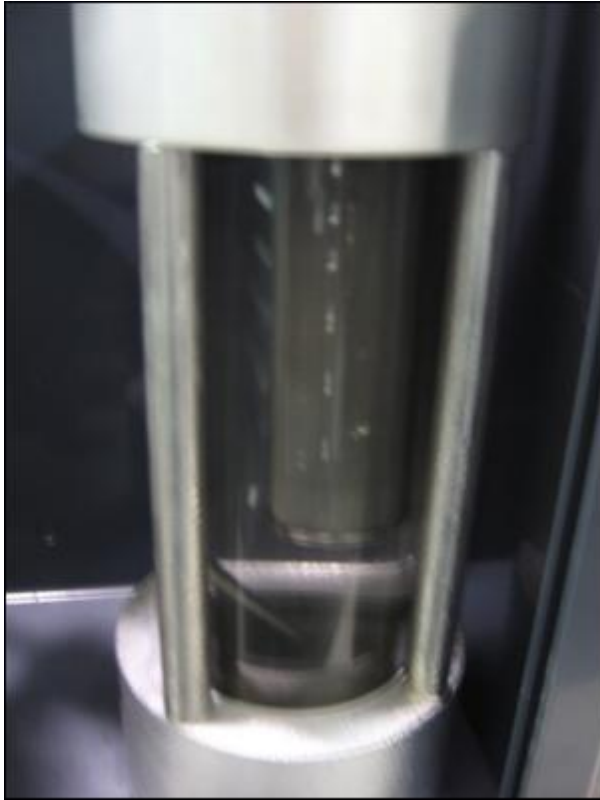
Figure 6. The third cycle.

- The debris is then rinsed from the circuit and contained within the filtration in the flusher. After the flush program, the system will be evacuated.
5. After the system is evacuated, remove any adapters that were installed from the VAS 6338/1.
 6. Replace Expansion Valve (if equipped), Receiver-drier and Restrictor (if equipped).
 7. Connect the station in the usual manner through the service fittings and perform the normal evacuation and refrigerant recharge operations.
 8. Print a log of the job and attach to the repair order.

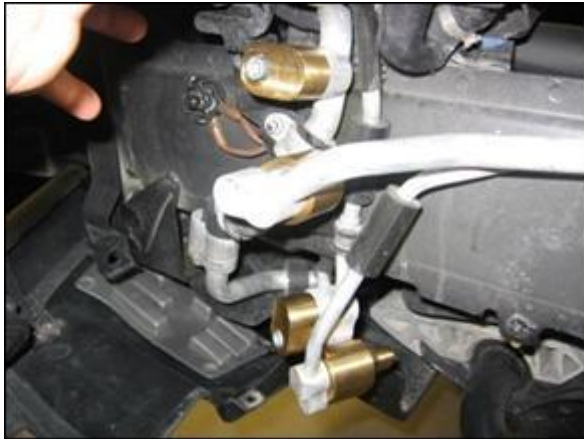
Figure 7. The location of the connections inside the left front wheelhouse on a Touareg with four zone climate control.

1. Separate the front and rear air conditioning systems for individual rinse operations (Figure 7).

The VAS 6338/1 contains the necessary adapters to separate the systems for the individual rinse operations.

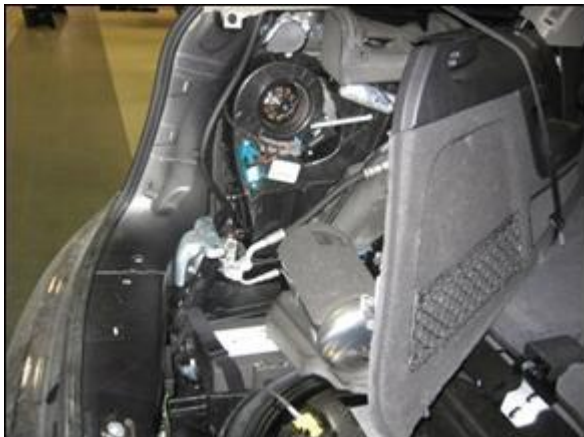
Figure 8. Location of rear air conditioning unit and expansion valve.

2. Bypass the rear expansion valve with an adapter (Figure 8).
