Unpleasant odor is coming from Heating and Ventilation system. Odor mainly occurs after vehicle has been sitting (unused) at least 5 hours and within 20 to 60 seconds after vehicle is first started.

87-18-12 - HVAC, Unpleasant Odor

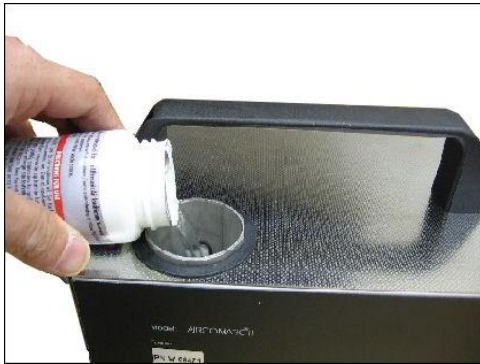
1. The vehicle should be cool, if necessary cool it down with the air conditioning to about 72°F
2. Dry the evaporator by running the ventilation (air conditioning "OFF") at the highest blower level for about 30 minutes.
3. Remove the activated carbon filter or pollen filter according to the repair manual. Close the cover on the AC duct without filter.
4. Open all vents, align them to the passenger compartment and select them with the control panel.
5. Leave the air conditioning switched off. Set the fan speed to level 1 and switch on the recirculation so air is not brought into the vehicle. Run the engine during the complete cleaning process or switch on the ignition and connect a battery charger.
6. Remove the neck (long black pipe) of air conditioning cleaner VAS 6189A / VAS 6189B and fill with a bottle of cleaning fluid part number 30208 (observe instructions on bottle).

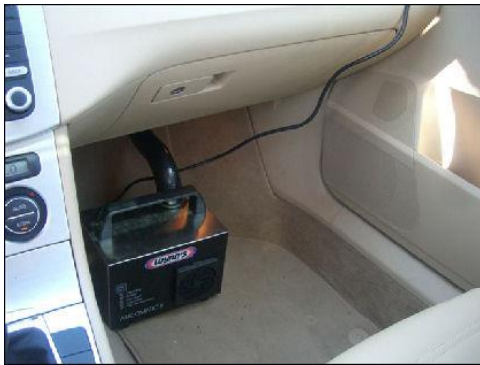
7. Place the air conditioning cleaner on the floor underneath the passenger glove box and point the neck towards the front of vehicle (see illustration).

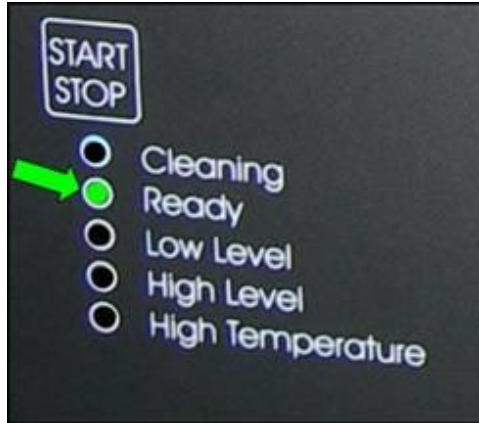
8. Route the cable of cleaner through the side window to the outside. Close the side window and connect the power cable. A self-test starts; when a green arrow lights up the unit is operational.
