NUMBER: 23-026-19

Liftgate Glass May Break

This bulletin involves installing anti squeak tape to the liftgate glass.

2015 - 2017 (ZD) Dodge Viper

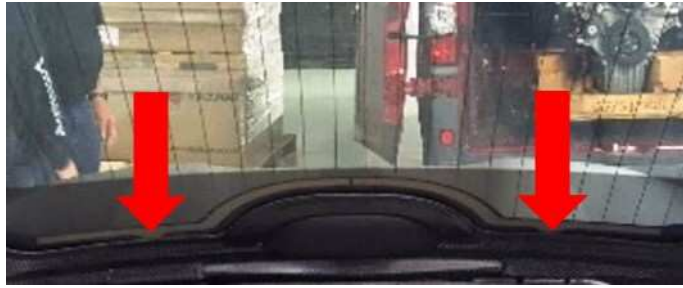
Fig. 1
Areas To Clean

1. Open the liftgate.
2. Using isopropyl alcohol and a rag, clean the two areas on the glass (Fig. 1) .

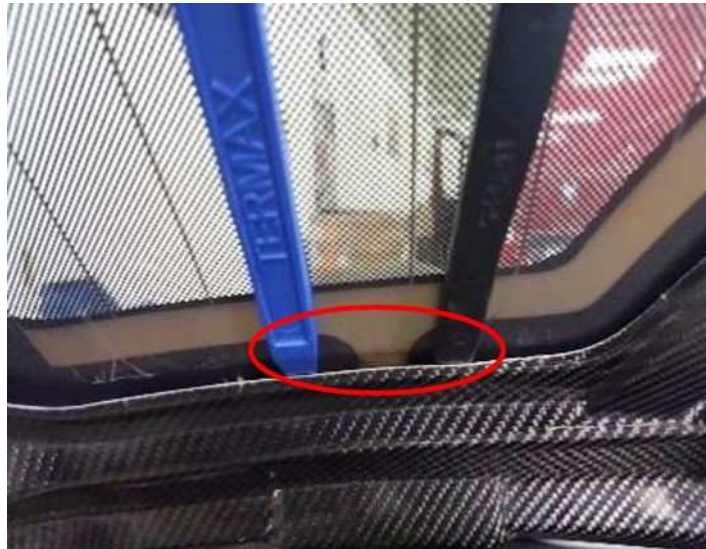
Fig. 2
Trim Sticks Opening Gap

3. **NOTE: Use a trim stick or equivalent tool to open the gap between the glass and the carbon fiber trim (Fig. 2) if needed before applying tape to the glass. The anti squeak tape must not be placed beyond the defogger grid for appearance purposes.** Cut two pieces of Mopar Anti Squeak Tape 19 mm (.75 in) and apply to glass (Fig. 3) .
