NUMBER: 22-003-19 REV. A

GROUP: 22 - Tires and Wheels

Spare Wheel Missing the Anti-theft Screw

2019 - 2020 (B1) Jeep Renegade (Brazil)

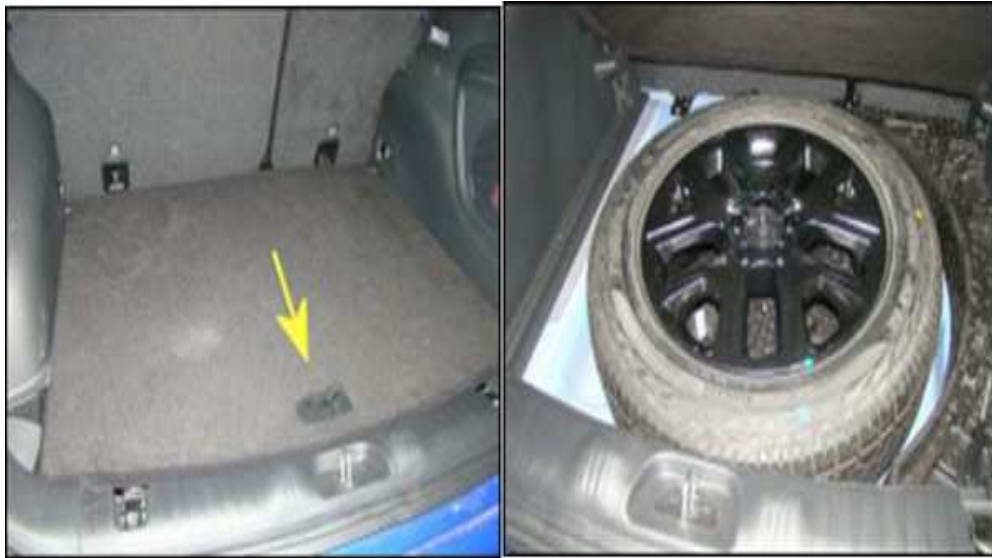
Fig. 1
Spare Wheel Cover

1. Open the trunk and remove the spare wheel cover (Fig. 1) .

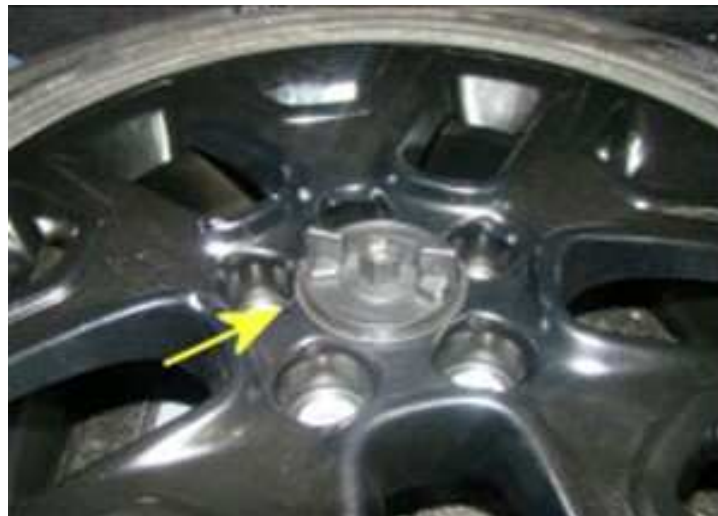
Fig. 2
Existing Spare Wheel Retainer Screw

2. Does the vehicle have the anti-theft screw (Fig. 3) ?
 - YES>>> This bulletin has been completed. Use inspect LOP ****(22-25-05-96)**** to close the active RRT.
 - NO>>> Install the anti-theft screw for the spare wheel. Proceed to [Step 3](#).
3. Remove the existing spare wheel retaining screw (Fig. 2) .

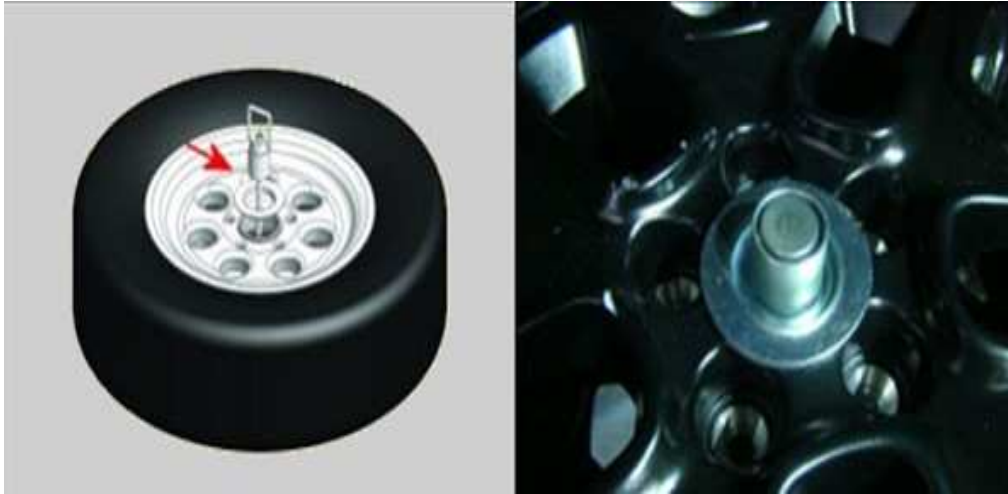
Fig. 3
Spare Wheel Anti-theft Retainer Screw

4. Install the new anti-theft spare wheel retaining screw by aligning the screw arrows with the arrow on the wrench, and thread the screw until the end (Fig. 3) .
