NUMBER: 22-004-19

GROUP: 22 - Tires and Wheels

Spare Wheel Missing the Anti-theft Screw

2019 - 2020 (M1) Jeep Compass (Brazil)

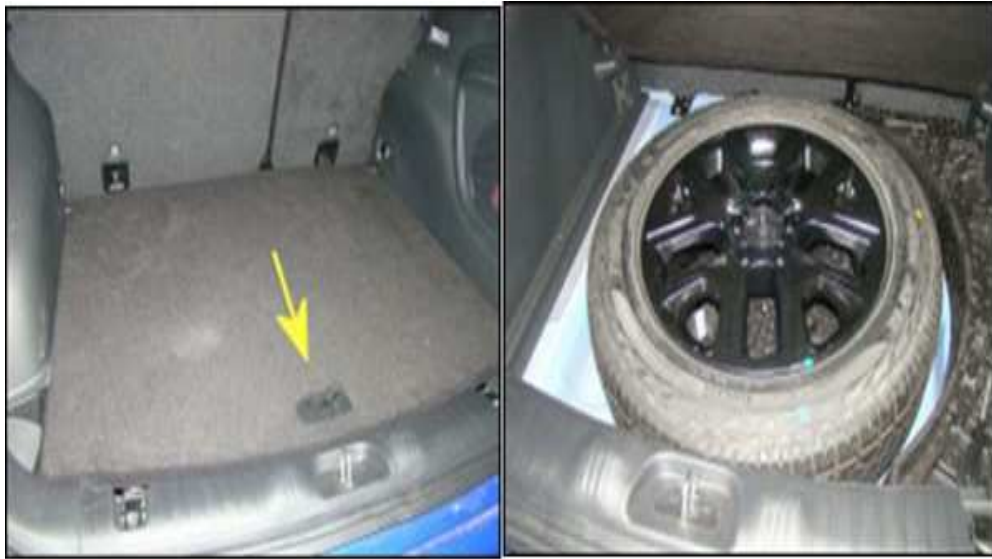
1. Open the trunk and remove the spare wheel cover (Fig. 1) .

Fig. 1
Spare Wheel Cover

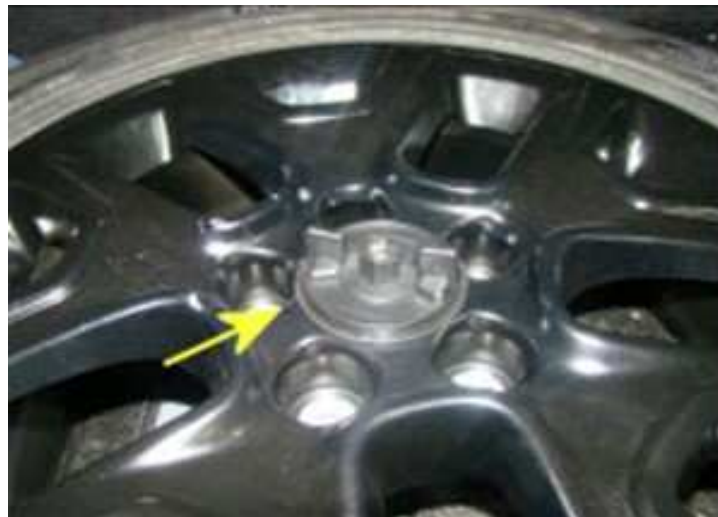
Fig. 2
Existing Spare Wheel Retainer Screw

2. Does the vehicle have the anti-theft screw (Fig. 3) ?
 - YES>>>The anti-theft screw is installed. This bulletin has been completed. Use inspect LOP (22-25-05-98) to close the active RRT. Proceed to [Step 6](#).
 - NO>>> Install the anti-theft screw for the spare wheel. Proceed to [Step 3](#).
3. Remove the existing spare wheel retaining screw (Fig. 2) .

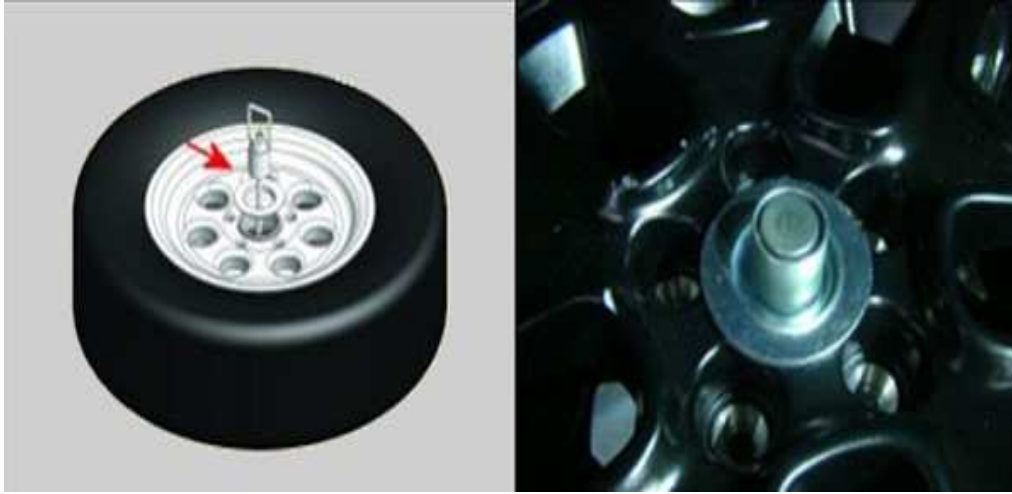
Fig. 3

Spare Wheel Anti-theft Retainer Screw

4. Install the new anti-theft spare wheel retaining screw by aligning the screw arrows with the arrow on the wrench, and thread the screw until the end (Fig. 3) .
