**87-18-11 - Refrigerant Recovery Printout / All Refrigerant Circuit A/C Repairs**

Release date: 11/4/2019

The A/C system has been diagnosed as low on refrigerant and will be repaired under warranty.

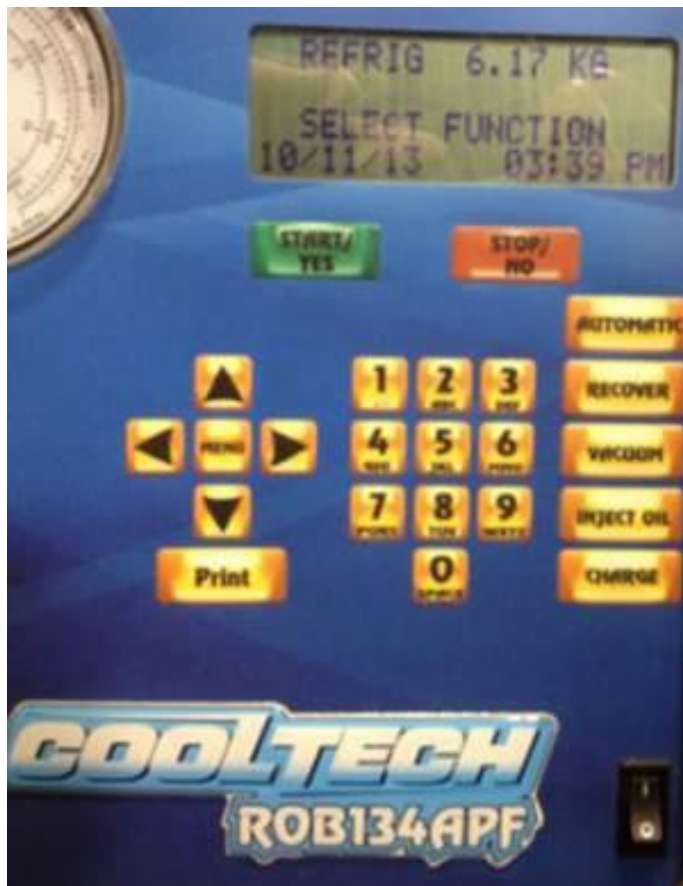
1. Ensure that the A/C service unit shows the correct date and time (Figure 1). If the date and time are incorrect, use the menu to program the correct date and time before proceeding.

**Figure 1:** Date and time screen.

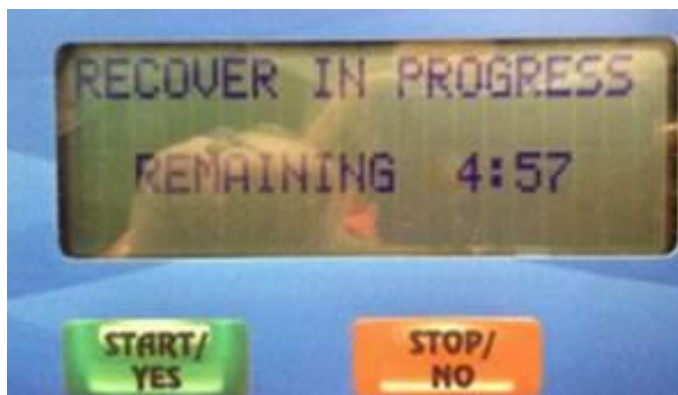
2. Perform a recovery of the system.

**Figure 2:** System recover process.

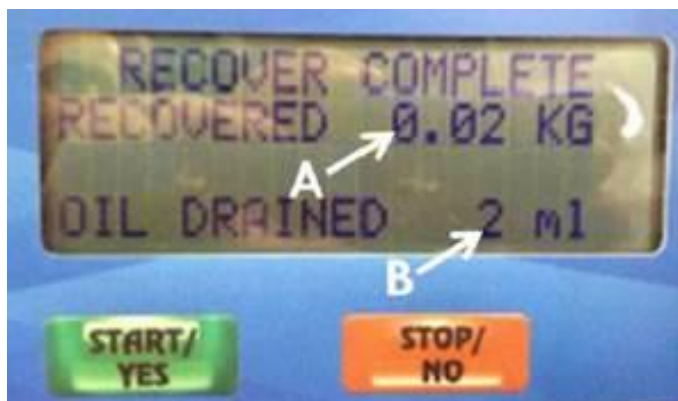
3. Record values for RECOVERED and OIL DRAINED on the repair order.

**Figure 3:** Amount of refrigerant recovered (A), and amount of oil drained (B).

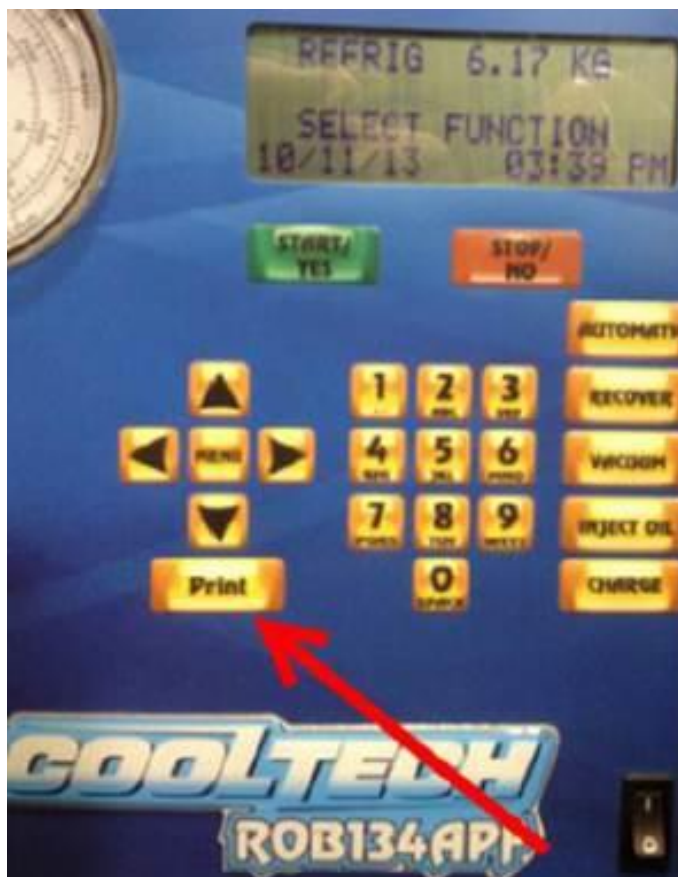
4. Immediately after recovery, select the Print button.

**Figure 4:** Location of the Print button.

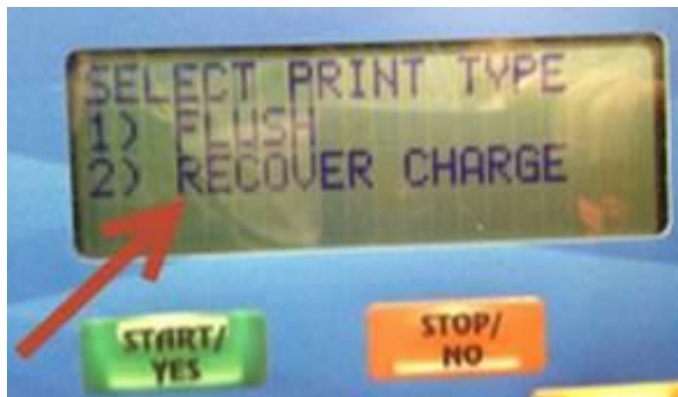
5. When the SELECT PRINT TYPE screen opens, use the keypad to select 2) RECOVER CHARGE.

Figure 5: Selecting a print type.

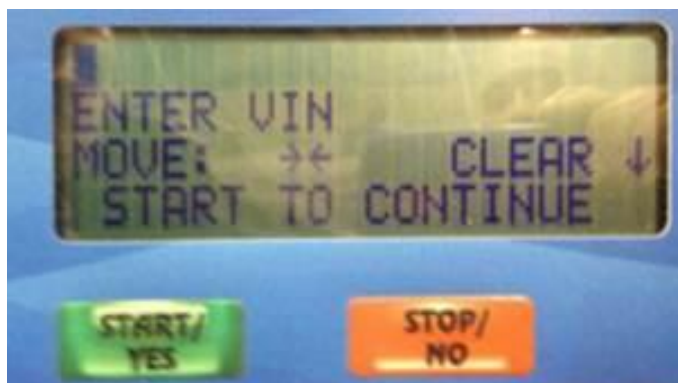
6. On the next screen, use the keypad to enter the last 8 digits of the VIN and then press the START/YES key.

Figure 6: Enter VIN screen.

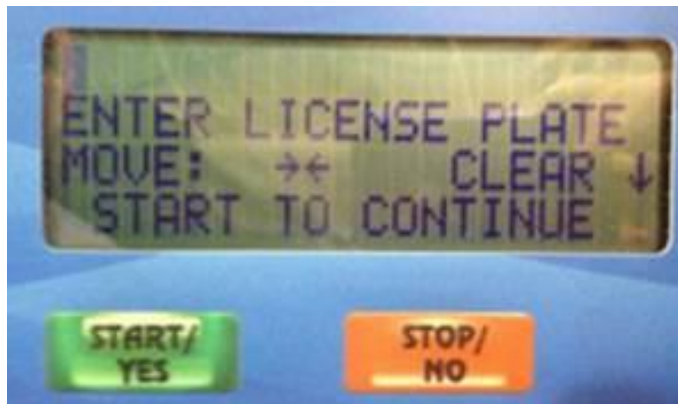
7. The next screen will request the license plate. Entering the license plate is not necessary. Press the START/YES key to continue.

Figure 7: Enter license plate screen.
