QUARANTINE NOTICE

Reference number:	QN-01-1327	Issued: 21 November, 2019
Subject:	Incorrect Installation of the Passenger Airbag	
Model(s):	DB11, Vantage (19MY), DBS Superleggera	
VIN Range:	Refer to the separately published list of Vehicle Identification Numbers (VINs)	
Applicable to:	All Dealers	
Distribute to:	After Sales Manager Executive Manager Service Manager Sales Manager	Warranty Staff Technician(s) Parts Staff

On the affected vehicles, it is possible the locking nuts that attach the passenger airbag to the instrument panel (IP) are not torqued to the correct specification.

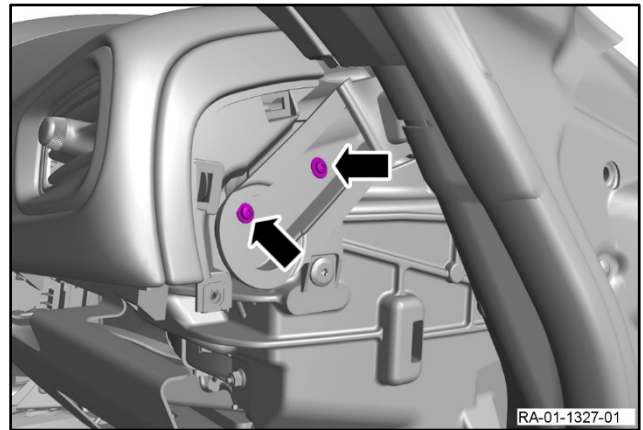
Figure 1

1. Remove the passenger side bottom panel for the IP (refer to Workshop Manual procedure 01.12.DV).
2. Remove the two screws that attach the duct for the door (refer to Figure 1).

7. Install the duct for the door (refer to Figure 2).
8. Install the two screws that attach the duct for the door (refer to Figure 1).
9. Install the passenger side bottom panel for the IP (refer to Workshop Manual procedure 01.12.DV).

4. Install the duct for the door (refer to Figure 2).
5. Install the two screws that attach the duct for the door (refer to Figure 1).
6. Install the right side end cover for the IP (refer to Workshop Manual procedure 01.12.BK).

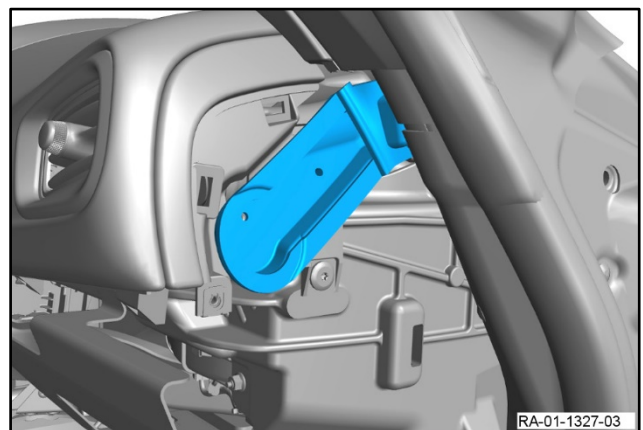
Figure 2

3. Remove the duct for the door (refer to Figure 2).

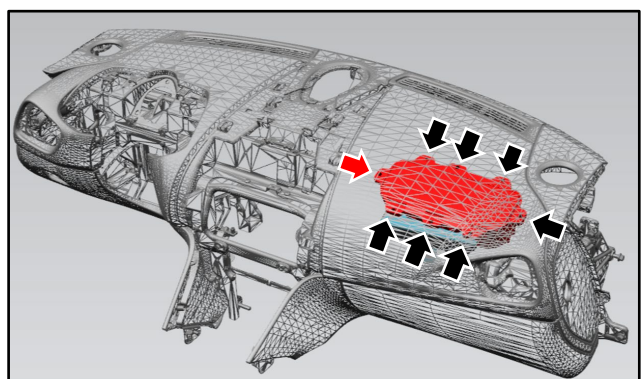
Figure 3

4. Use a fibre-optic camera to inspect the seven locking nuts that are accessible in the locations shown (refer to Figure 3).

Note: There are eight locking nuts in total, but one locking nut is not visible (refer to the red arrow).

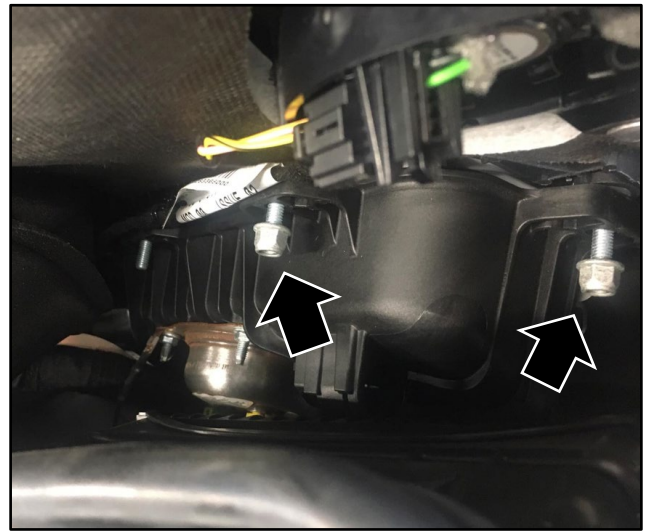
Figure 4

5. If any of the locking nuts are not installed correctly (refer to Figure 4) go to Part B: Torque the Locking Nuts to the Correct Specification.

1. Remove the front evaporator and heater assembly (refer to Workshop Manual procedure 12.03.AH).

WARNING: IF A LOCKING NUT IS MISSING, INSTALL A NEW LOCKING NUT WITH THE PART NUMBER GIVEN IN THE PART DATA. IF YOU DO NOT USE THE CORRECT PART, IT IS POSSIBLE THAT THE AIRBAG WILL NOT BE ATTACHED CORRECTLY IN THE EVENT OF AN ACCIDENT AND NOT DEPLOY CORRECTLY.

2. Torque the eight locking nuts that attach the passenger airbag to the IP to 6.5 Nm.
3. Install the front evaporator and heater assembly (refer to Workshop Manual procedure 12.03.AH).

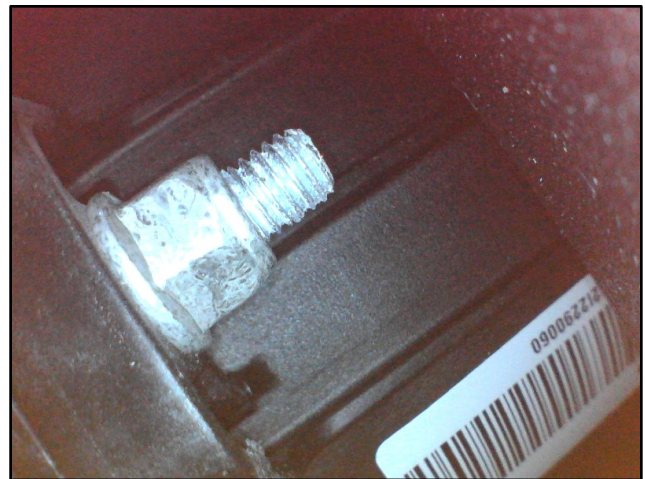
Figure 5

6. If all the locking nuts have been installed correctly (refer to Figure 5) go to step 7.
