87-18-08 - Air Conditioning, Cleaning of the R1234yf Refrigerant Circuit (U.S. Only)

Release date: 11/4/2019

In cases where an air conditioning system component (such as a compressor or other system component) has failed and debris from the compressor or component is circulated throughout the refrigerant circuit, the refrigerant circuit must be cleaned of any and all debris or damage to the replacement components will result.

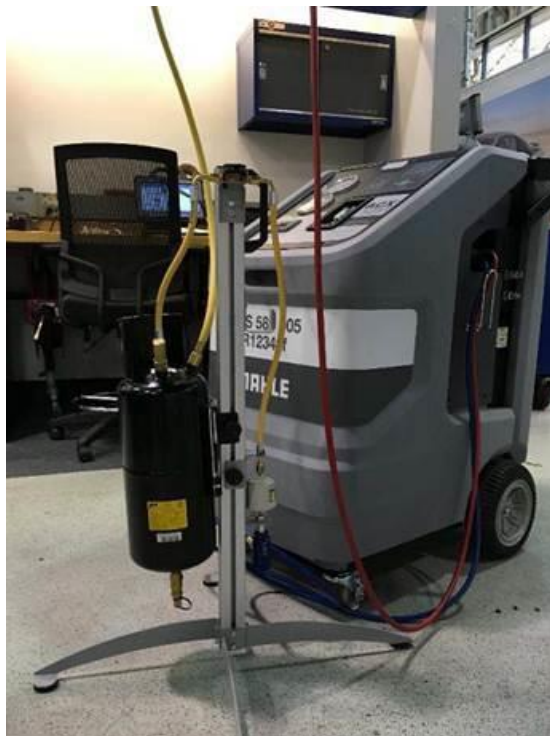
Use the MAHLE R1234yf A/C Service Unit VAS581005 and the R1234yf Flush Kit RTI360831040 (Figure 1).

Used for effective refrigerant handling and air conditioning circuit flushing after air conditioning component failure.

Figure 1. The VAS581005 Air Conditioning Service System with Flushing Device.

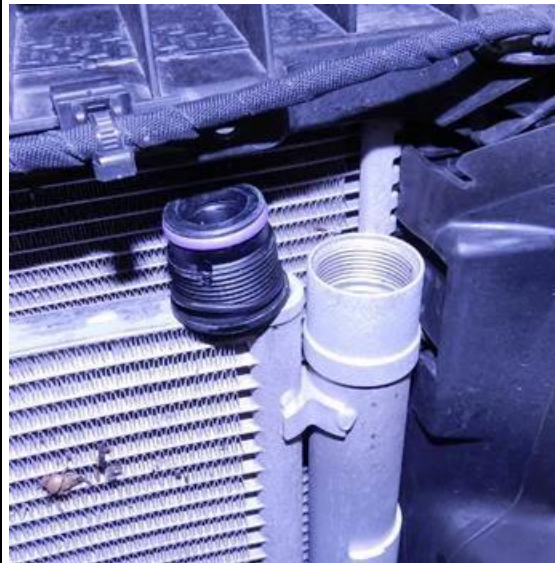
Figure 2. Location of the Receiver Drier

6. Remove receiver drier cartridge.

Reinstall cartridge cap with O-ring. (Figure 2)

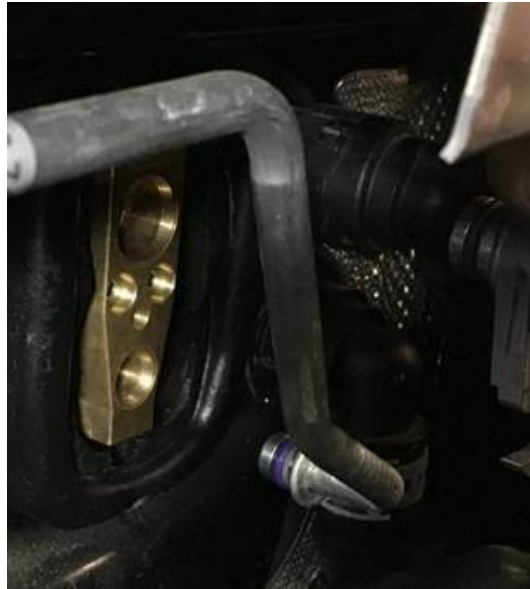
Figure 3. Installation of front expansion valve bypass adaptor VAS 6338/38.

7. Remove expansion valve and install flush plate VAS 6338/38. (Figure 3)

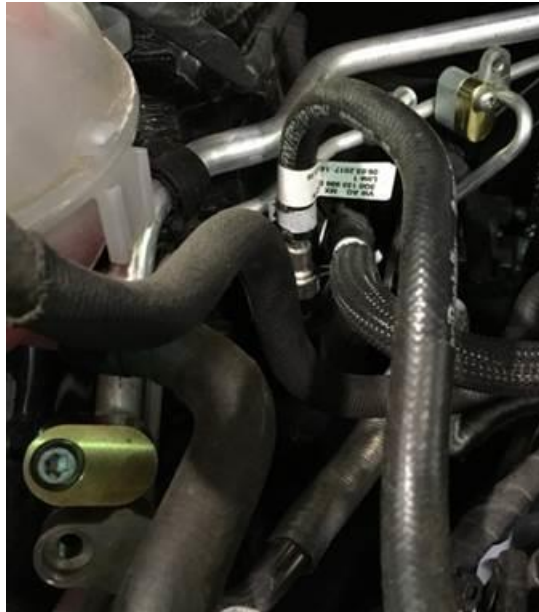
Figure 4b. Installation of Low side rear A/C Line connection block adaptor VAS 6338/5

8. (Atlas Only) Disconnect rear refrigerant lines and install adaptors VAS 6338/5 and VAS 6338/63 as shown. (Figure 4a, 4b)

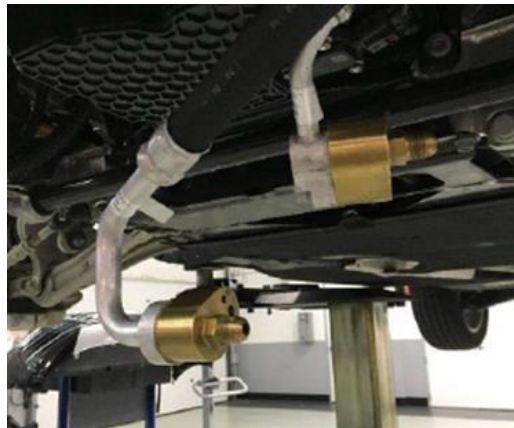
Figure 6. Installation of VAS 6338/3 and 6338/12.

10. Disconnect AC compressor hoses from the compressor.

Install flush adaptor VAS 6338/3 on the high side compressor hose.

Install flush adaptor VAS 6338/12 on low side compressor hose. (Figure 6)

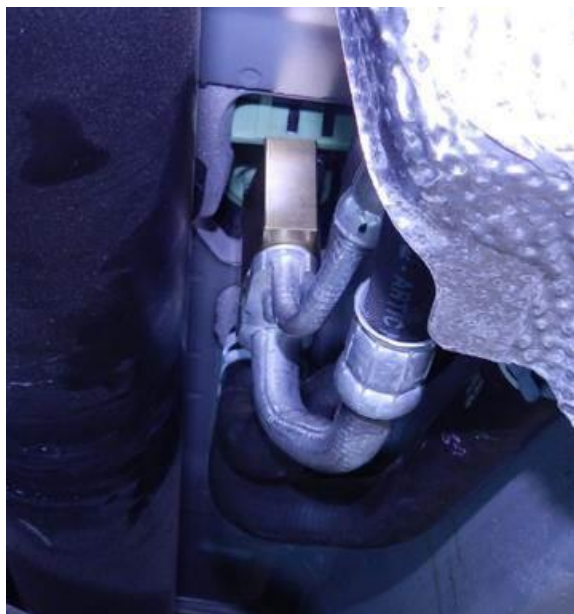
Figure 13. Location of rear air conditioning unit expansion valve.

23. Remove rear expansion valve and install VAS6338/38 as shown. (Figure 13)

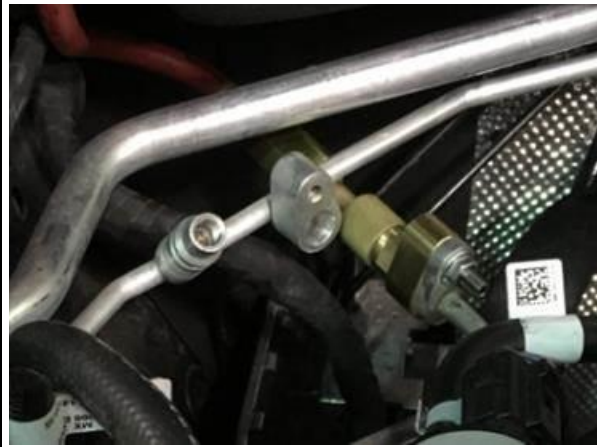
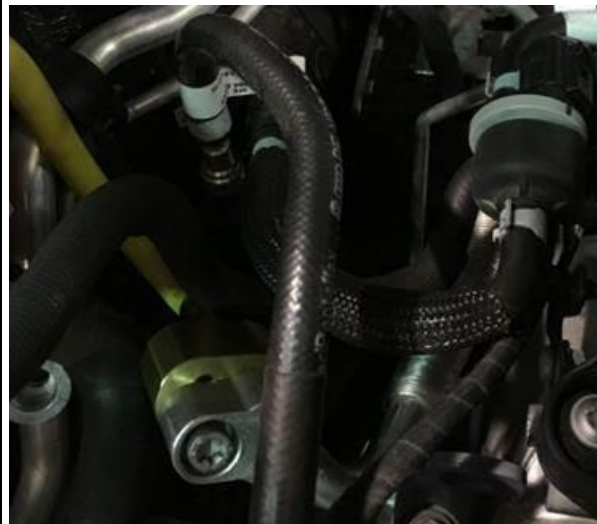
Figure 15. Attaching service station and flush hoses to rear A/C lines.

25. Connect the VAS 6338/3 and VAS 6338/60 to the rear refrigerant A/C lines.

26. Connect the VAS 6338/48 to adaptor VAS 6338/60

27. Connect flush tank hose (Yellow) to the high side compressor hose adaptor VAS 6338/3. (Figure15)
