# Emissions Service Action

## Code: 26L7

**Subject** Exhaust Gas Recirculation (EGR) Cooler (Parts catalog error)

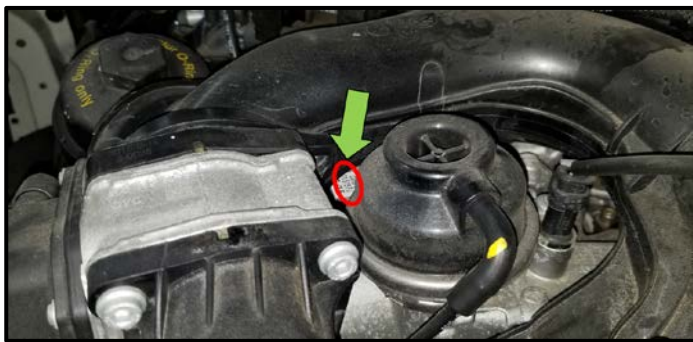
### Inspect EGR Cooler:

- Remove engine cover.
- From the driver's side of the vehicle, locate the part number listed on the EGR Cooler.
  - If part number **059.131.515.FP** is present:
    - Reinstall the engine cover.
    - **Proceed to Section D.**
  - If any other part number is present or if the part number is unknown:
    - **Proceed to Section C and replace the EGR Cooler.**

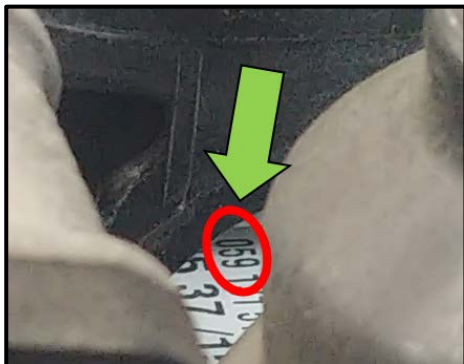
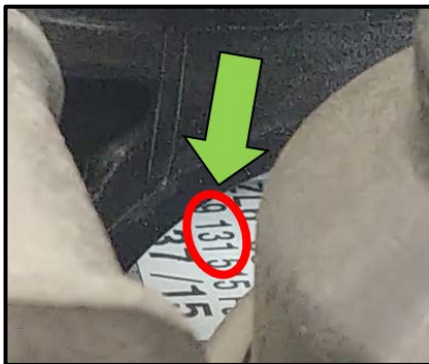
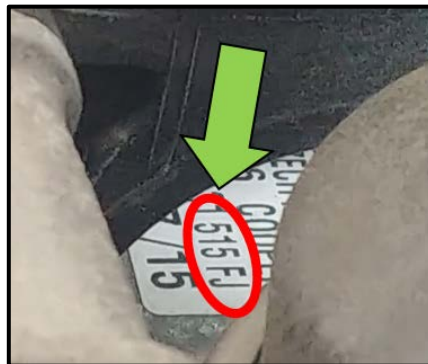
Use of a borescope or digital camera is advised to accurately record the EGR Cooler part number. The part number is partially obscured by the intake manifold. See the images below for details.
