Field campaign

Topic	Valet key (SC19/18)
Market area	United States E05 Bentley USA and rest America (6E05)
Brand	Bentley
Transaction No.	2056320/2
Campaign number	EB32
Note	
Type	
US code

New Continental GT and New Continental GTC

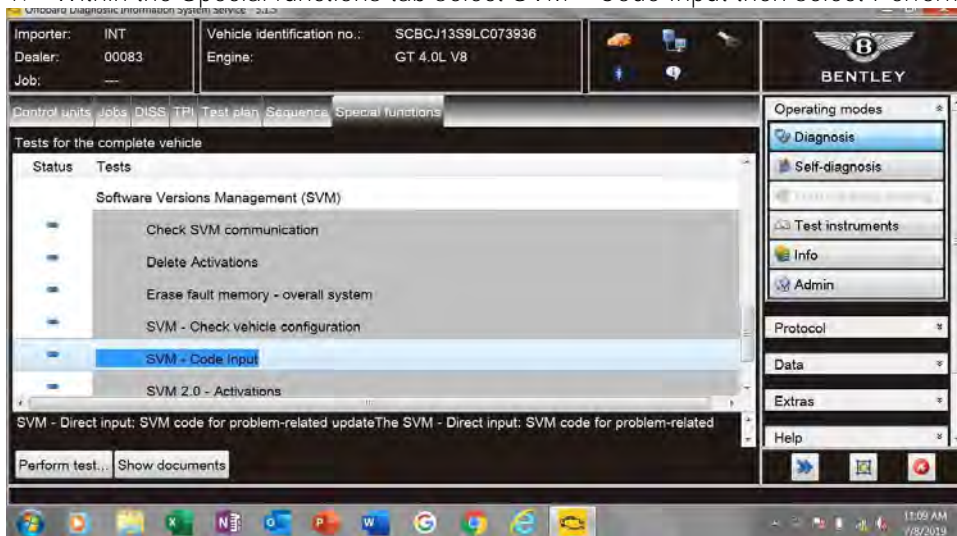
Figure 1

1. Within the Special functions tab select SVM – Code Input then select Perform test (Figure 1)

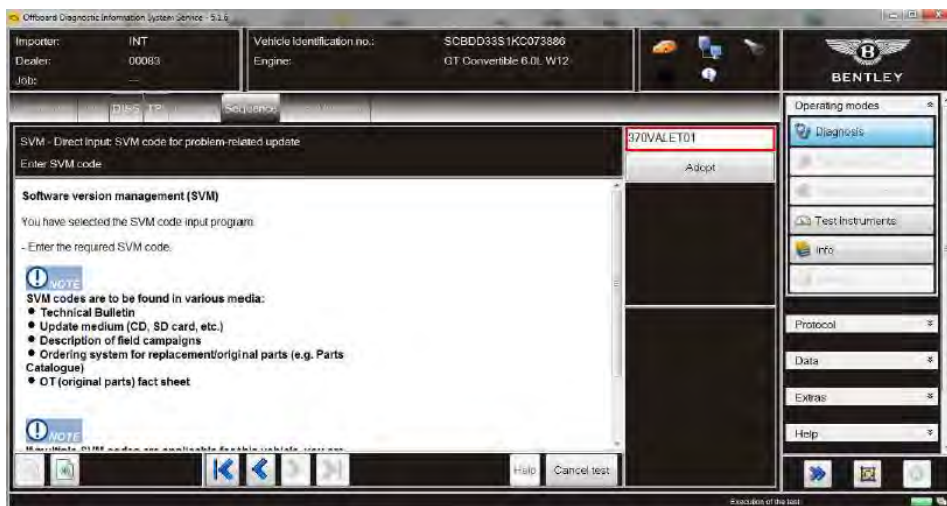
Figure 2

2. On the next screen enter the SVM code 370VALET01 and select Adopt (Figure 2).

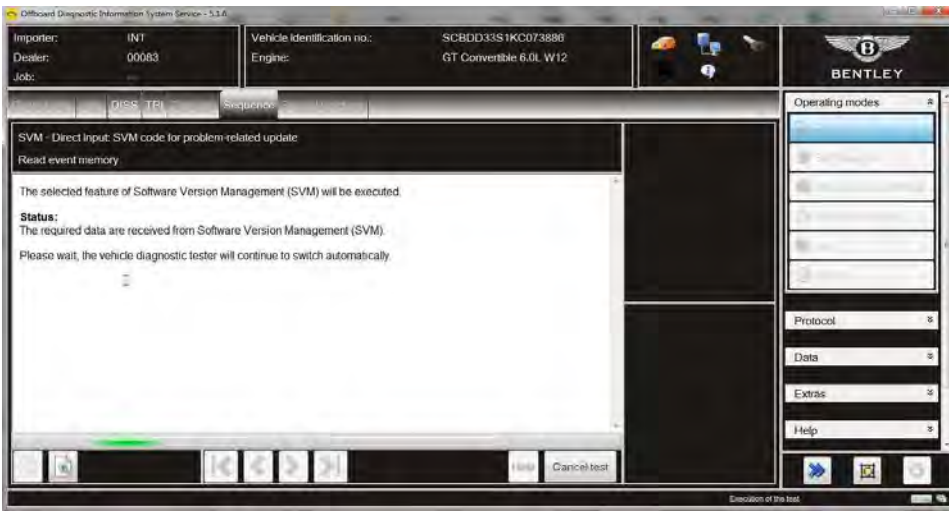
Figure 3

4. All control modules will now be interrogated.
5. The SVM will now begin (Figure 3).

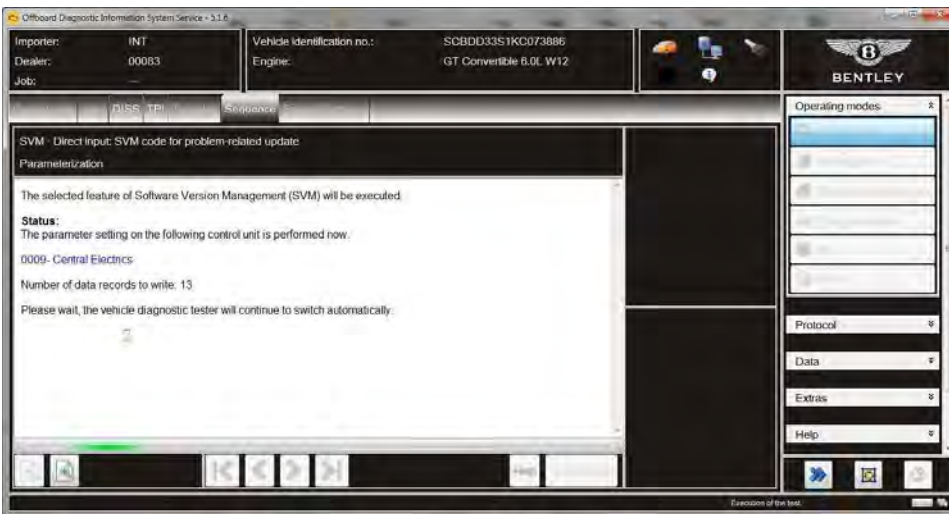
Figure 4

6. The parameters of the relevant control units will now be parametrised (Figure 4).

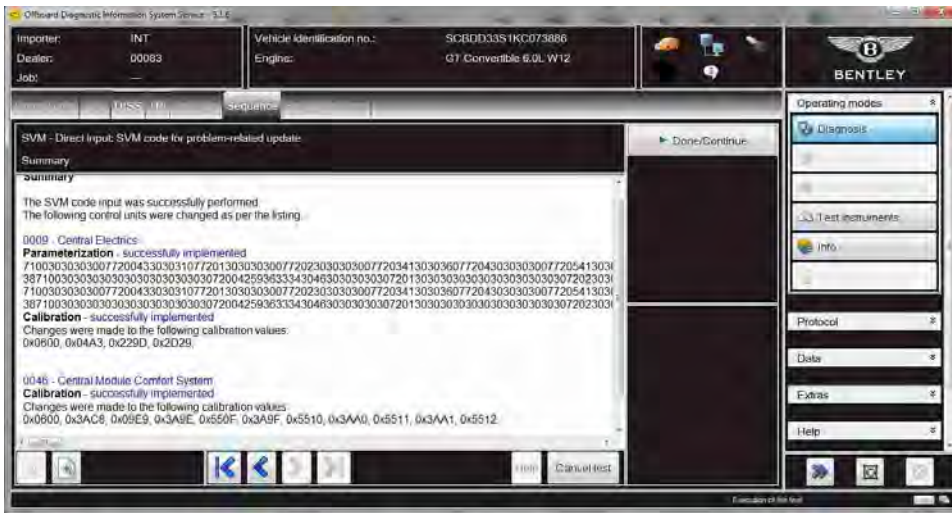
Figure 6

9. On the next screen you will get a summary of the completed actions, select Done/Continue (Figure 6).

10. Now code the valet key to the immobiliser, ensure all keys are present when doing so.
