# Technical Service Bulletin

## 60 Panoramic sunroof noises

60 19 37 2054203/3 November 18, 2019. Supersedes Technical Service Bulletin Group 60 number 19-34 dated August 9, 2019 for reasons listed below.

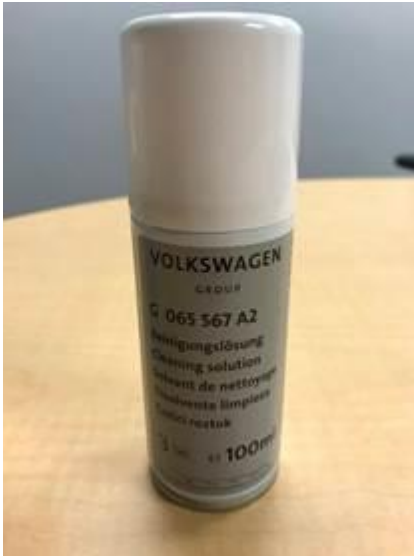
*Figure 1. All purpose cleaner: G 065 567 A2.*

The only maintenance materials approved for use on the sunroof frame are the cleaner and lubricant specified above. Alternative cleaners and lubricants used on this sunroof mechanism may cause permanent mechanical damage and worsen the level of noise from the sunroof mechanism.

If the sunroof mechanism has been lubricated with an unapproved lubricant it must be thoroughly cleaned off of the mechanism components using the cleaner G 065 567 A2 and lubricated with the approved lubricant G 060 567 A2.

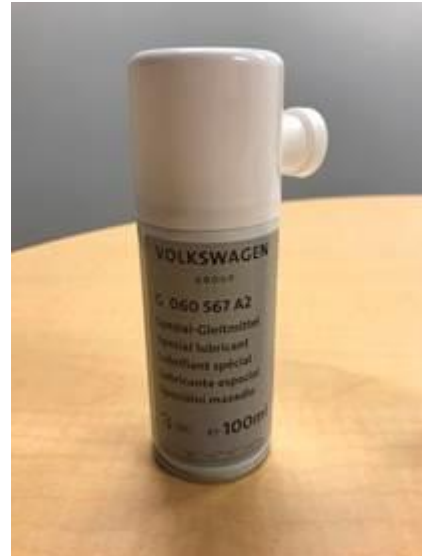
*Figure 2. Special lubricant: G 060 567 A2.*

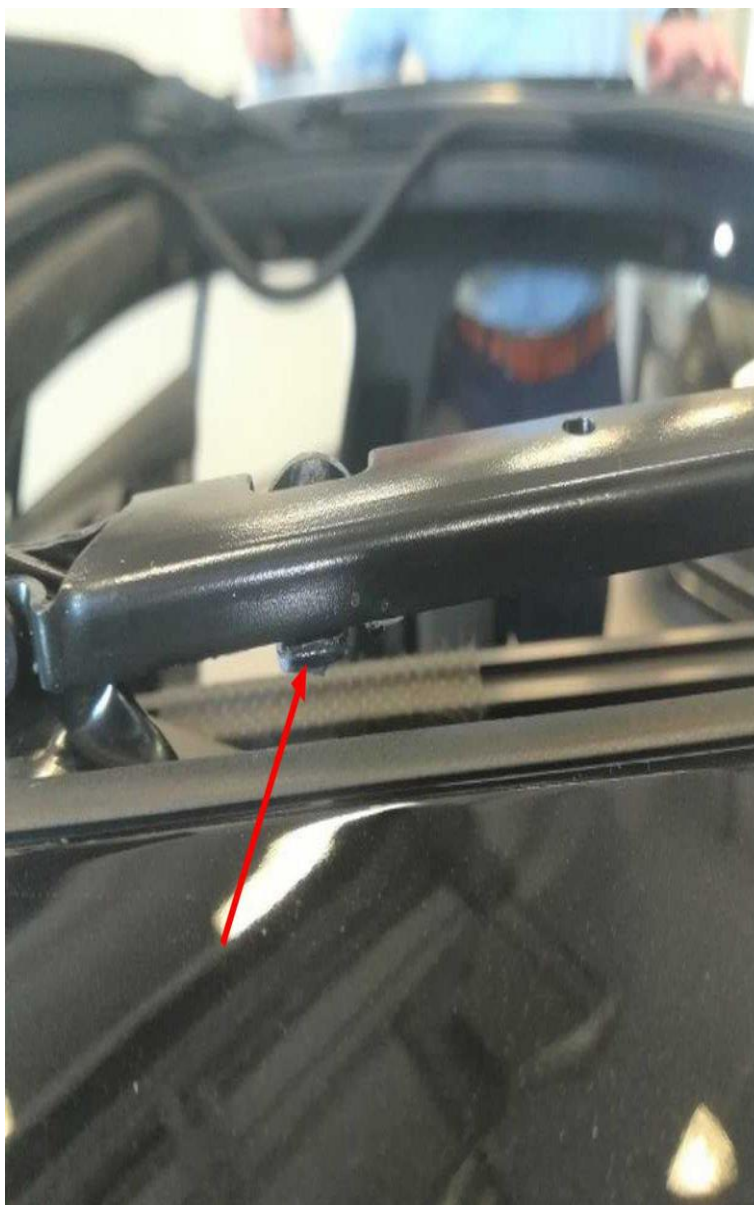
*Figure 4. Lug to be lubricated on slide and tilt mechanism.*

3. There is a lug under the first mounting point (Figure 4, red arrow). This point has to be lubricated with G 060 567 A2 lubricant.

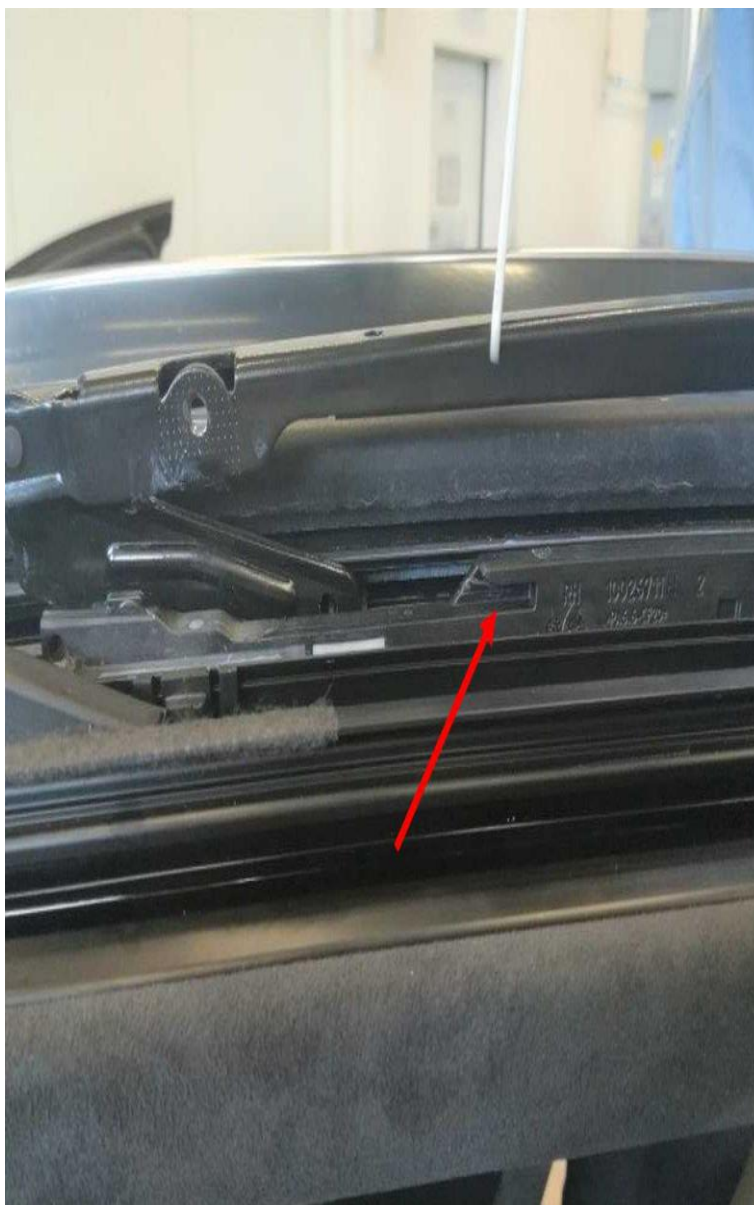
**Figure 5.** The groove in the slide and tilt mechanism.

4. Figure 5 and 6 shows the right slide and tilt mechanism from the inside. The groove indicated by the red arrow should be lubricated with G 060 567 A2 lubricant.

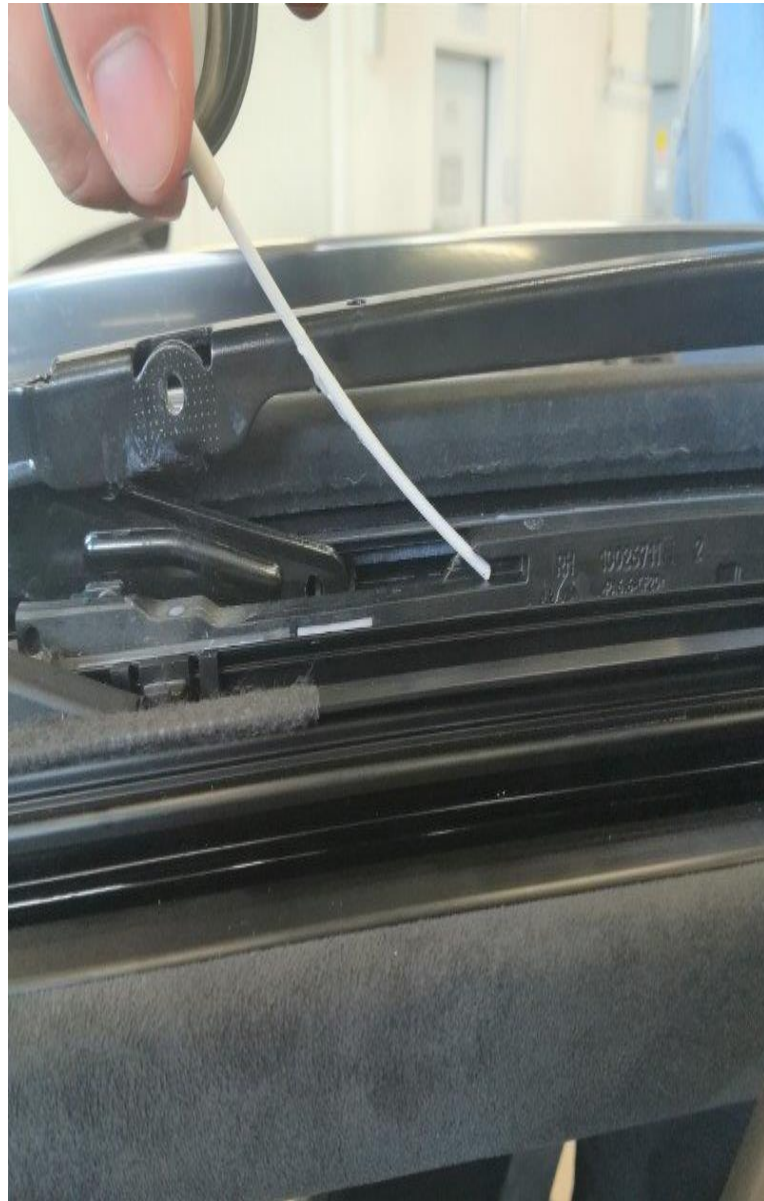
**Figure**

**6.** *Lubricating the groove in the slide and tilt mechanism.*

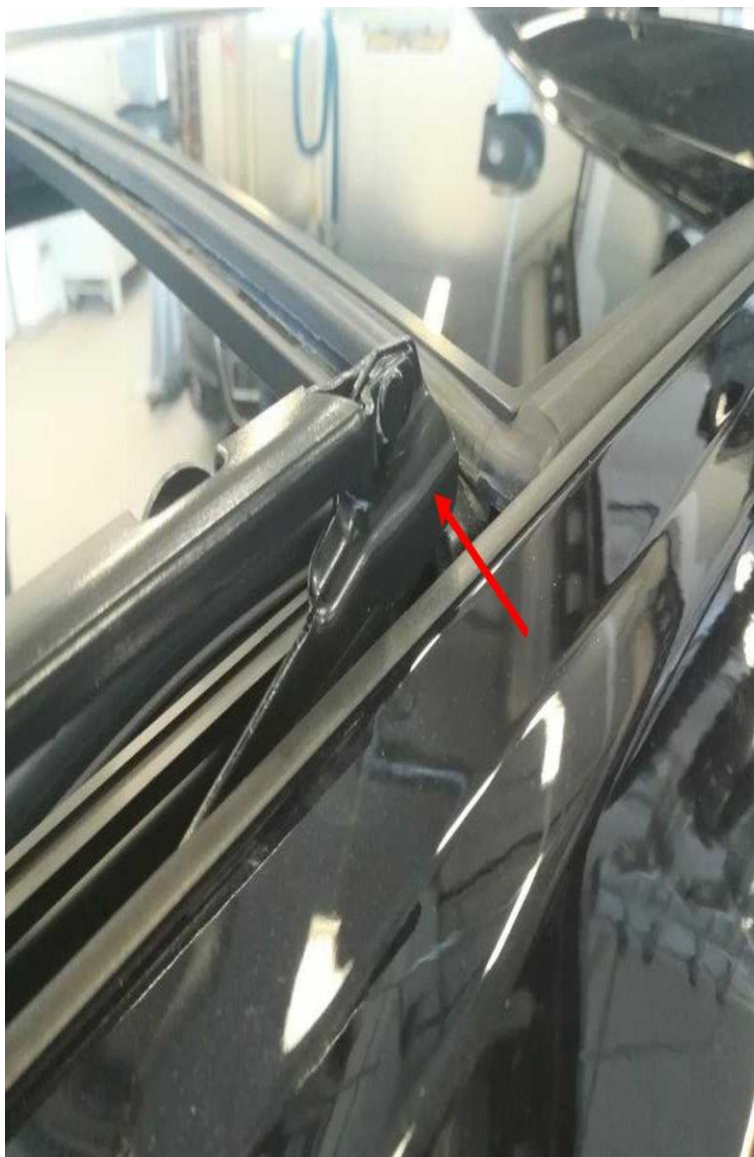
*Figure 7. Section of slide and tilt mechanism to be lubricated.*

5. Figure 7 and 8 shows the rear section of the left side and tilt mechanism that must be lubricated with G 060 567 A2 lubricant. The outer area of this bracket will be lubricated (see red arrow).

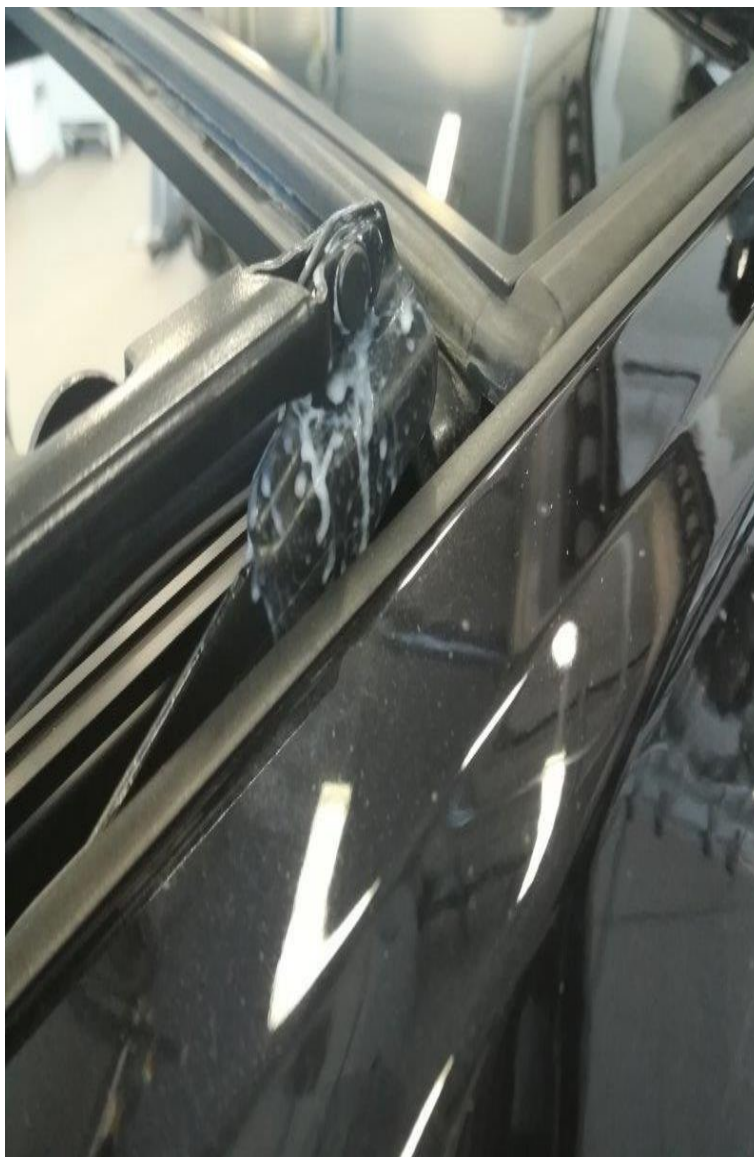
**Figure 8.** *The bracket after lubrication.*

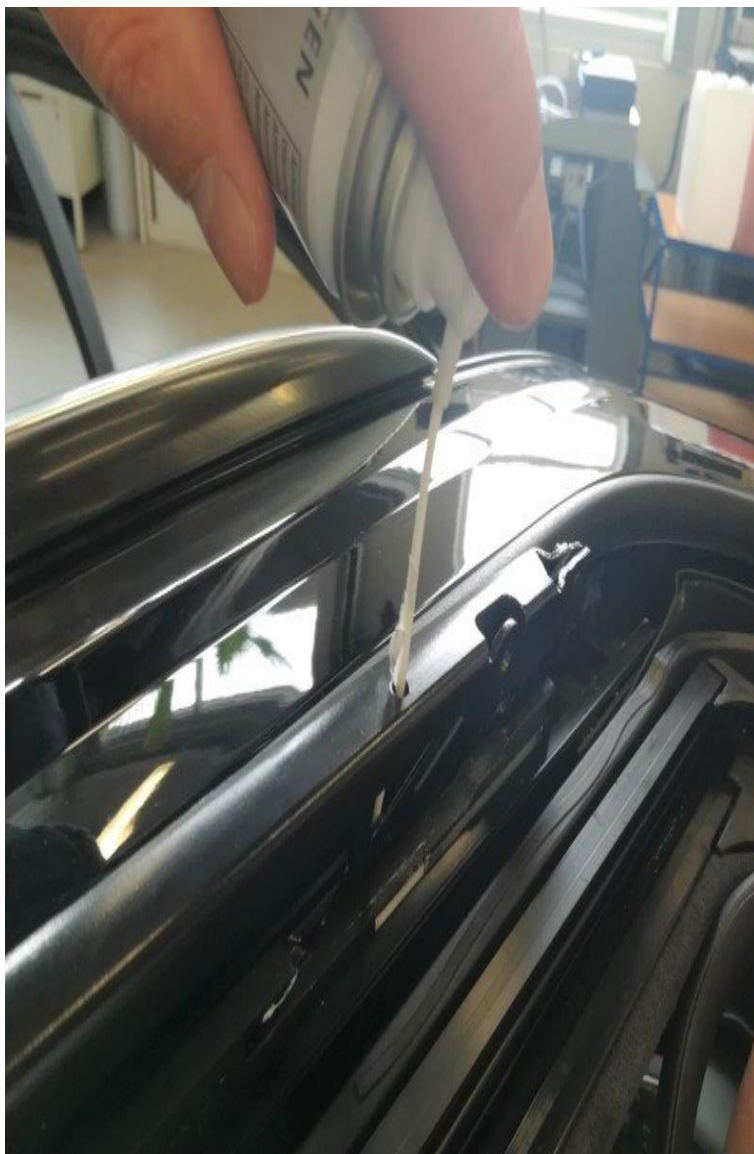
**Figure 9.** Accessing the channel through the arm of the slide and tilt mechanism.

6. Figure 9 and 10 shows the left front slide and tilt mechanism. The channel that must be lubricated can be accessed with the spray tube through the first hole in the arm as shown.

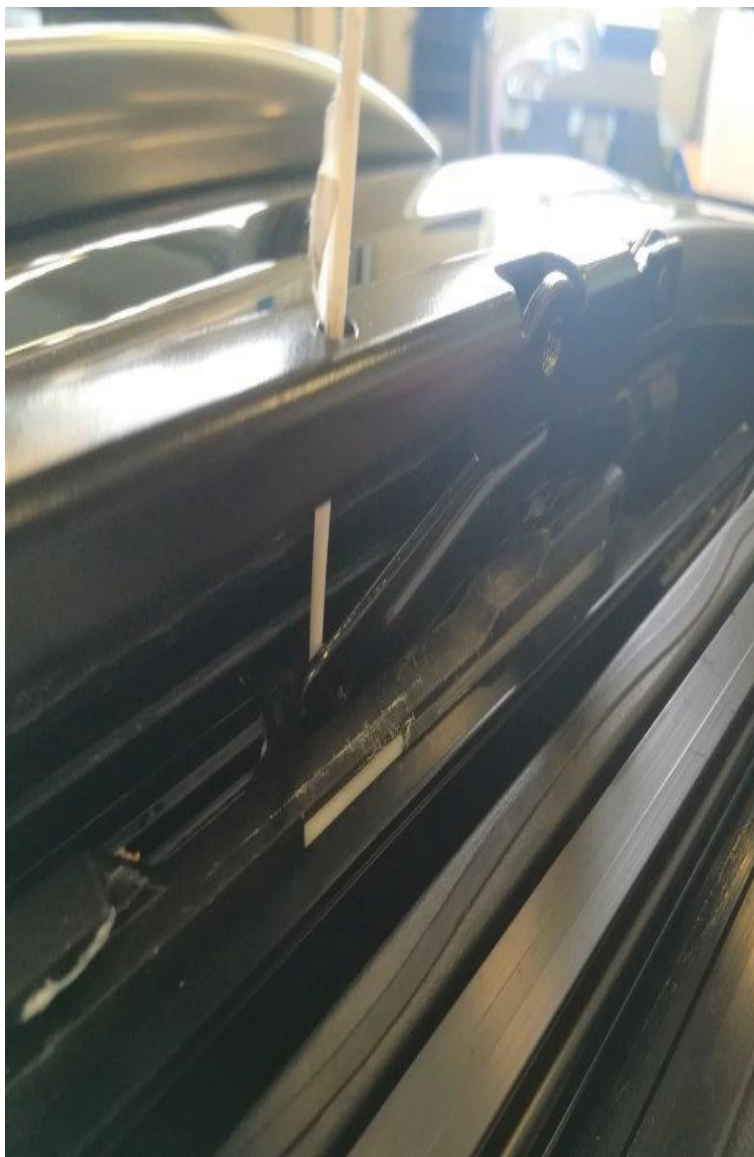
**Figure 10.** Close up view of the lubrication of the channel under the arm of the slide and tilt mechanism.

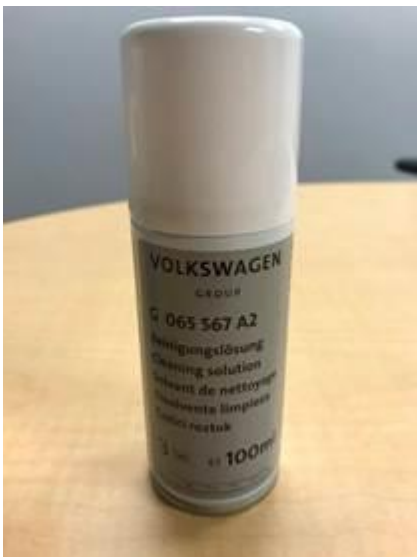
| Part Number | Part Description | Quantity |
|---|---|---|
| G 065567A2 | <br>All-purpose cleaner | 0.3 |

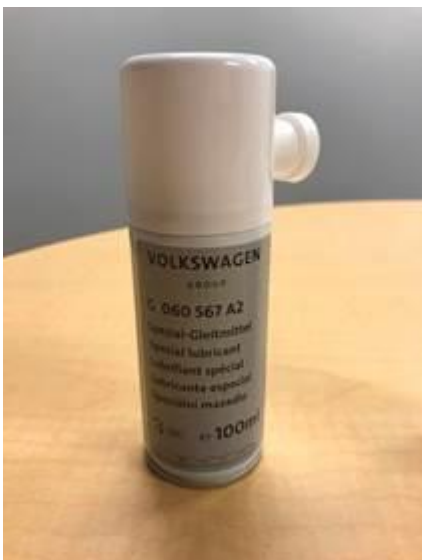
| Part Number | Part Description | Quantity |
|---|---|---|
| G 060567A2 | <br>Special lubricant | 0.3 |
